Las Vegas City Schools

2017 - 2022 District-Wide Facility Master Plan

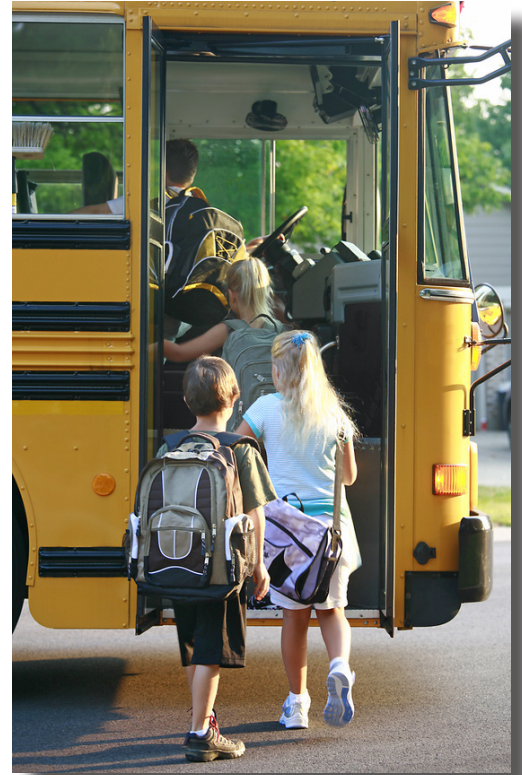
The Facilities Master Plan is comprised of five main sections:

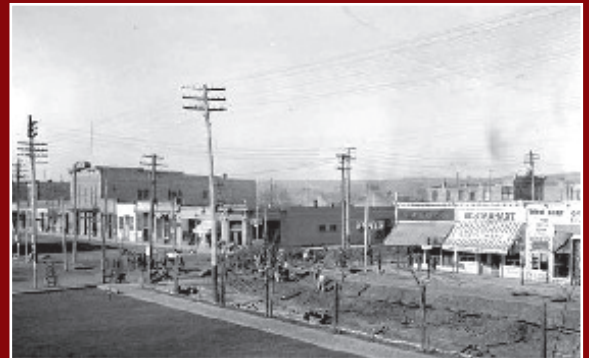
Historic Plaza - Source: mainstlvnm.com

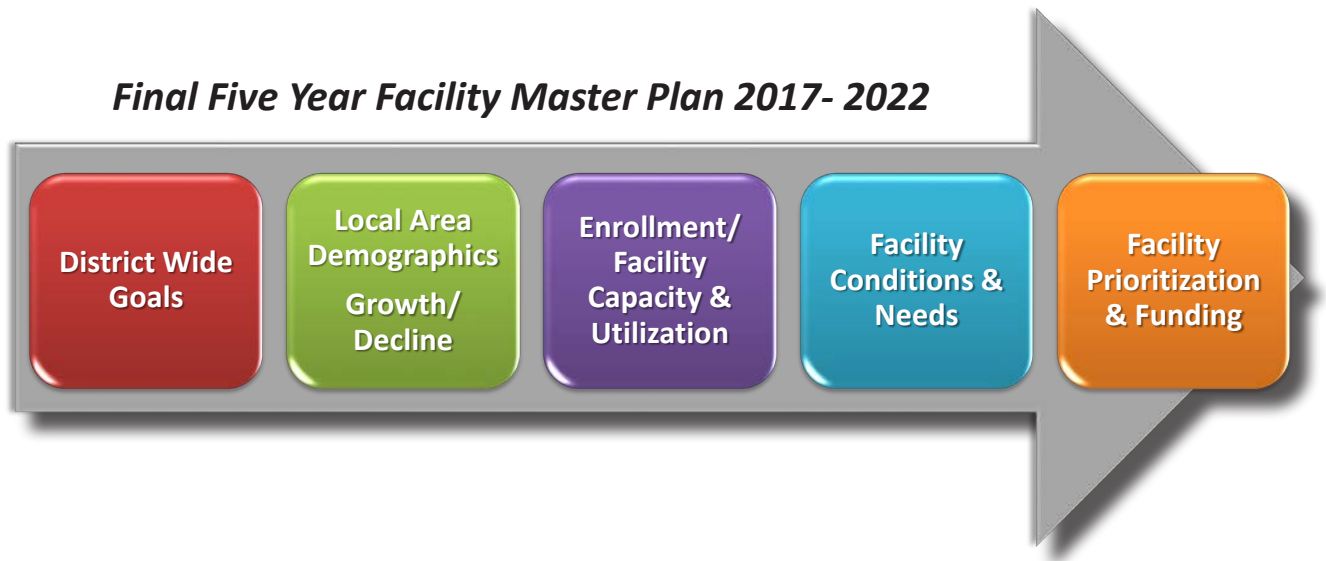
Authority and How Decisions Are Made

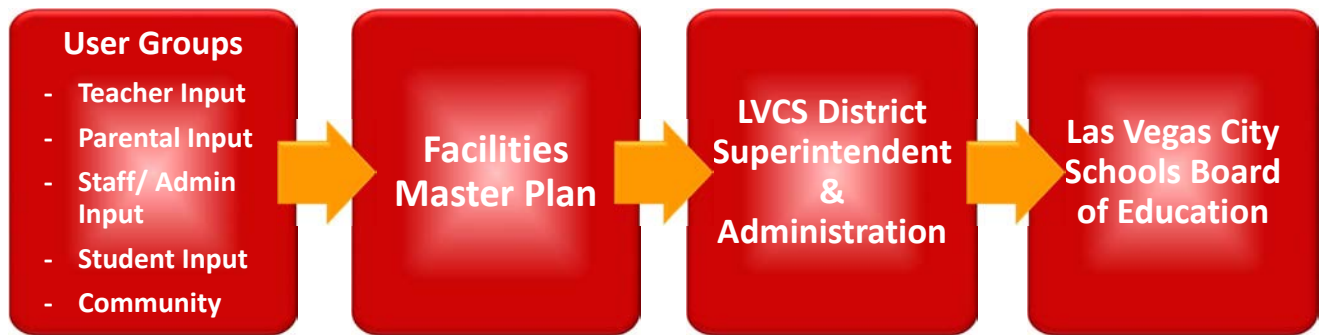
Facility Assessments -April 10-11, 2016

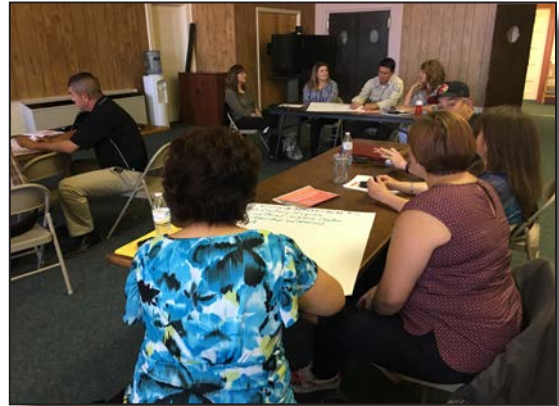
The Facilities Committee was broken into groups to conduct a SWOT (Strengths, Weaknesses, Opportunities, Threats) of the Dexter Consolidated School District. While the lists for each area were quite extensive, the committee determined that the overall key items for each area were:

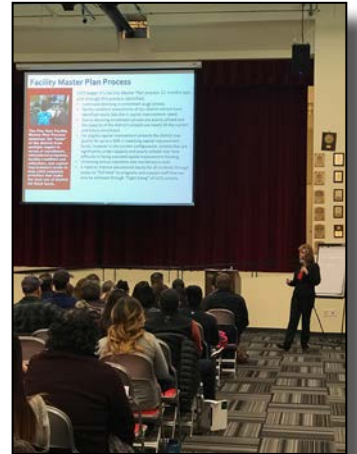
February 11, 2017 - Board of Education Retreat 9am-1pm

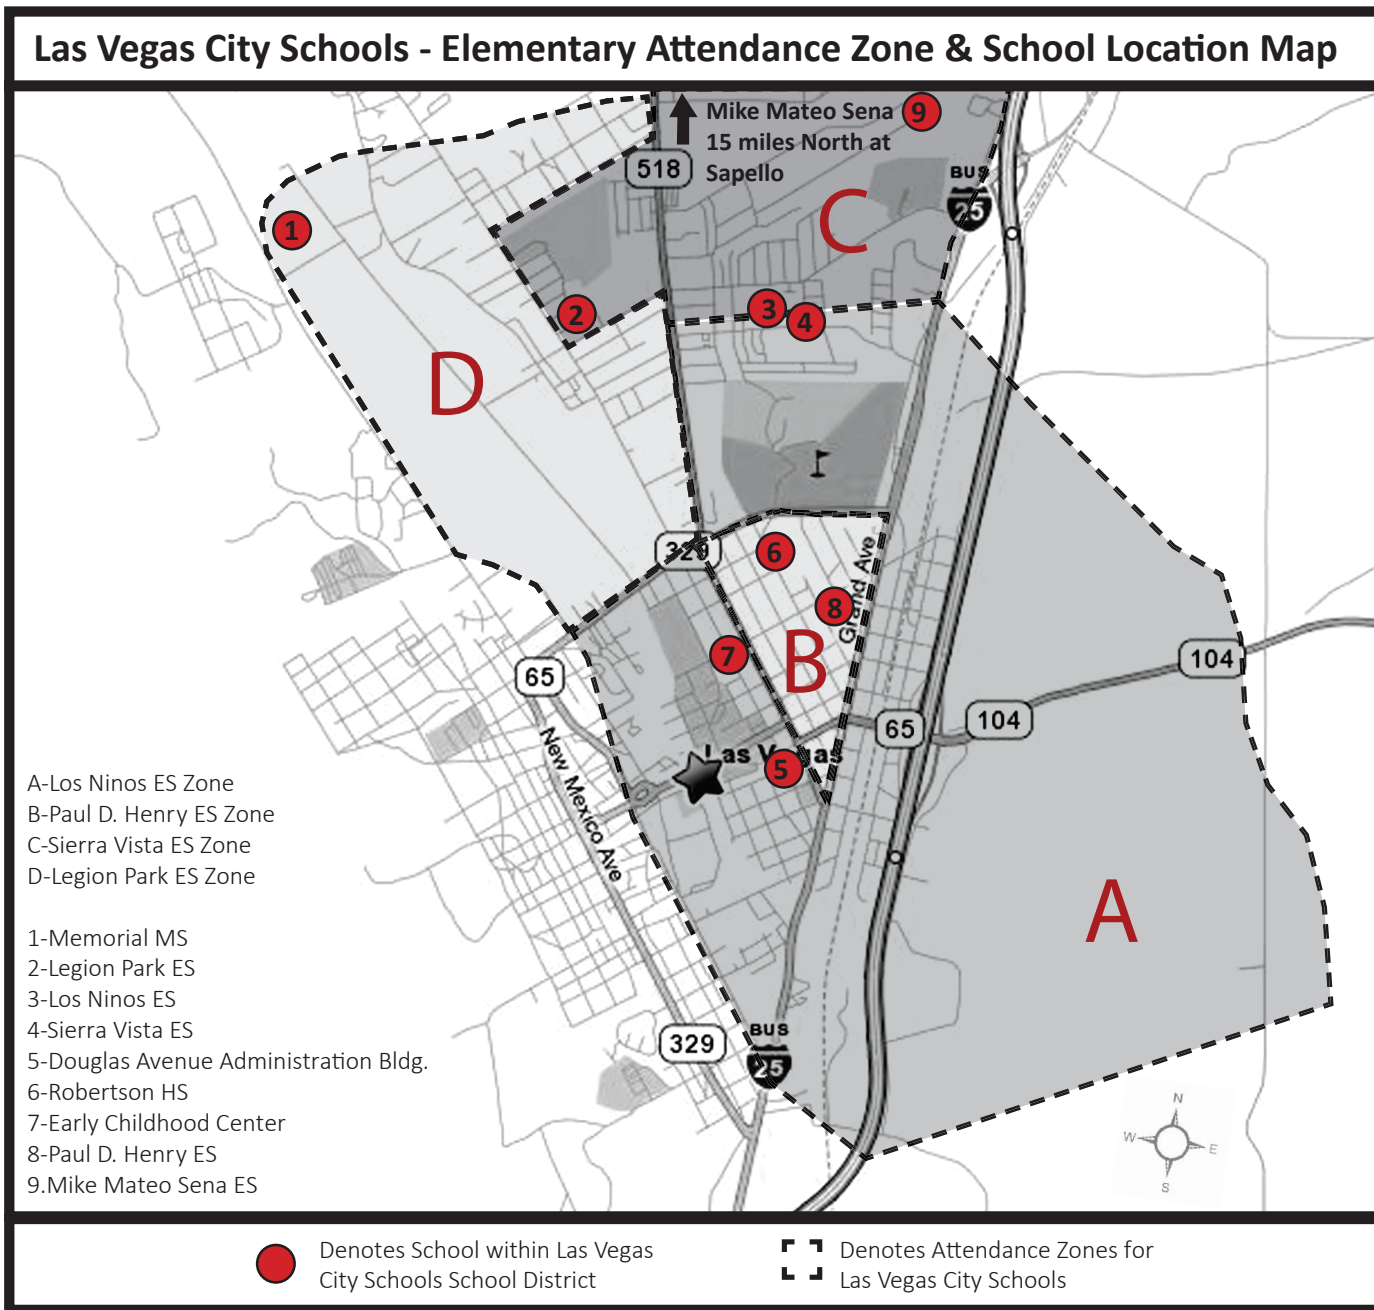
See Table 2.2.2 for an overview of the district facilities, additional details about each facility can be found in Section 4.1.

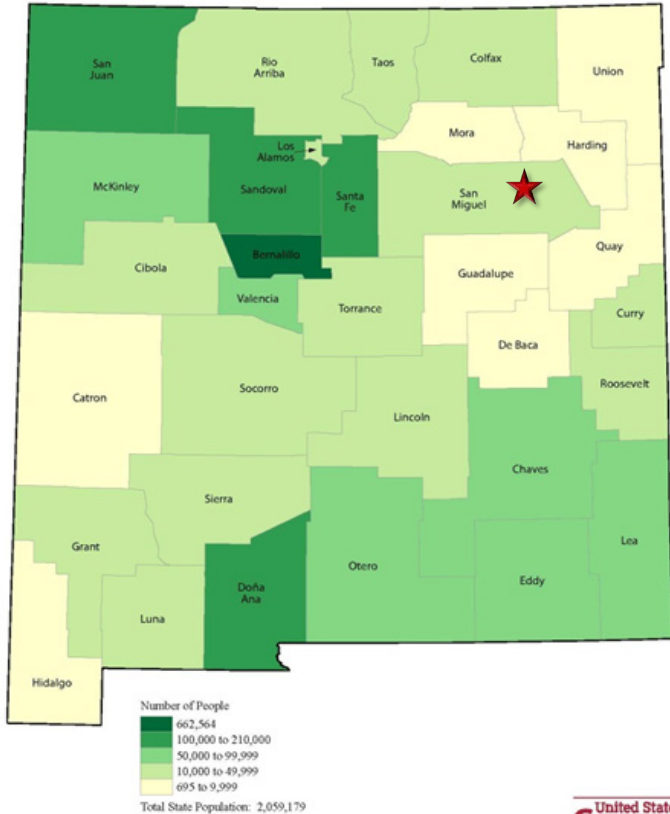
NEW MEXICO - 2010 Census Results
Percent Change in Population by County: 2000 to 2010

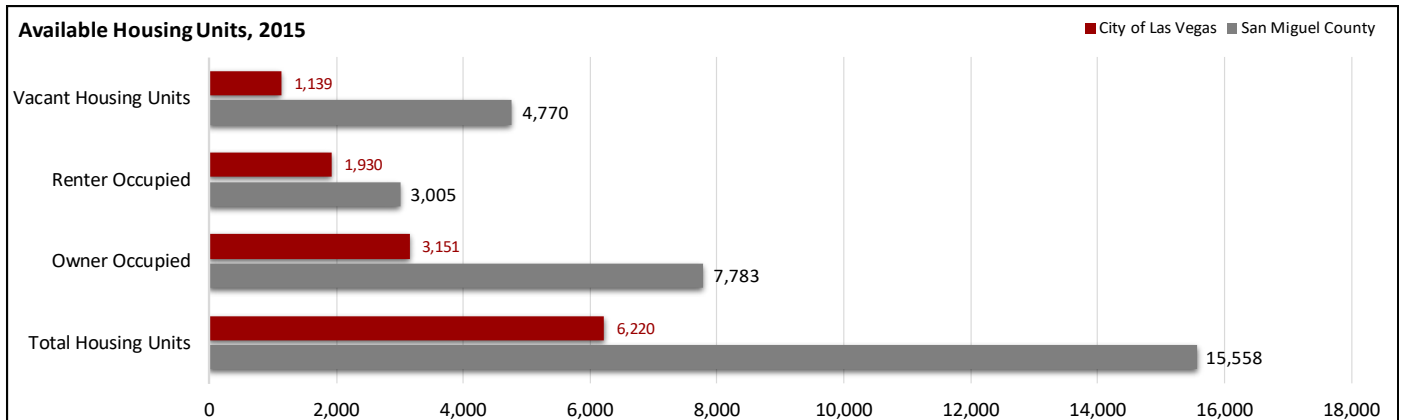
Source: U.S. Census Bureau, 2010-2015 American Community Survey DP04 Select Housing Characteristics

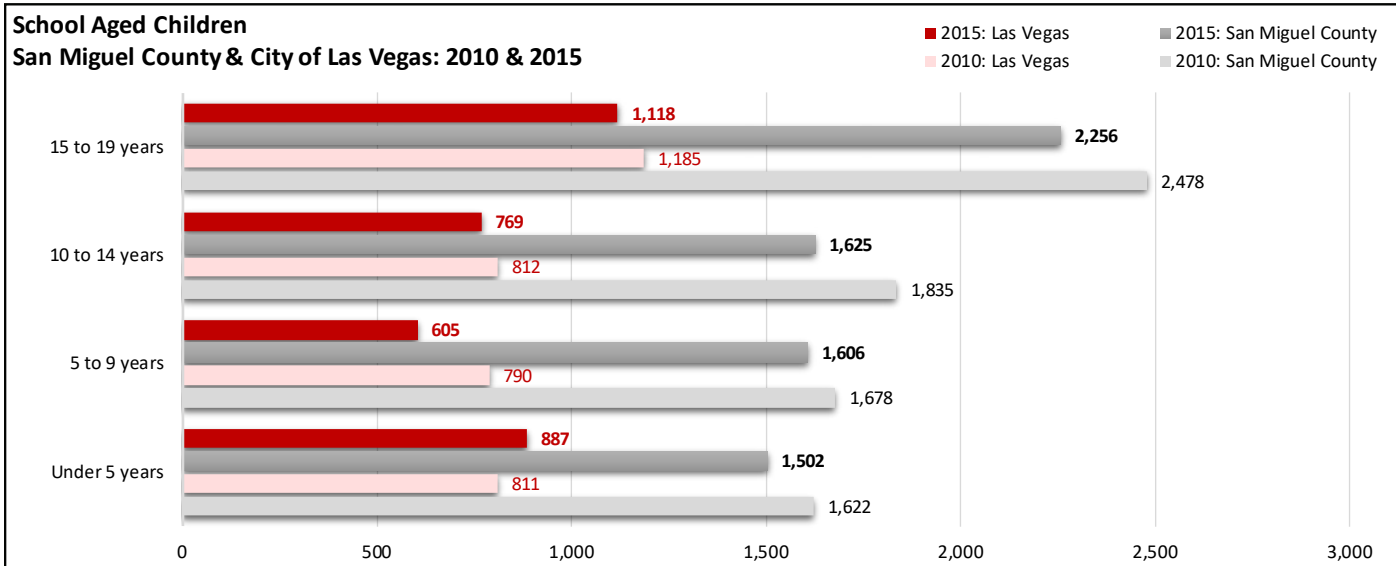
Source: US Census - 2010 DP-1 and 2010-2015 American Community Survey, City of Las Vegas / San Miguel County Population

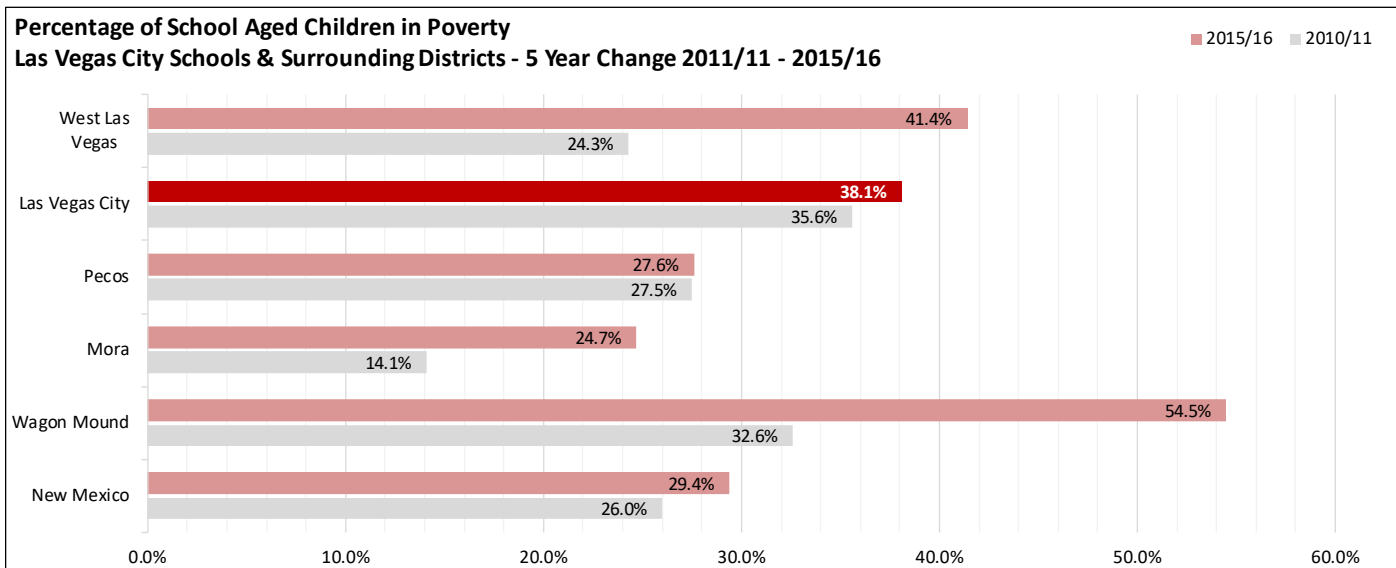
Source: US Census - 2010 and 2010-2015 American Community Survey, DP-3, New Mexico School Districts

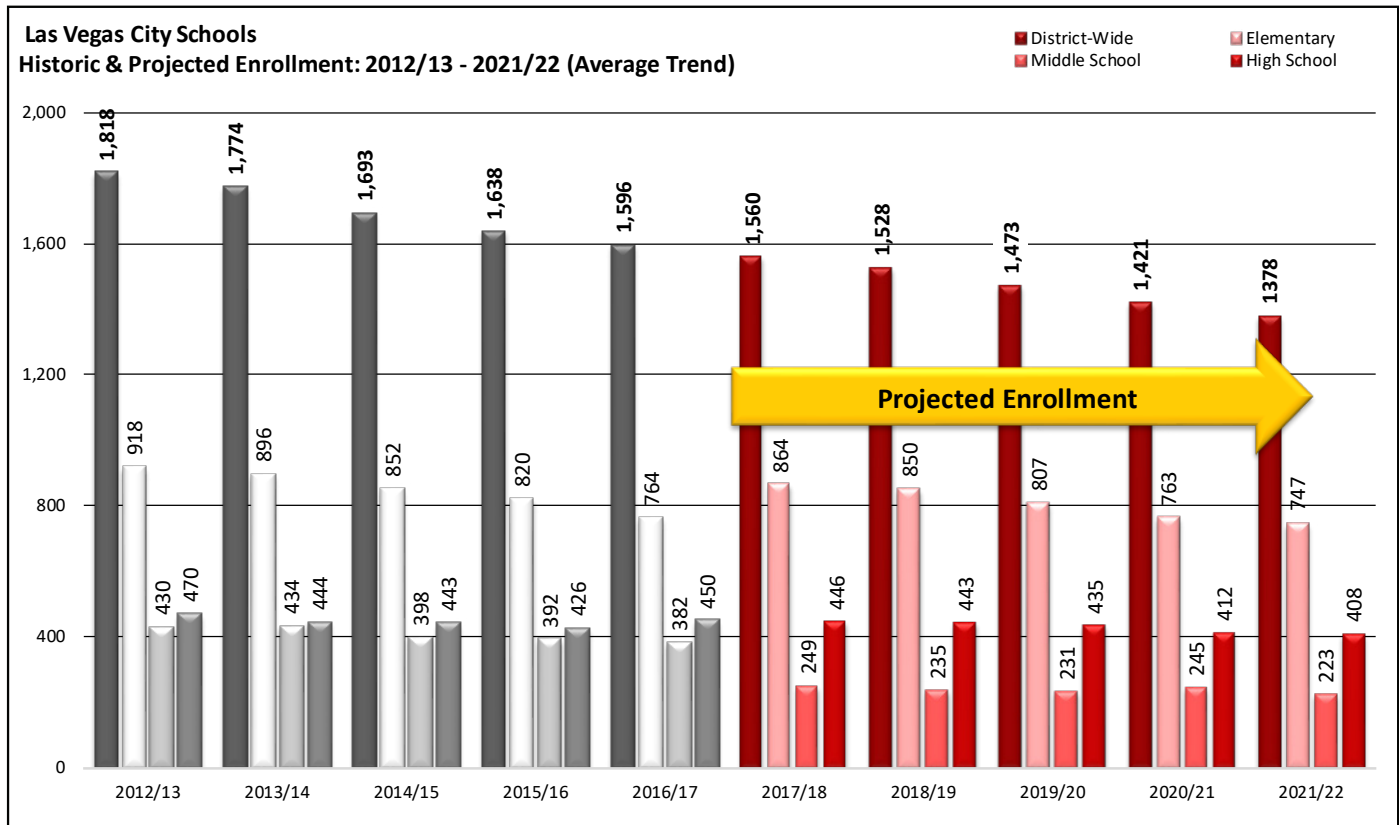
Elementary Enrollment Projections - Pre-K through 6th Grade

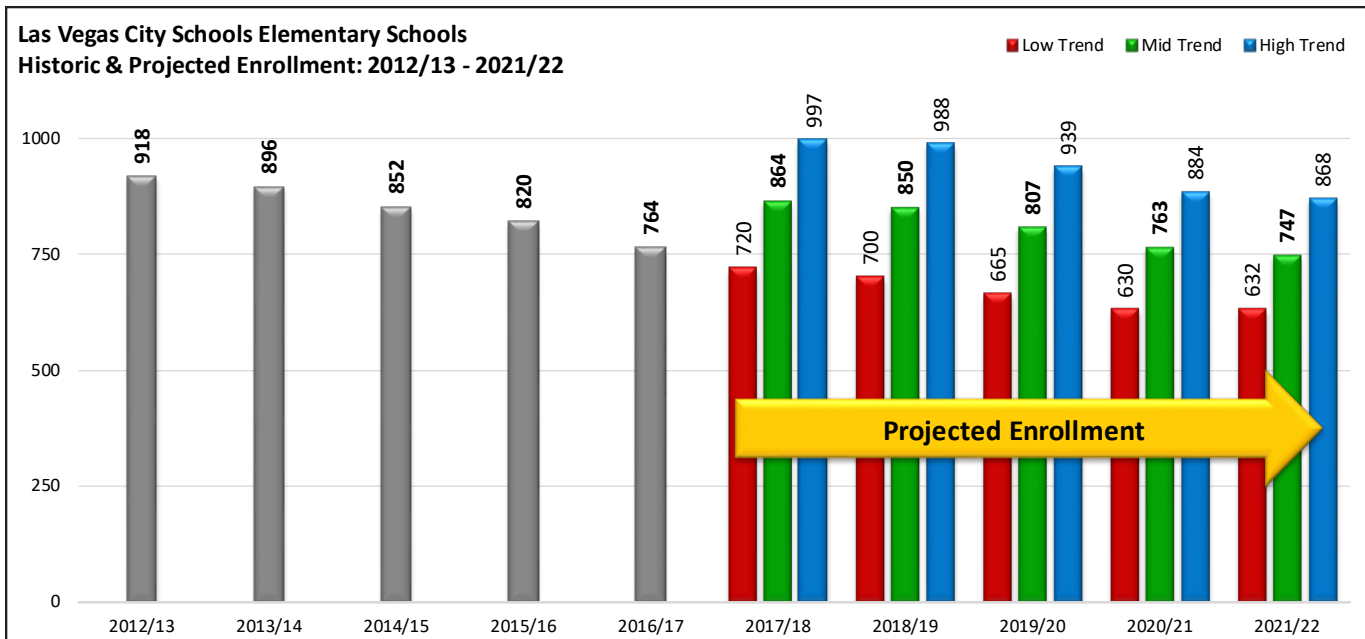
Elementary Mid-Range Enrollment Projections - By School

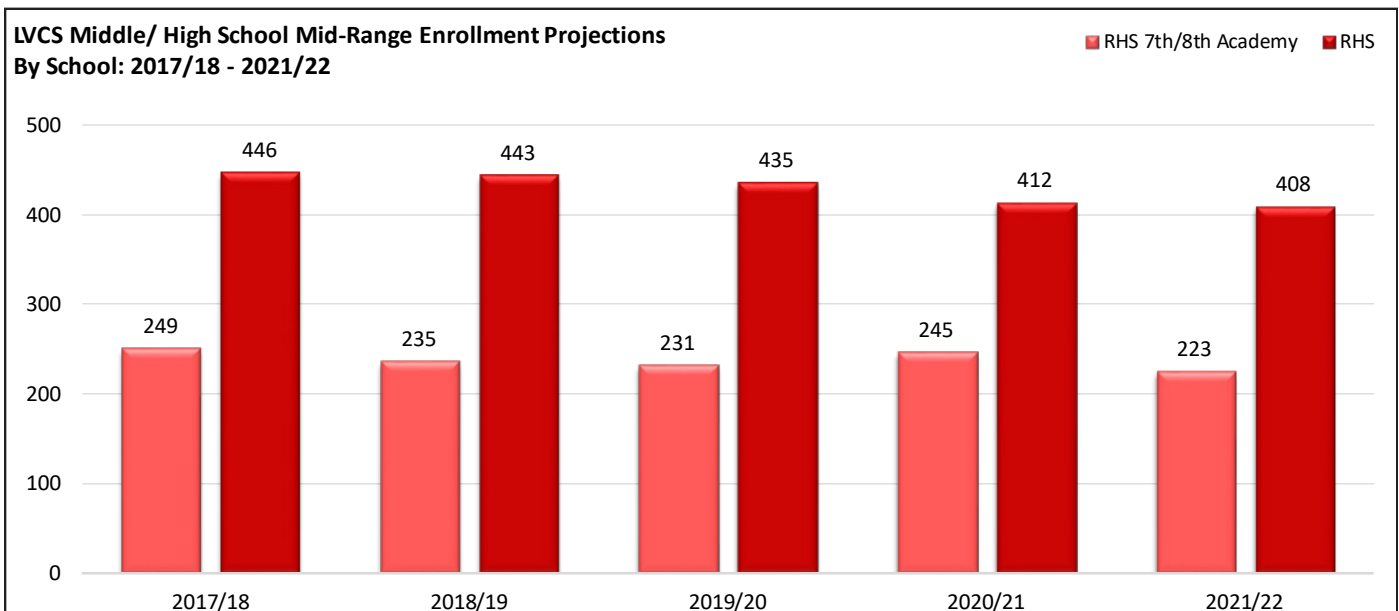
SECTION 2.0 - EXISTING & PROJECTED CONDITIONS

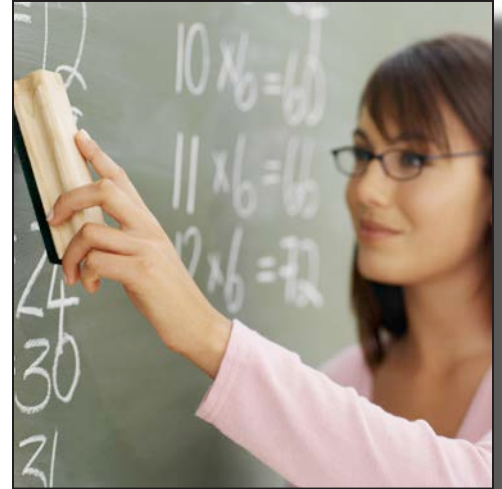
- Silas Lopez Early Childhood Center (SLECC): Will continue to serve traditional Kindergarten students until 2019/20 when a new classroom addition is completed at Los Ninos Elementary School. SLECC will also become the new location for the WLVS Head Start/ Pre-K Program.

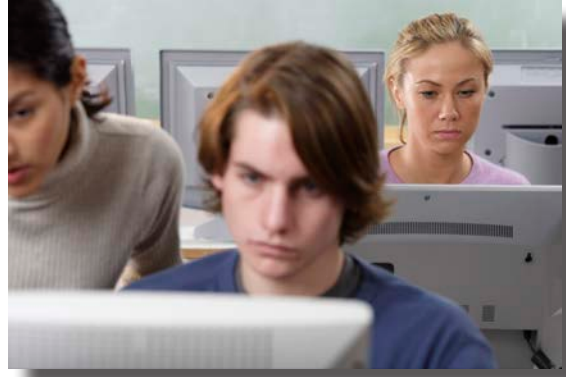
Funding sources in future years will include operational funds, state technology funds, technology grants, mil money, bond money, and Title funds, as well as E-Rate funding. The chart below lists specific strategies within the Technology Plan and expected sources of funding for those strategies. If strategies do not require specific funding, they are not included in the chart.

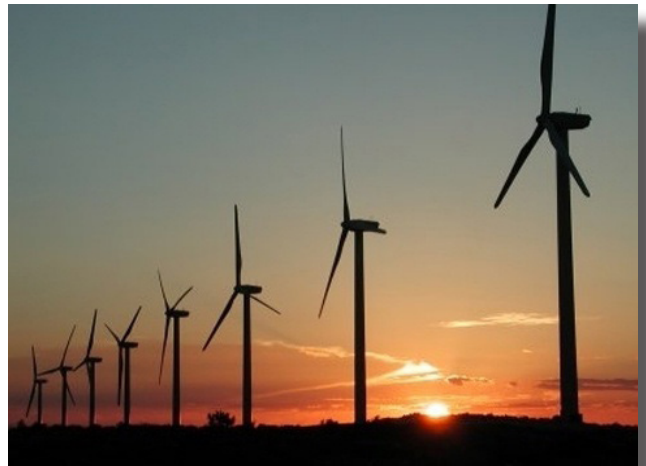
The purpose of these guidelines is to provide Las Vegas City Schools with the necessary short and long range guidelines to implement energy awareness and conservation in order to better utilize available operational funds for improving student achievement. These guidelines are not intended to be all-inclusive and may be modified for specific conditions or events.

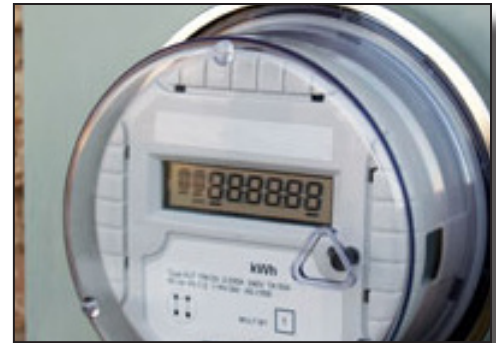
1. Thermostats shall be set to obtain a building temperature of no cooler than 72 degrees Fahrenheit during the school day, in accordance with the American Society of Heating, Refrigeration and Air Conditioning Engineers standard 55, "Thermal Conditions for Human Occupancy". Use of "hold" feature on programmable thermostats is not permitted.
2. Cooling setbacks shall be adjusted to obtain a maximum unoccupied building temperature of 80 degrees Fahrenheit.
3. The maintenance department shall adjust cooling system controls to ensure that the temperature of air-conditioned areas is maintained appropriately.
4. Cooling and air circulation problems should be reported to the maintenance department through the work order system.

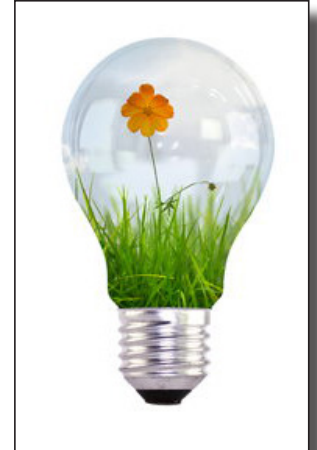
Note: All future renovation projects to install occupancy sensors in all occupied and non-occupied spaces to reduce energy. All exterior lighting replacement will be controlled with photo-cells, timers or both.

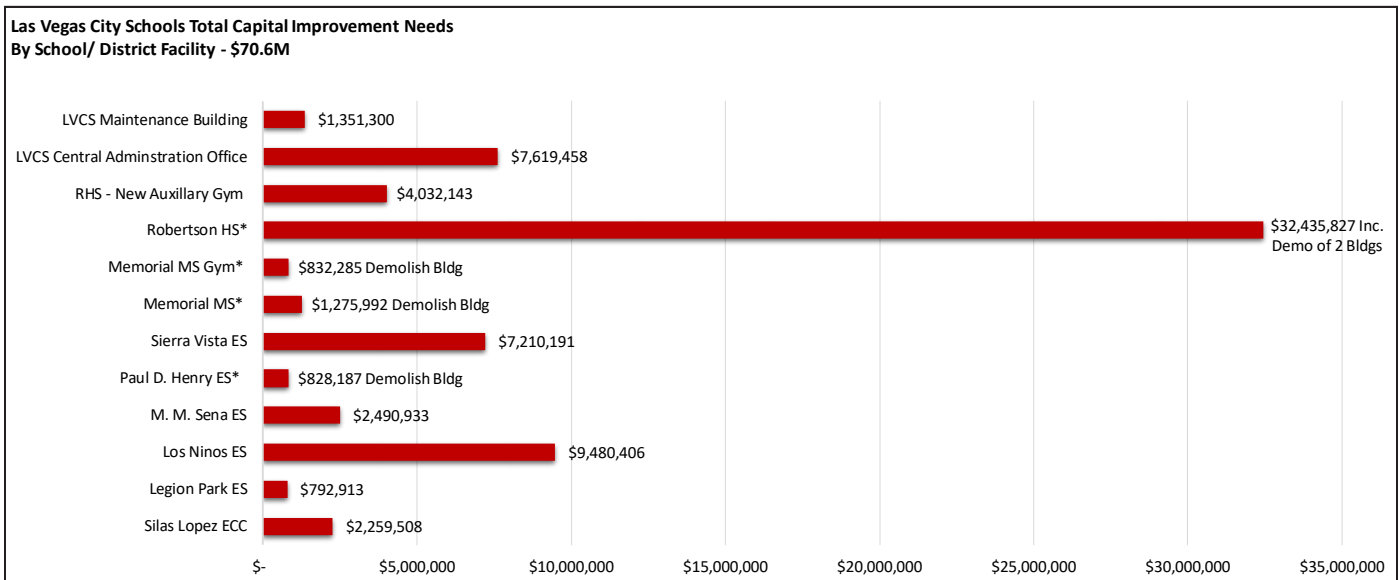
2.8.4– Maintenance Projects

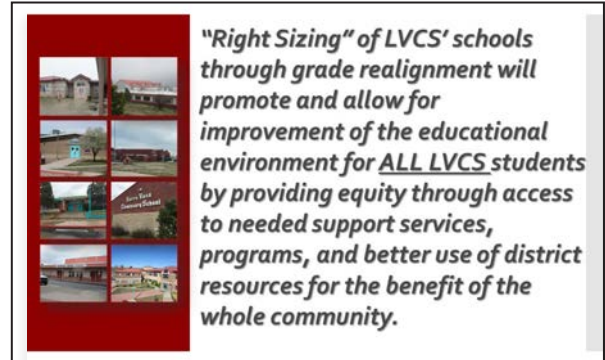
The LVCS Capital Improvement Plan focuses on the following goals and strategies:

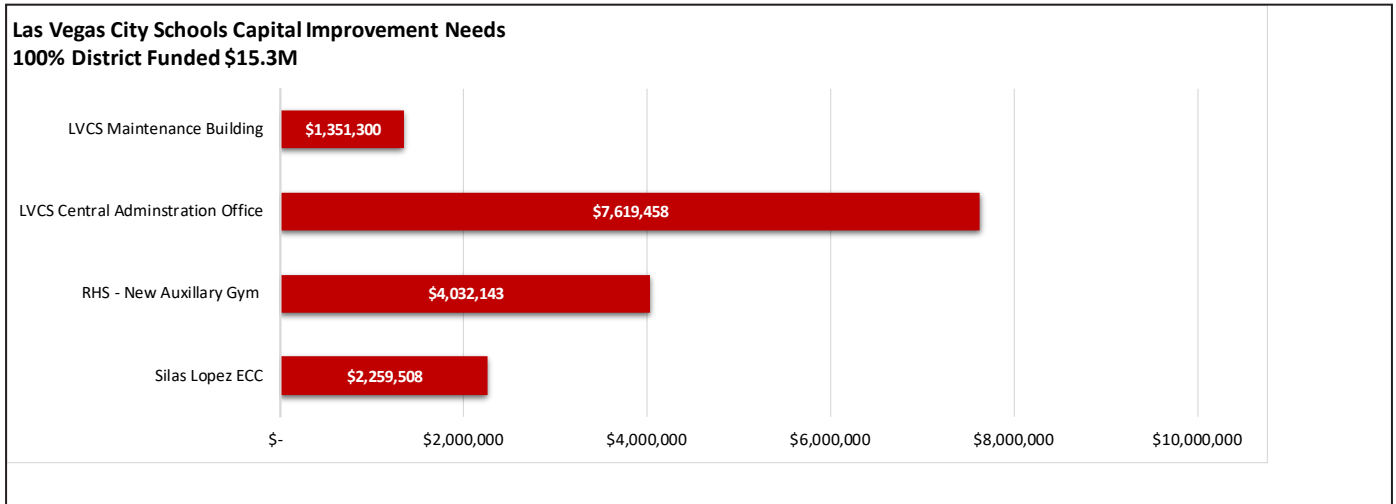
As with every school district, there are facility needs that are not typically covered by PSCOC funding and can range from district support facilities, to athletic facilities, special equipment, larger budgetary facility renewal items such as roofs or parking lots, minor renovation needs, playground equipment, technology and security upgrades. The chart below, identifies district funded projects over the next ten years, which could have funding allocated from the either the 2017 or 2022 GO Bonds including future GO Bond elections, as well as be supplemented where possible with SB-9 monies.

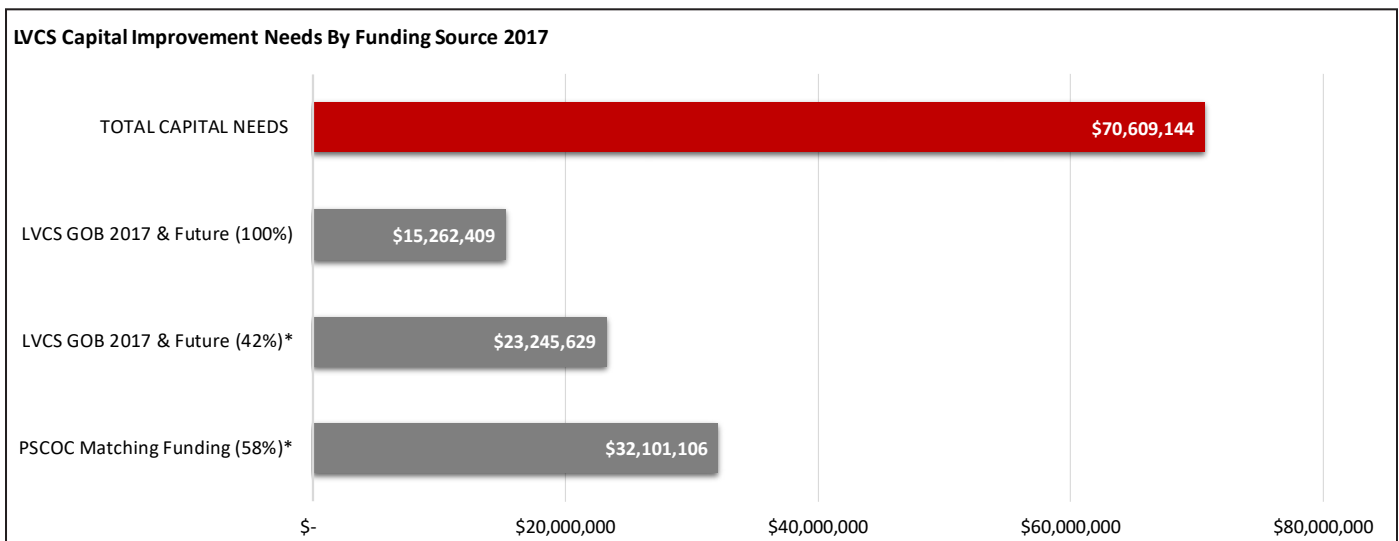
* Before Legislative Offset of \$611,538 Applied

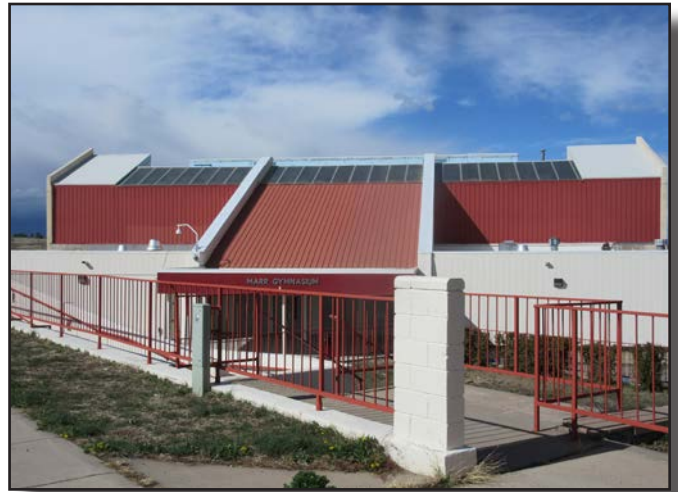
- The “actual” physical condition of all building systems at each school campus
- Site conditions (playgrounds, bus/ parent pick-up & drop parking, etc.)
- The availability of technology at each site
- The educational suitability and compliance with the NM Adequacy Standards

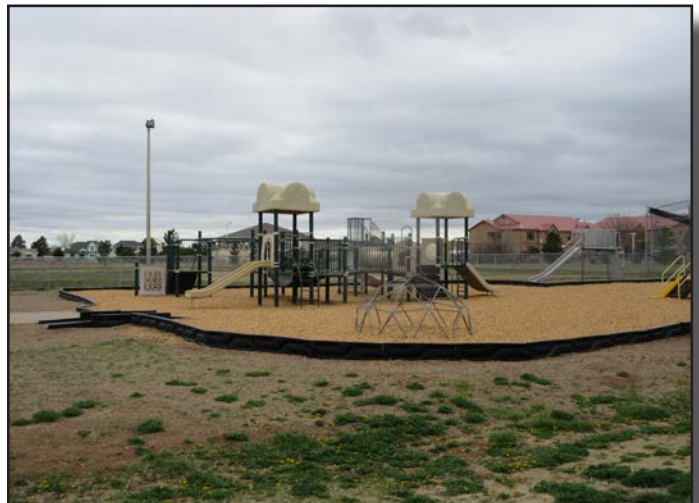
The review of the mechanical systems, electrical systems, and fire & life safety systems at the property

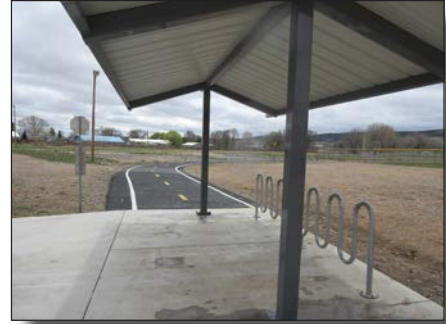
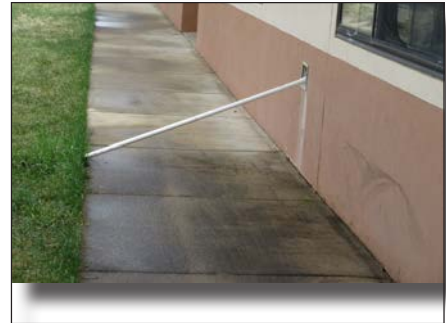
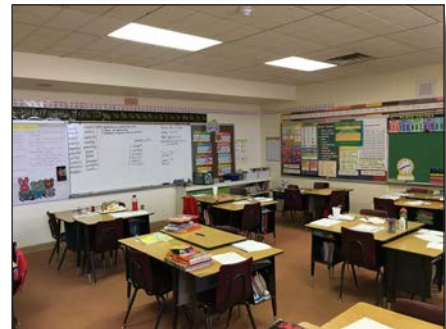
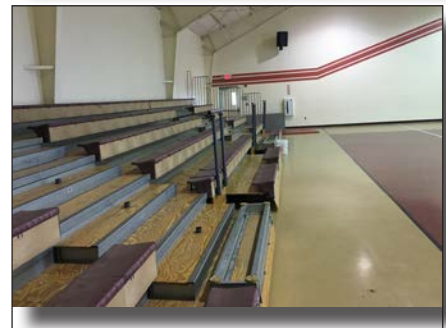
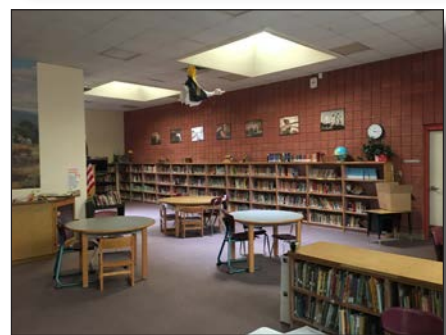
SECTION 4.0 - SUPPORT INFORMATION

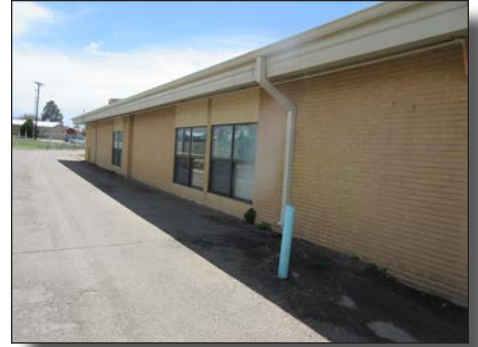
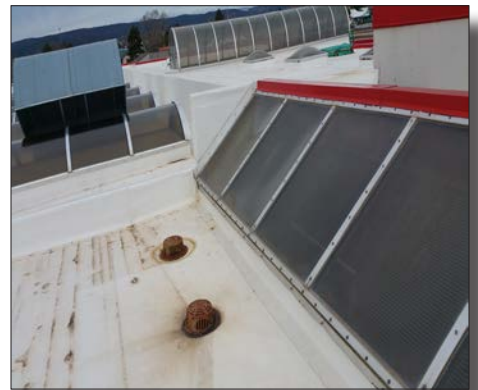
Sampling Of Observed Conditions - Educational Adequacy

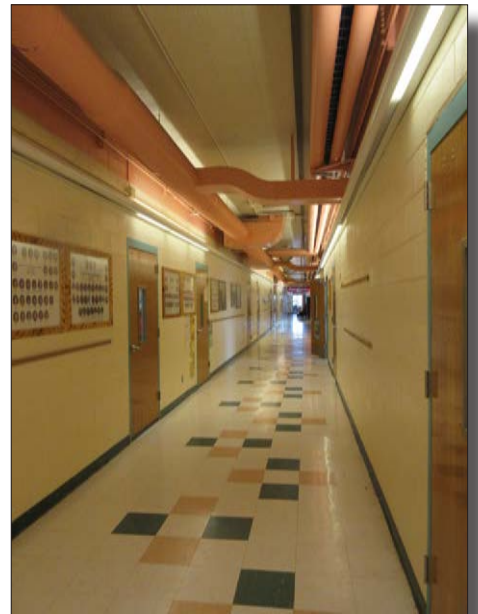
SECTION 4.0 - SUPPORT INFORMATION

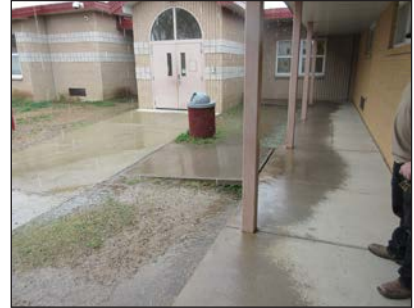
Drainage issues- Regrading needed

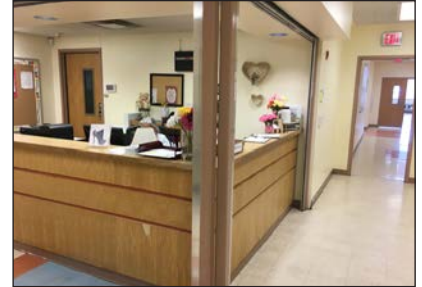
Provide secure admin & main entry

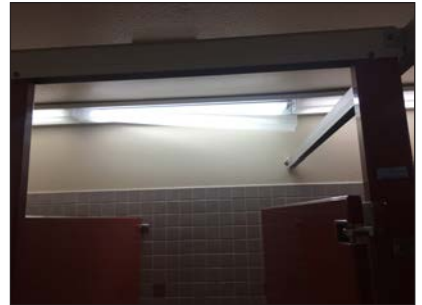
Reattach light lens in restroom

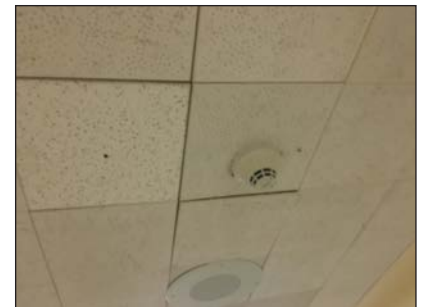
Replace ceiling tiles stained/damaged

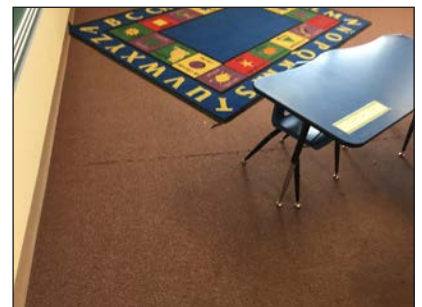
The school has several classrooms that do not meet minimum adequacy standards for kindergarten and may not have the capacity to accommodate its enrollment without the use of portable classrooms. Staff and faculty areas are inadequate in size, and the nurse’s office is too small to meet the needs of the current enrollment. The school does not have a secure entry as the administration office is very small and awkwardly arranged near the main entrance.

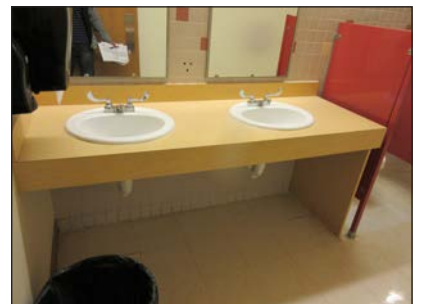
Replace damaged wall tile

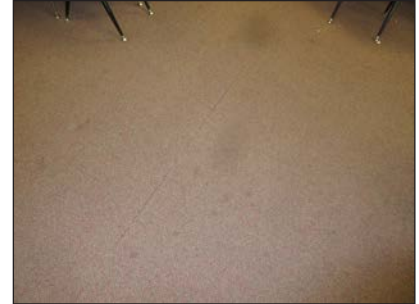
Replace carpet tripping hazard

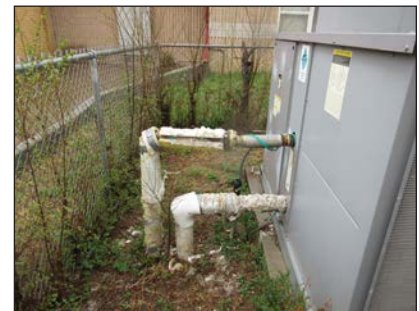
Replace damaged/missing insulation

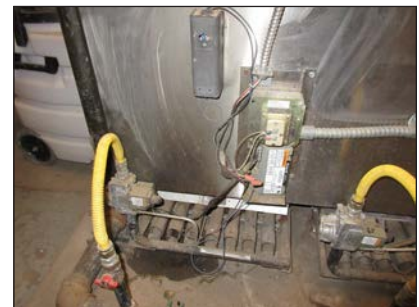
Wiring to be reworked at connections

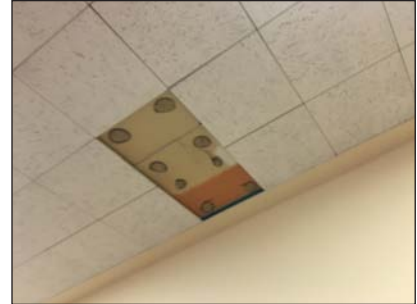
Replace missing ceiling tiles

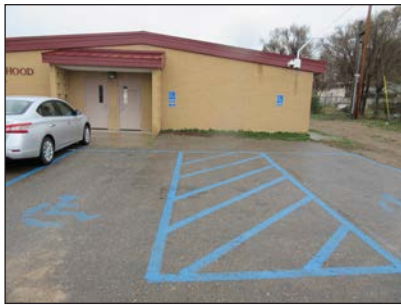
Parking bumpers needed & repave parking lot

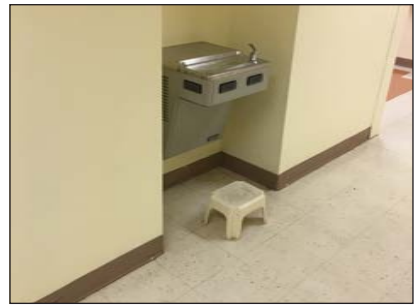
Replace water fountains & comply w/ ADA

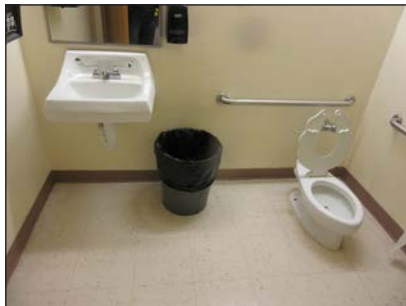
Restrooms need ADA upgrade

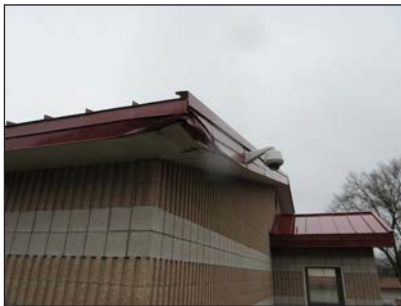
Repair damaged roof corner

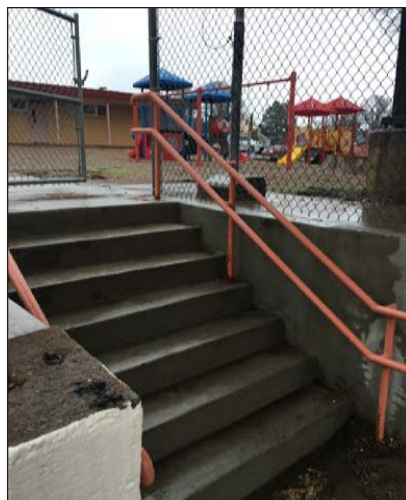
No ADA access to bus drop-off/pick-up

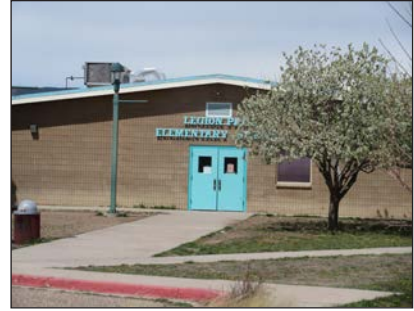
Grading & drainage improvements needed

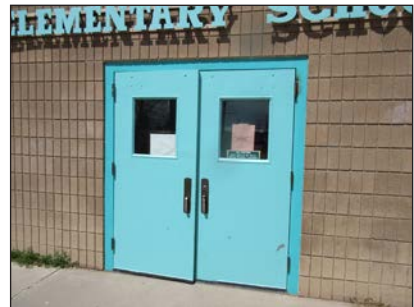
Replace exterior doors & frame

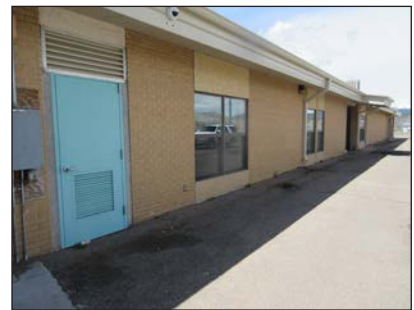
Replace exterior doors & windows

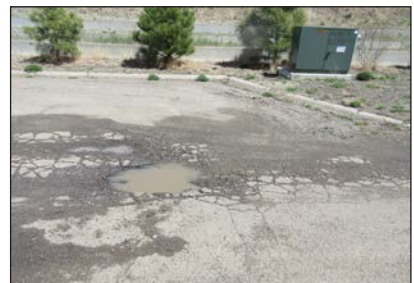
Pavement deteriorated

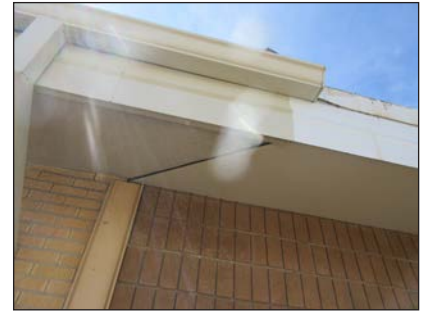
Repair/replace metal flashing

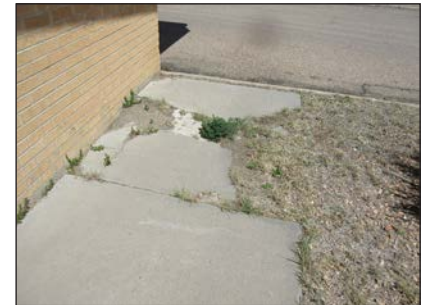
Replace deteriorated sidewalks

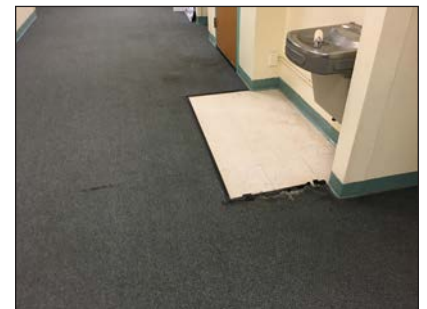
Replace carpeting throughout

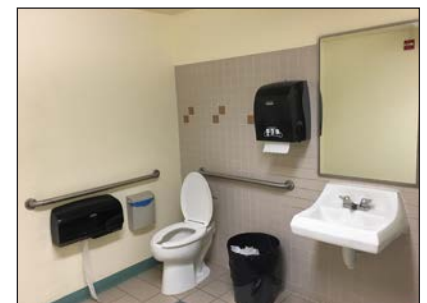
Restrooms renovations needed including ADA compliance

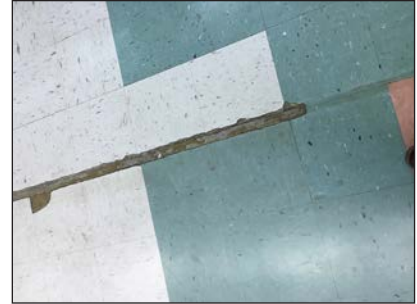
Replace VCT throughout

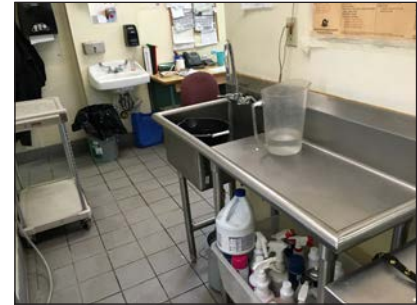
Kitchen renovation needed

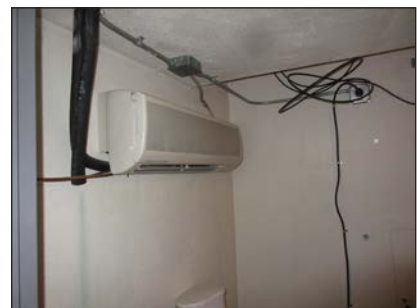
All wiring needs to be cleaned up

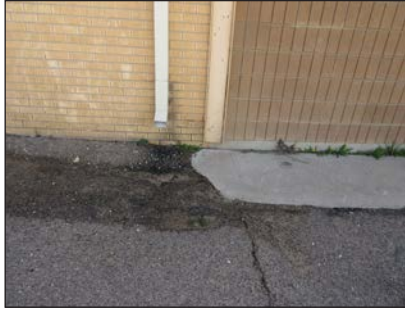
Replace missing downspouts

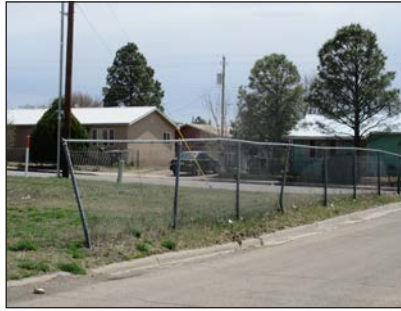
Replace all damaged site fencing

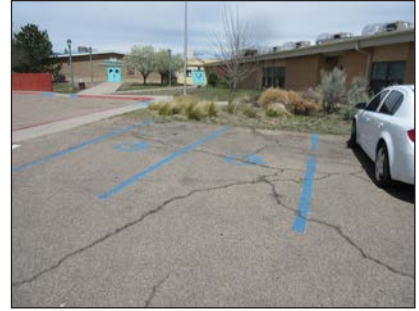
Resurface & re-stripe parking lot to meet ADA requirements

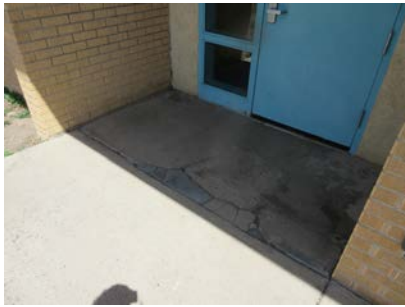
Replace spalled/broken sidewalk

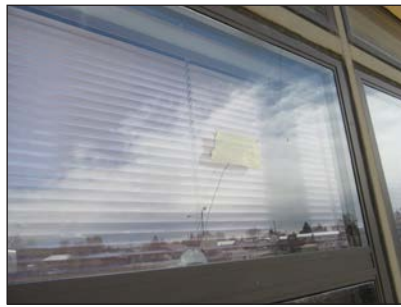
Replace exterior windows

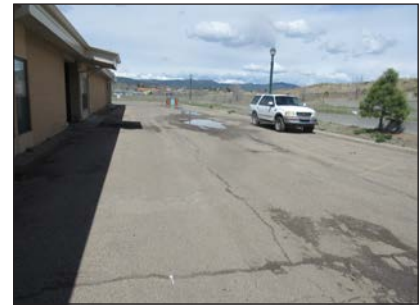
Resurface paving on northeast side of building

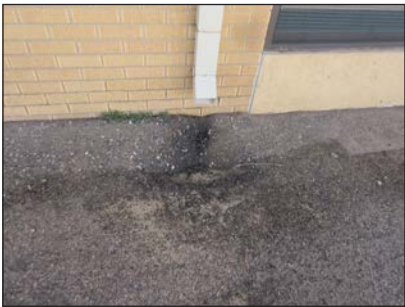
Splash blocks missing

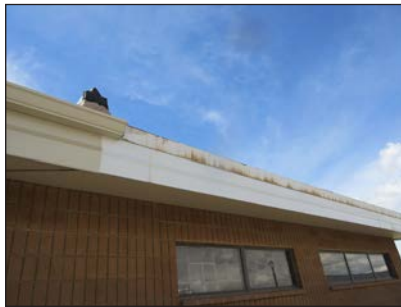
Replace missing gutters

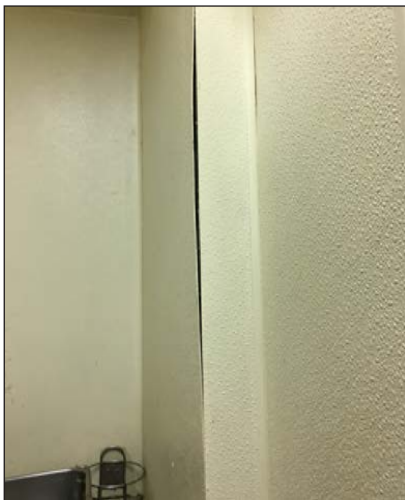
Install corner guards throughout

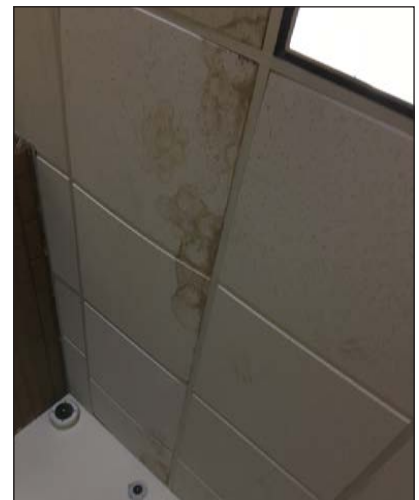
Replace damaged/stained ceiling tiles
