Las Vegas City Schools

2017 - 2022 District-Wide Facility Master Plan

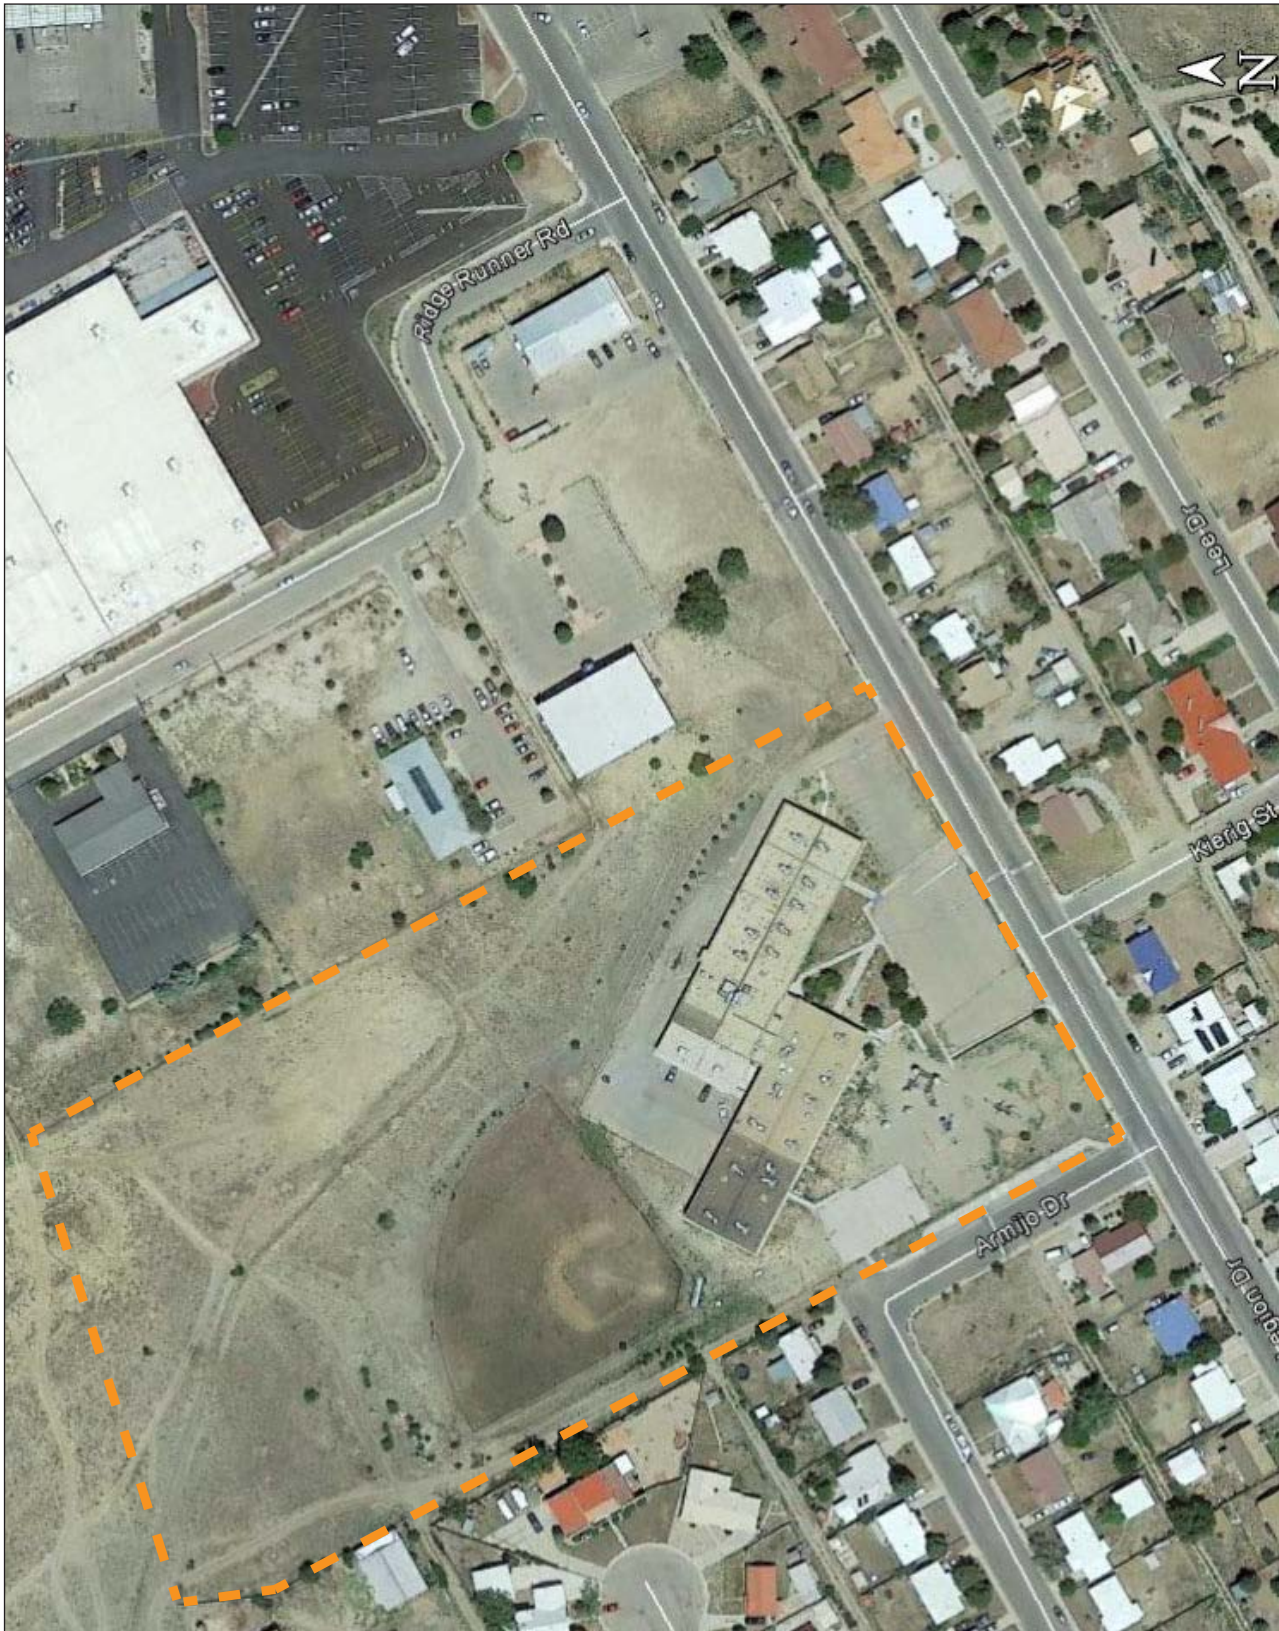
Site Plan - Legion Park Elementary
Las Vegas City Schools

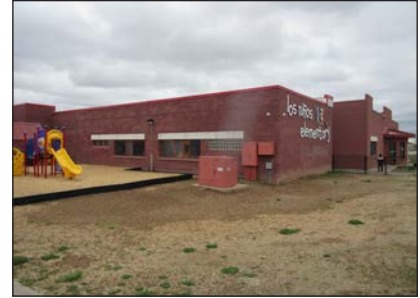
Drainage improvements needed around perimeter

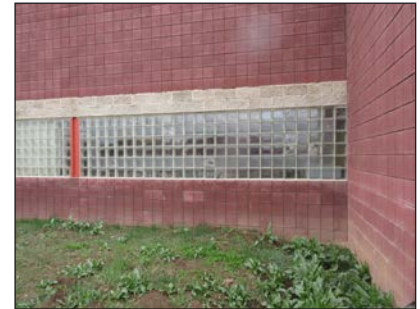
Tuck point masonry & replace glass block

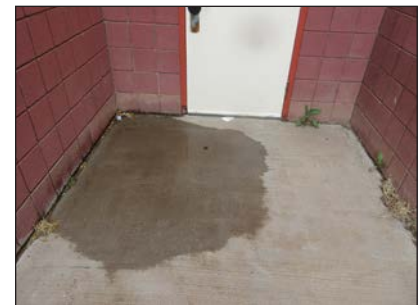
Replace rusted doors & frames & reseal at concrete base

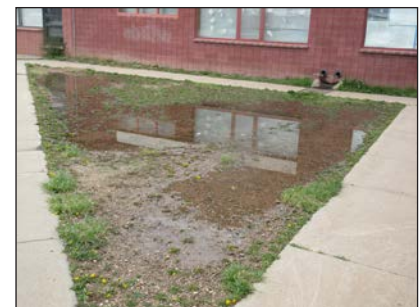
Ponding water - improve drainage

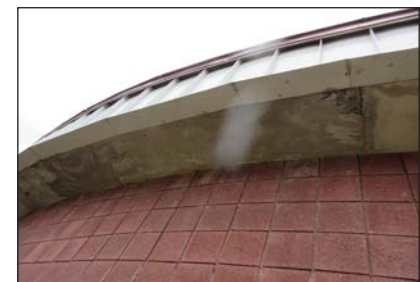
Repair & paint damaged soffits

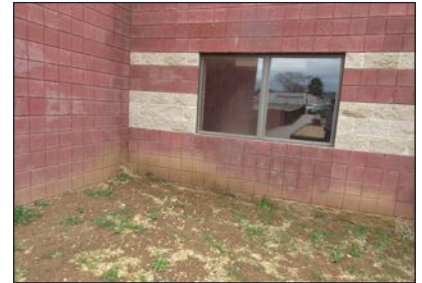
Re-caulk all vertical joints

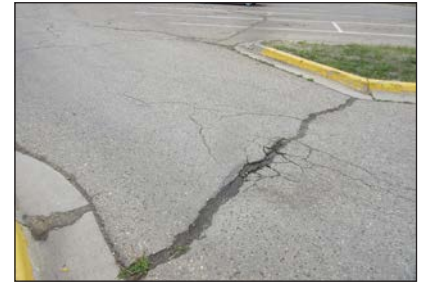
Repair all cracks & resurface parking lot

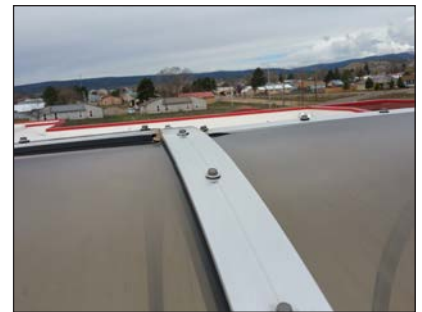
Skylights are in poor condition

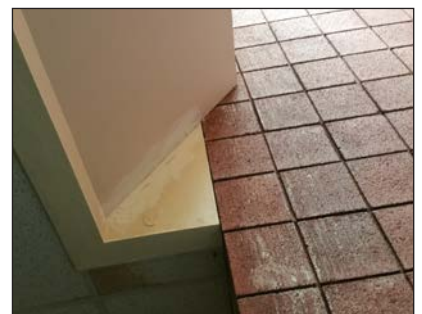
Clean/repair water damaged walls/soffits

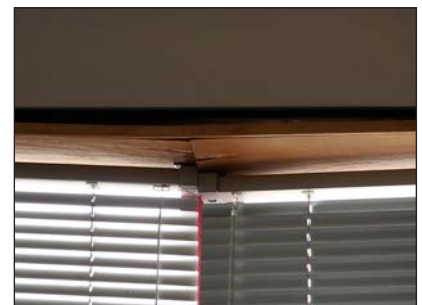
Water damaged window headers

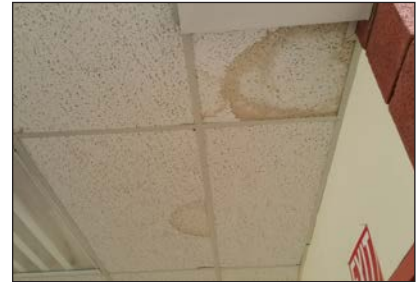
Replace stained/damaged ceiling tiles

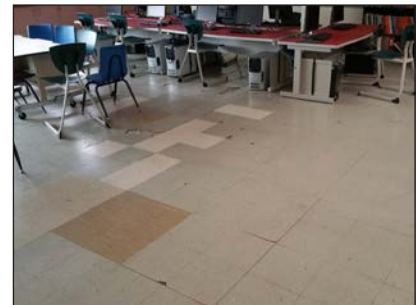
Replace VCT flooring

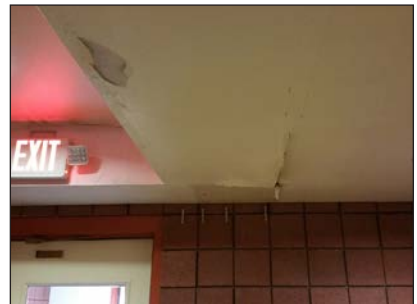
Repair water damaged ceiling

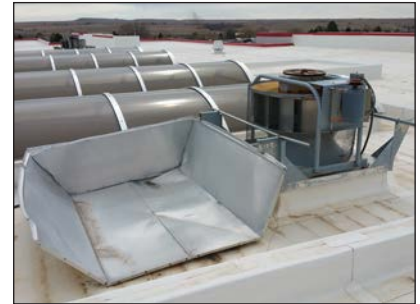
Reattach covers to equipment

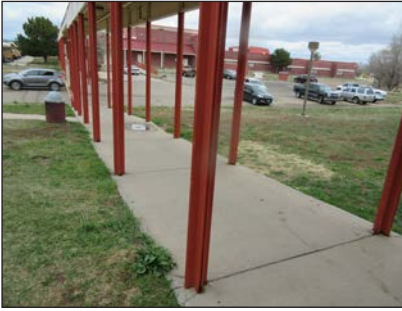
Sidewalk & canopy repairs/replacement needed

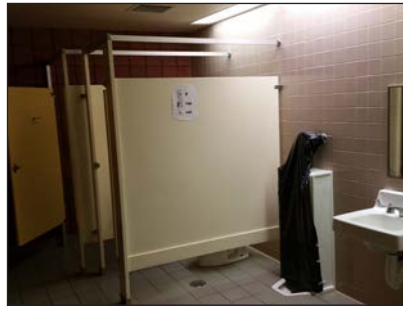
Renovate all restrooms

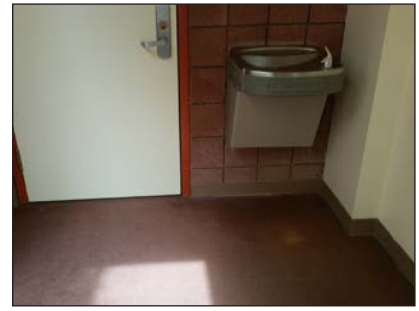
Replace water fountains

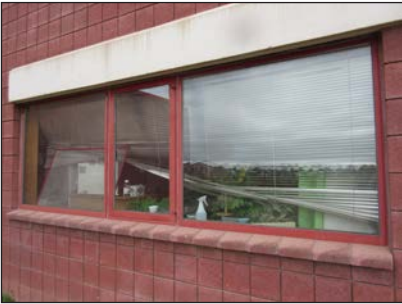
Replace all exterior windows

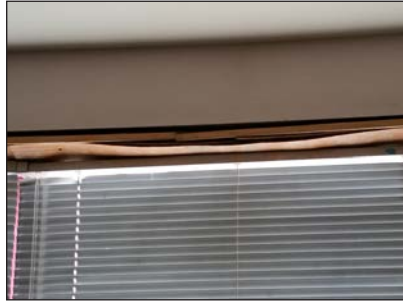
Repair window header

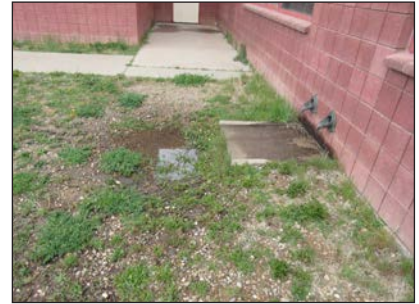
Drainage improvements needed

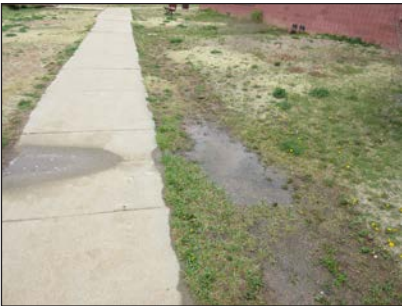
Replace damaged/spalled concrete sidewalks

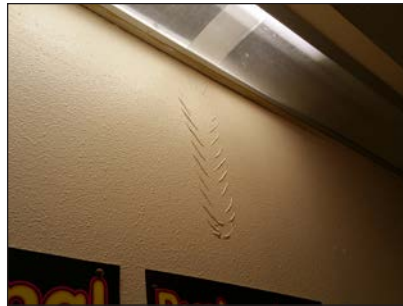
Repair water damaged walls

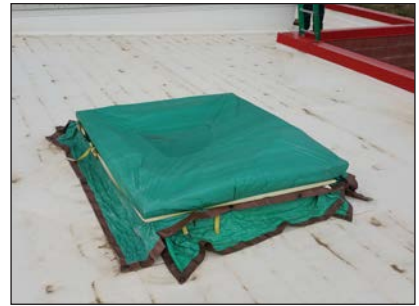
Remove damaged skylight

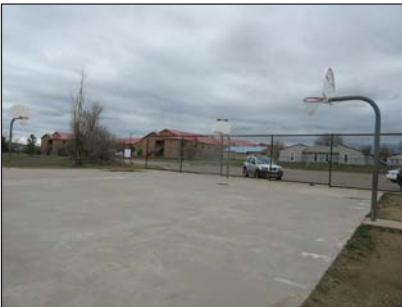
Repair basketball courts

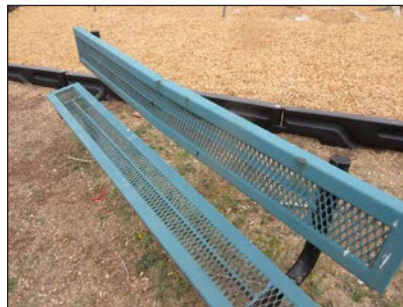
Replace damaged benches

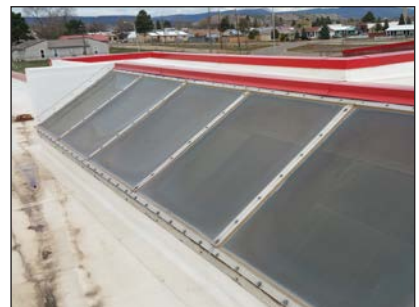
Skylight seals failing

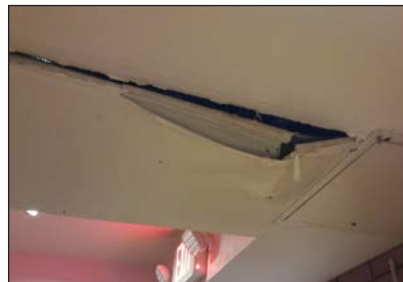
Patch repair & paint ceiling

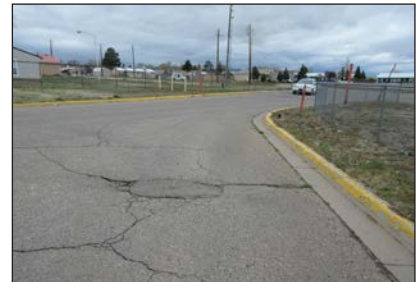
Resurface parking lot

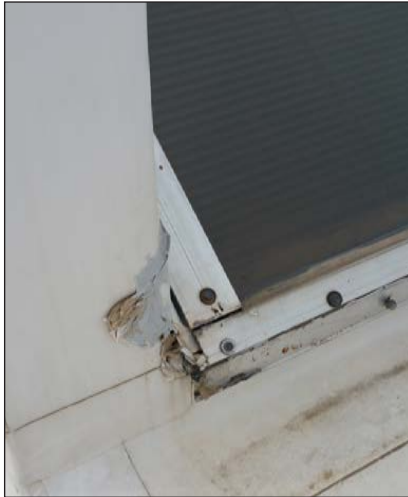
Damaged roof flashing at all skylights

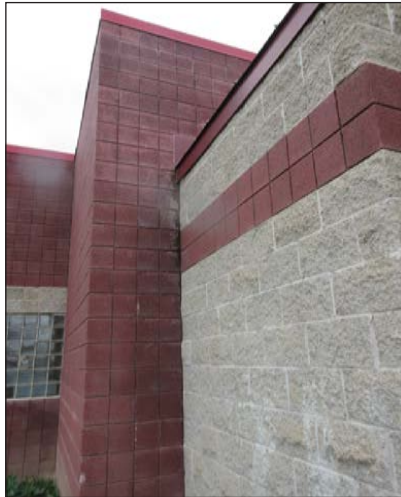
Re-caulk all vertical joints & tuck point masonry

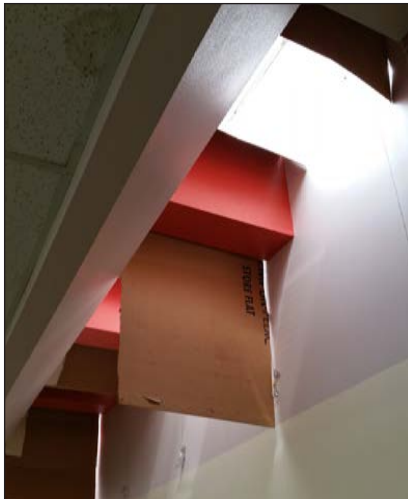
Repair all wall/ceiling water damage at all skylights

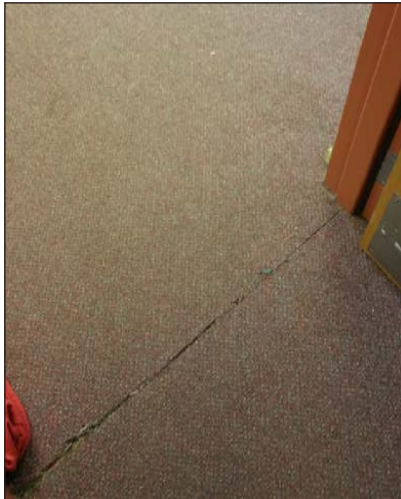
Carpet seams are deteriorating

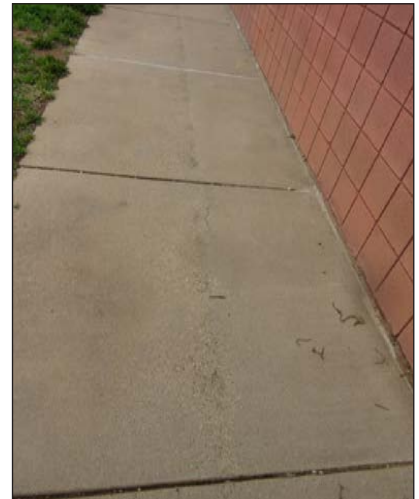
Reseal building perimeter at sidewalks

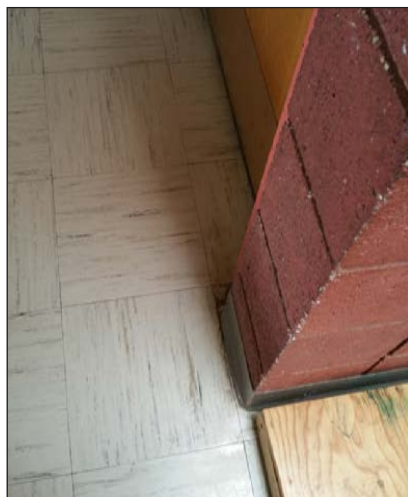
Replace VCT flooring & install corner guards

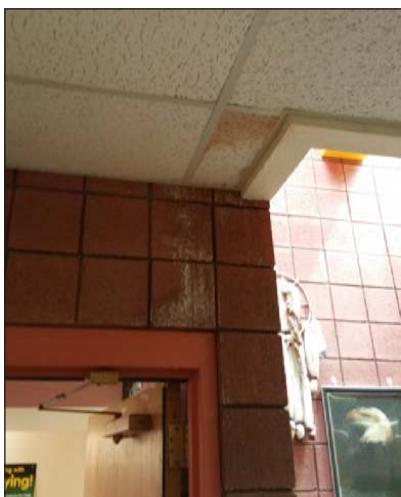
Repair interior walls/ceilings

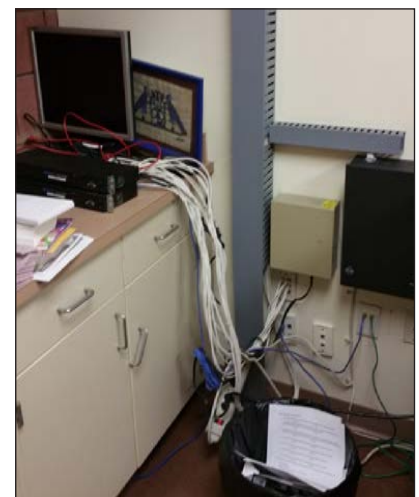
IT wiring & connection clean up required

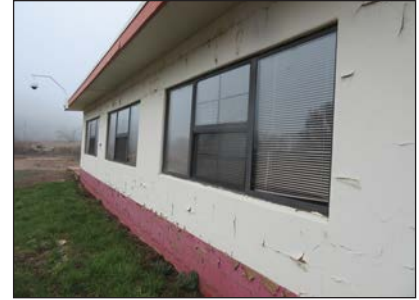
All exterior walls need to be repainted

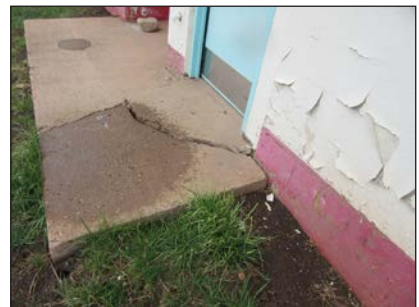
Replace broken concrete stoop

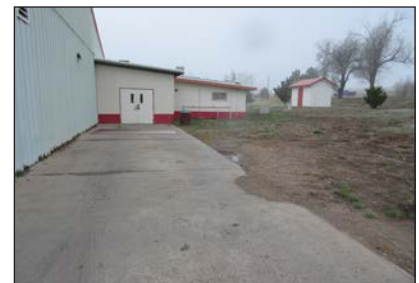
Grading & drainage improvements needed

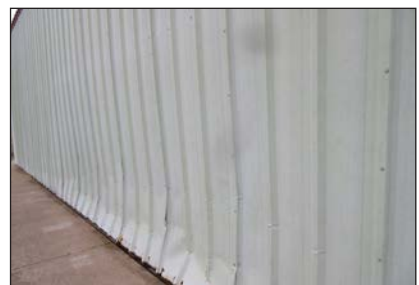
Replace metal wall panels

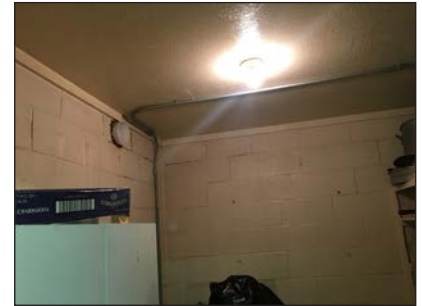
Upgrade lighting throughout

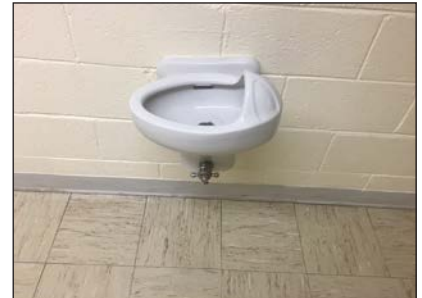
Replace water fountain

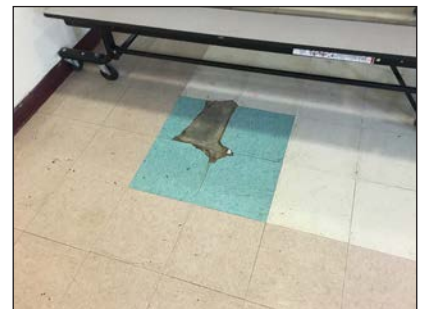
Replace VCT in multi-purpose room

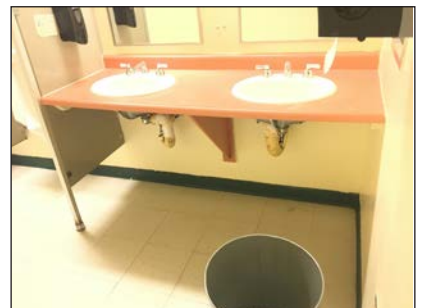
Renovate NE restrooms & comply with ADA requirements

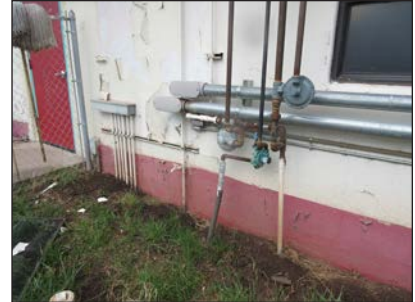
Evaluate all conduit lines & remove all unused conduit

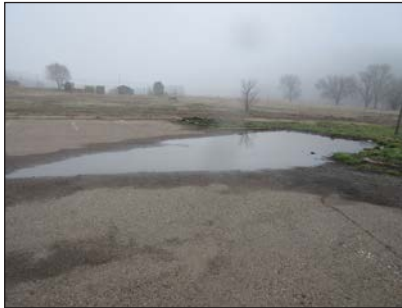
Grading & drainage improvements needed

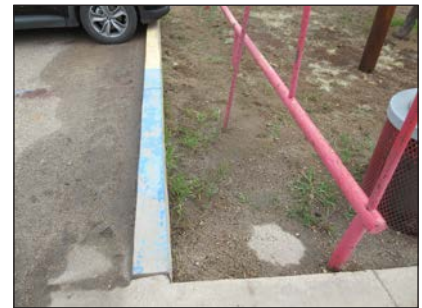
Replace metal railings, repaint curbs & install parking bumpers

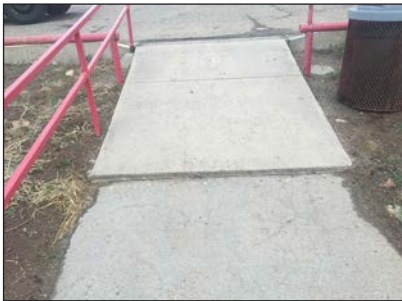
Replace access sidewalk with ADA compliant ramp

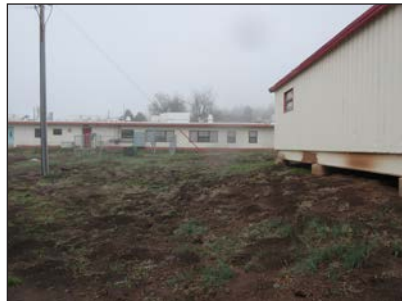
Improve drainage around portables

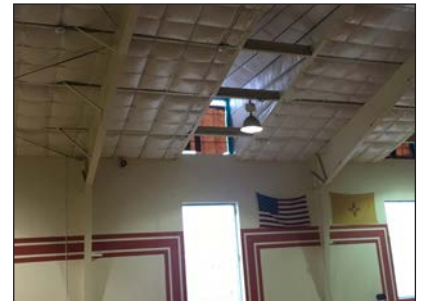
Replace dormer windows with insulated translucent panels to reduce heat

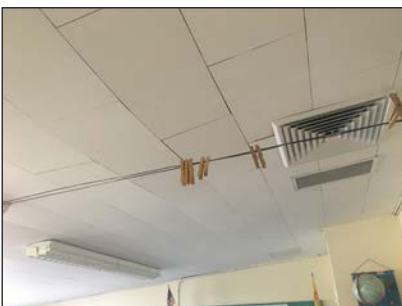
Replace lighting & ceiling system

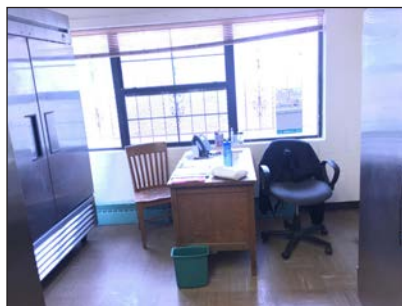
Renovate kitchen to NMAS & remove hazardous materials

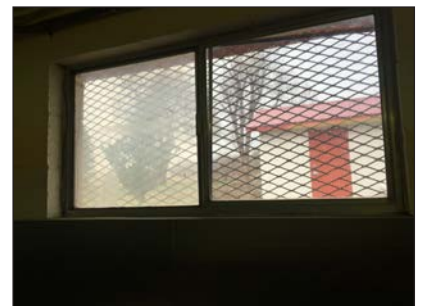
Replace exterior windows

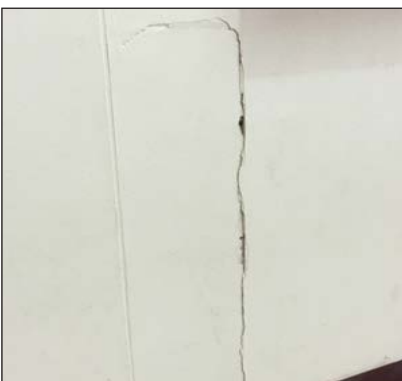
Repair damaged walls in Multi-Purpose room

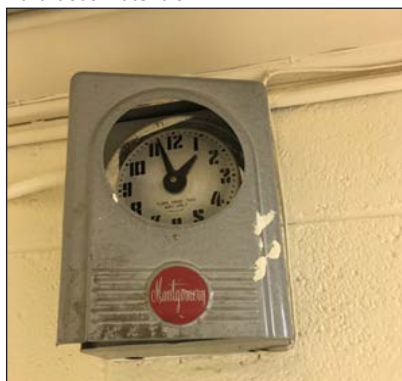
Replace original school clock system

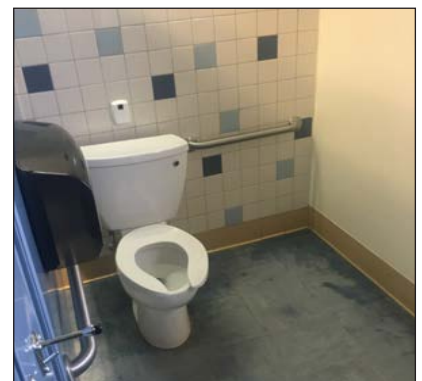
Replace floor finishes and update grab bars

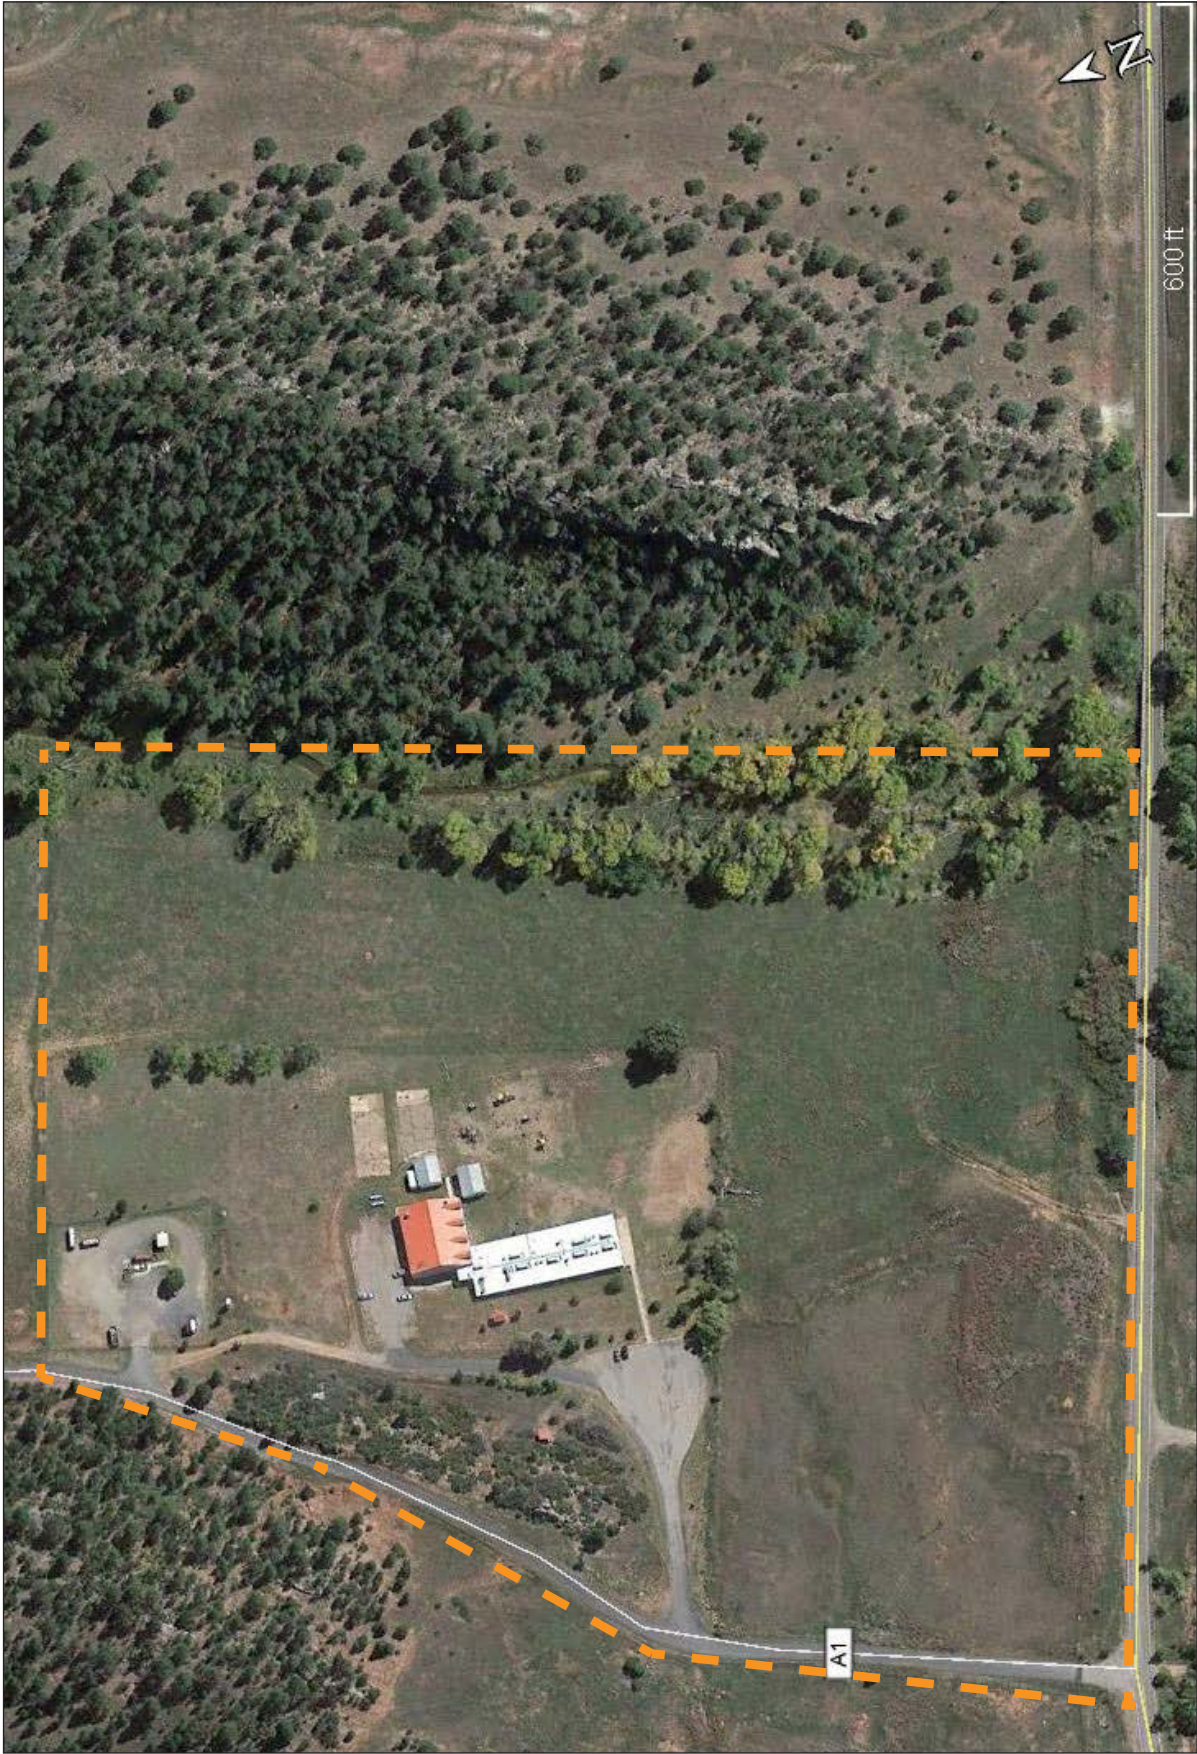
Site Plan - Mike Mateo Sena Elementary
Las Vegas City Schools

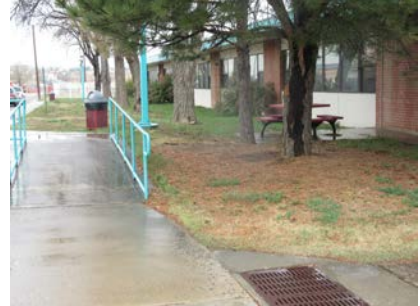
Paul D. Henry Elementary is located just southeast of Robertson High School at 1104 3rd Street and serves grades 1st-5th grade. The school was originally constructed in 1954 with additions in 1968, 1969, 1970 and 1996 that have resulted in 30,442 SF of permanent space. The facility layout is a classic L-shape design with double-loaded corridors and due to the extensive structural issues is in need of replacement. As part of the district’s approved “right sizing” plan, the district intends to close this facility effective the 2017/18 school year and relocate students to either Los Ninos or Sierra Vista Elementary Schools. This facility has been identified for demolition and the property will be retained by the school district and re-purposed for use by the high school.

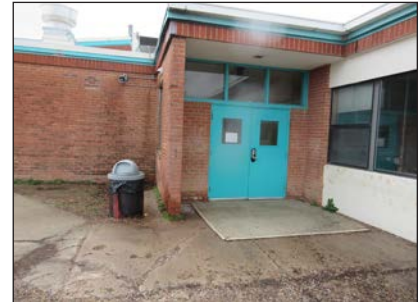
Replace all broken/spalled concrete

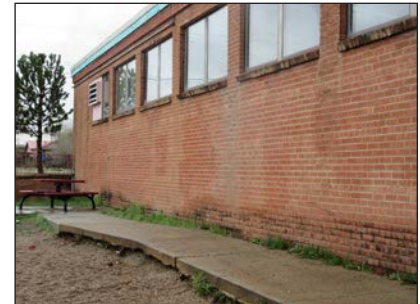
Grading & drainage improvements needed

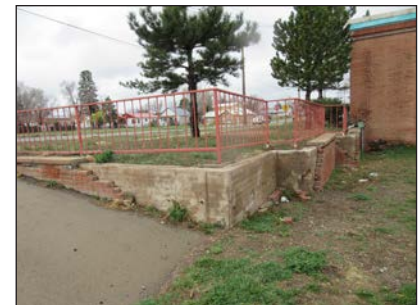
Replace retaining wall

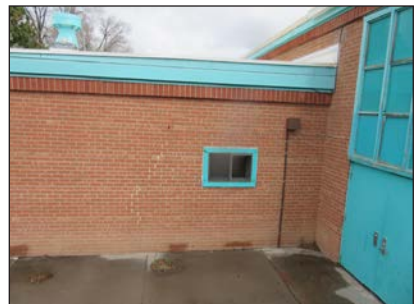
Rework drainage to move water away from building

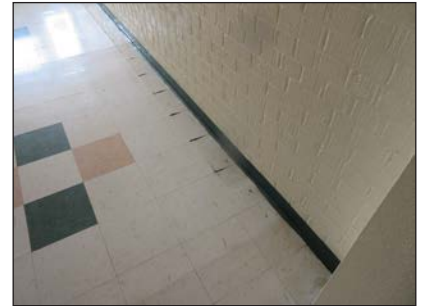
Replace VCT flooring

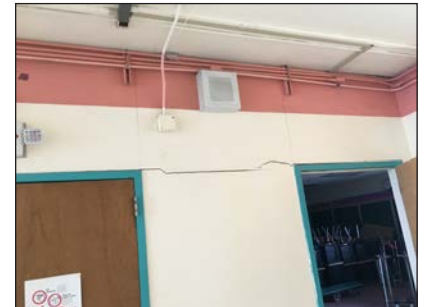
Settlement cracks at NE classroom wing

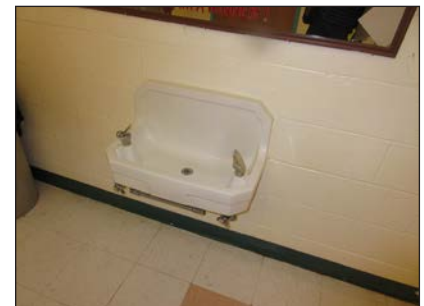
Replace water fountains

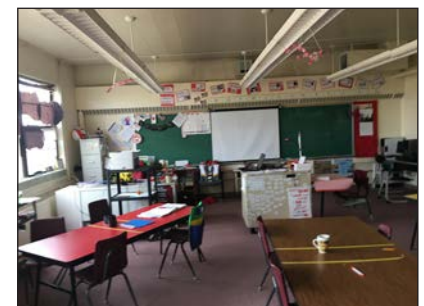
Renovate all classrooms

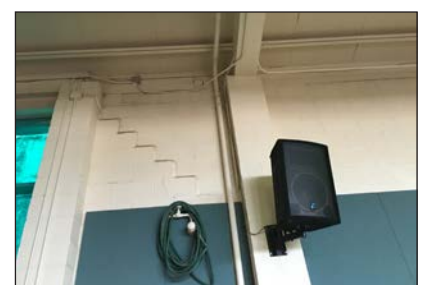
Structural repairs needed in multi-purpose

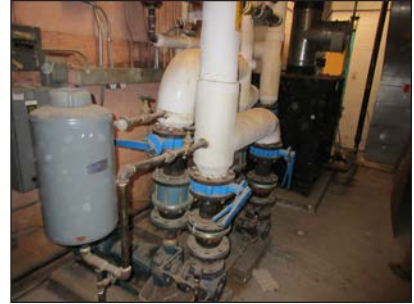
Replace boiler system

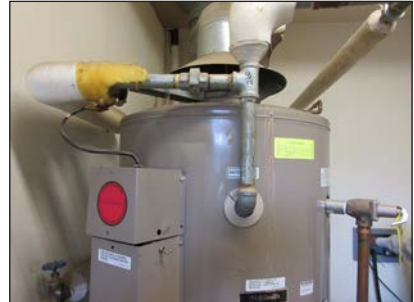
Upgrade & use to new code requirements

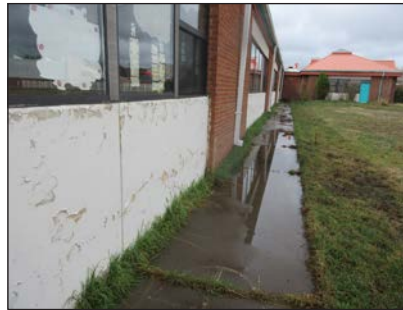
Remove loose paint at concrete panels, reseal & repaint

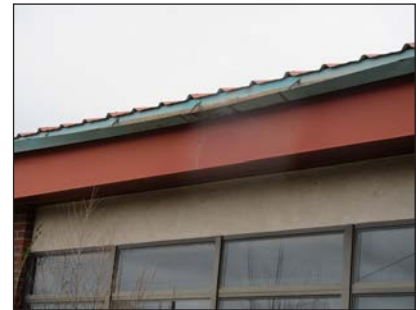
Replace metal roofing/ flashings

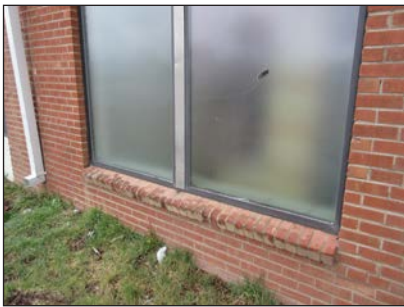
Replace all damaged brick & tuck point masonry

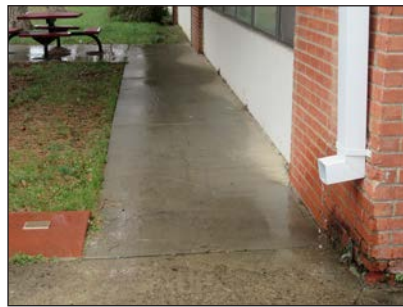
Install missing splash blocks

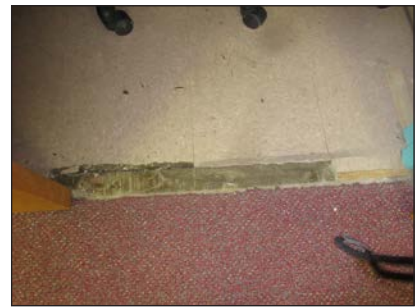
Structural settlement - various locations

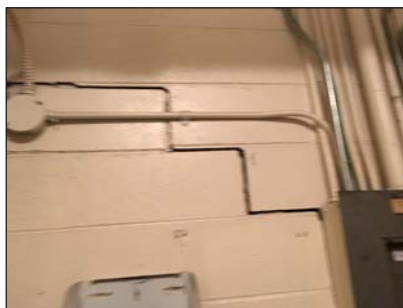
Stabilize & repair structural cracks

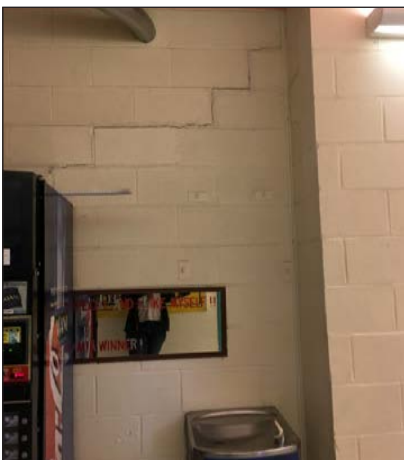
Structural repairs in corridors

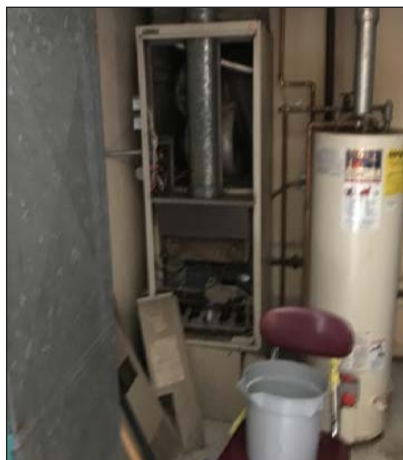
Replace furnace & water heater

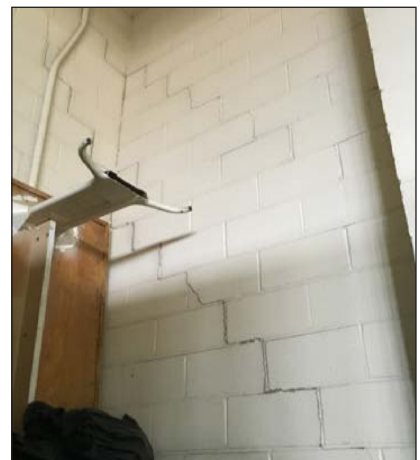
Extensive wall cracks in gym

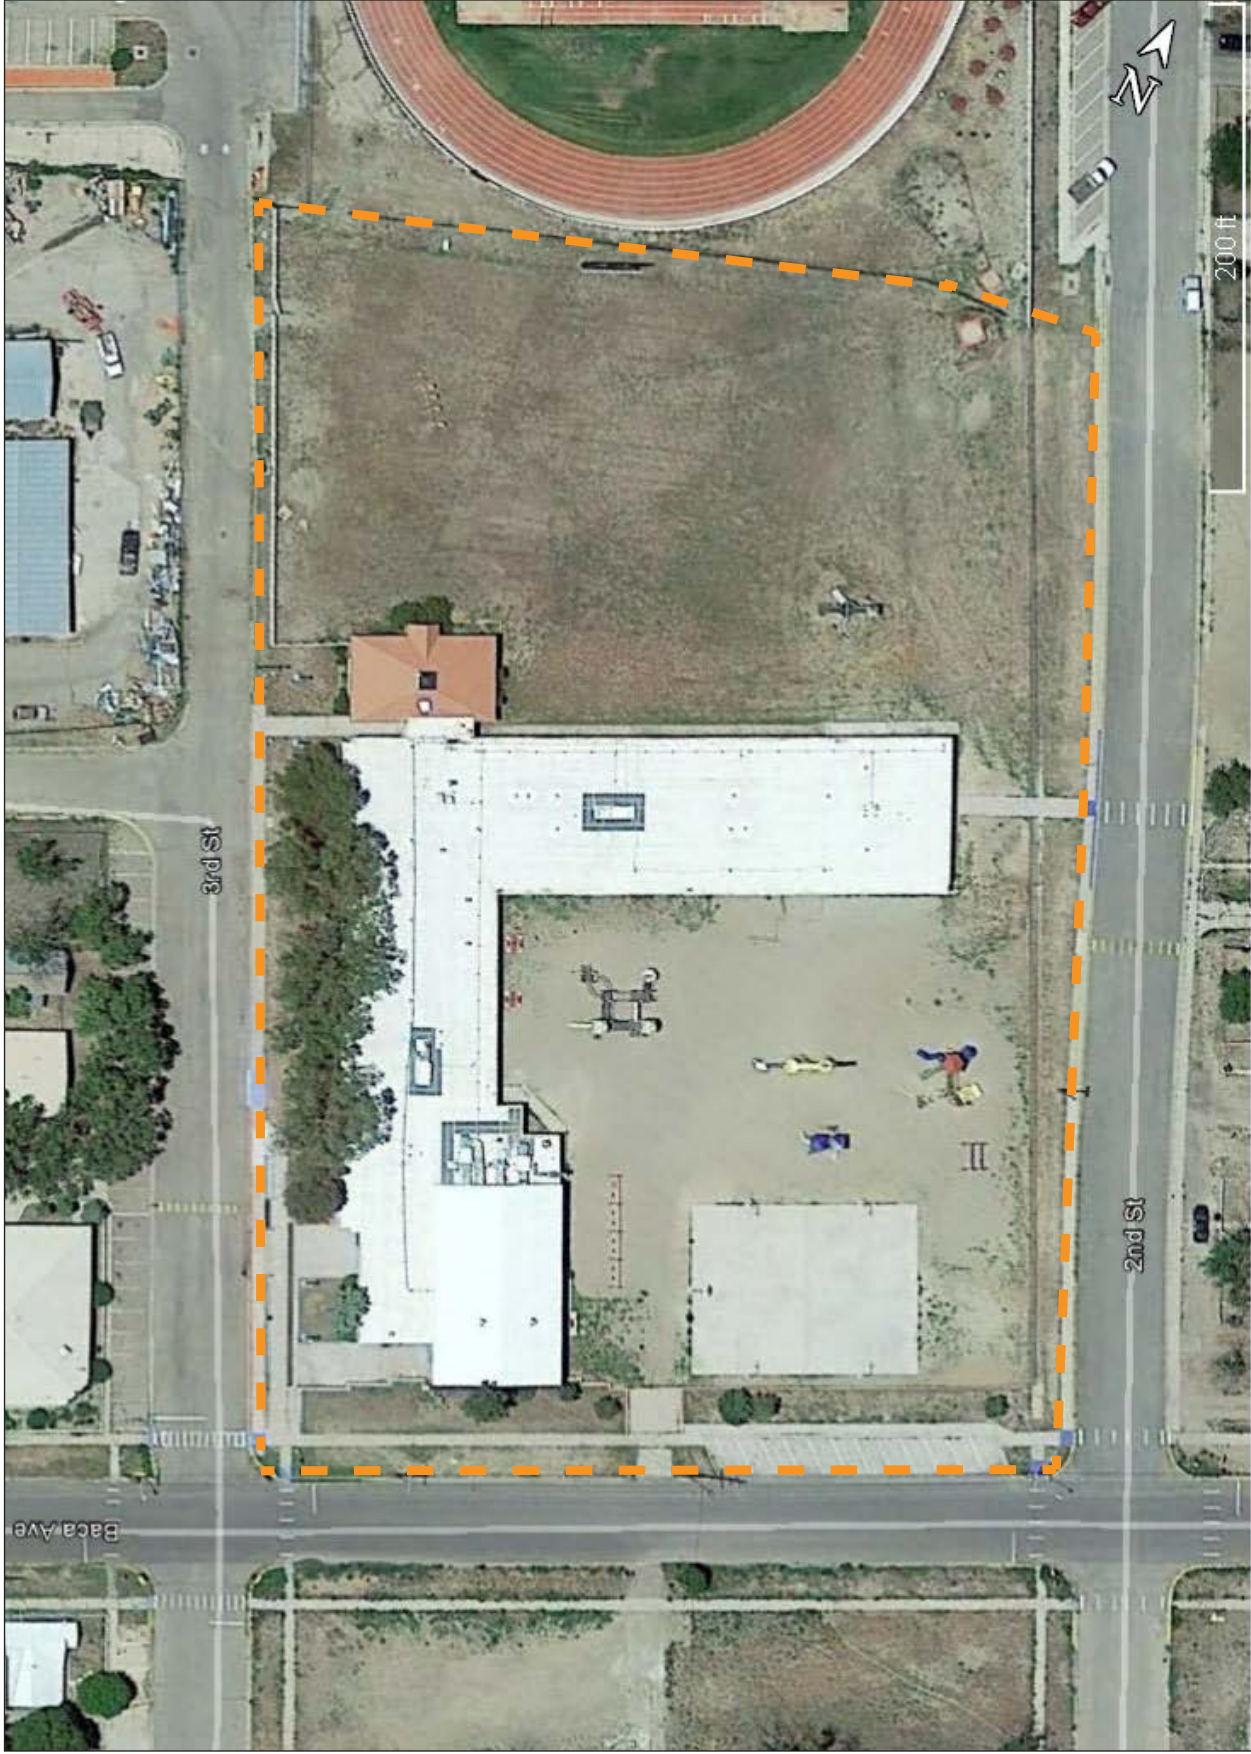
Site Plan - Paul D. Henry Elementary
Las Vegas City Schools

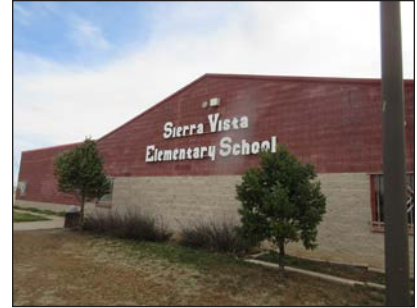
Concrete apron needed around building perimeter

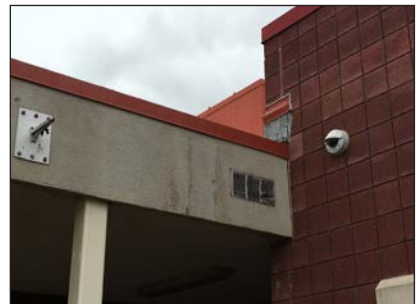
Replace roofing at covered walkway-East side

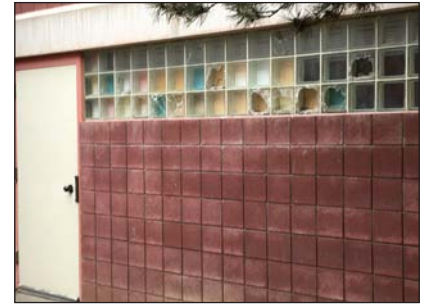
Replace glass block windows

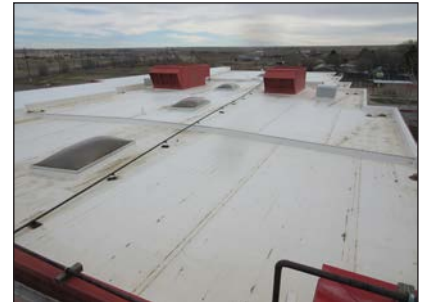
Roof maintenance needed

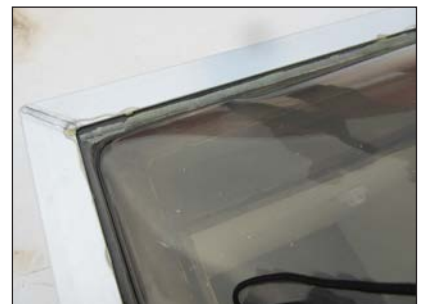
Replace all skylights. Many are broken

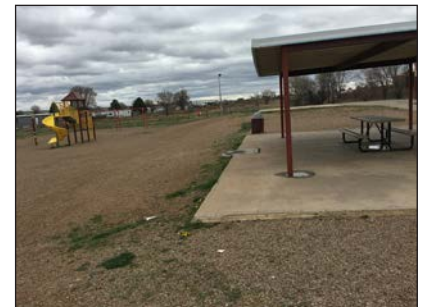
Regrade area near playground to eliminate drop-off

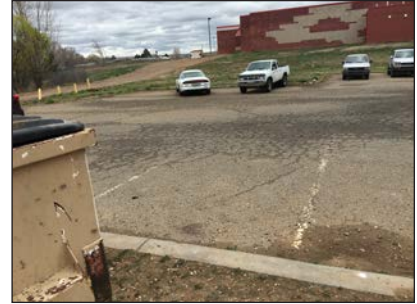
Repair & resurface parking lot

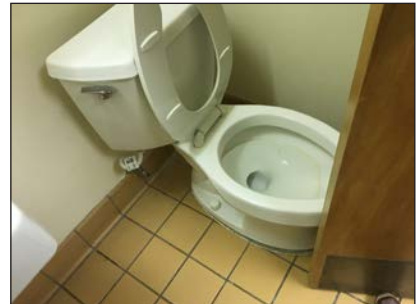
Renovate all restrooms & comply with ADA

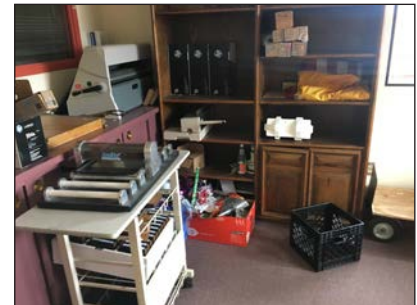
Replace casework throughout

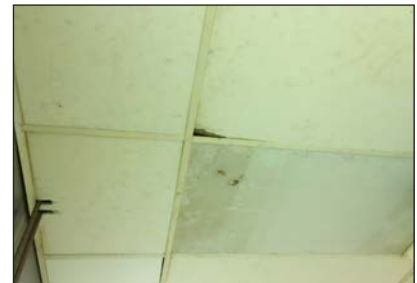
Replace damaged/stained ceiling tiles

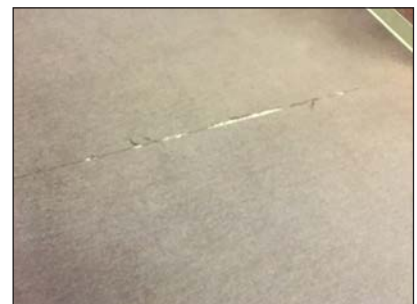
Remove all carpeting

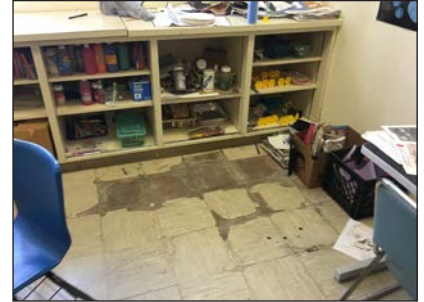
Replace flooring & casework in all restrooms

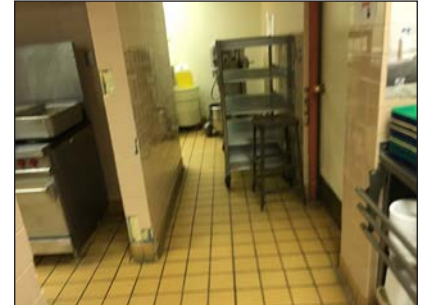
Replace tile & install corner guards

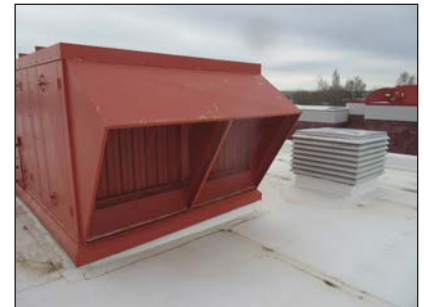
Air handlers need to be upgraded

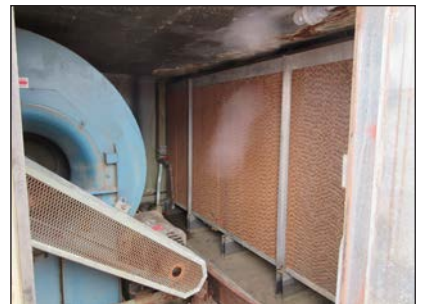
Replace cooling system

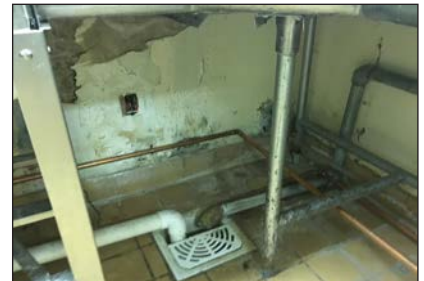
Repair sink & kitchen dishwasher & install j-box cover

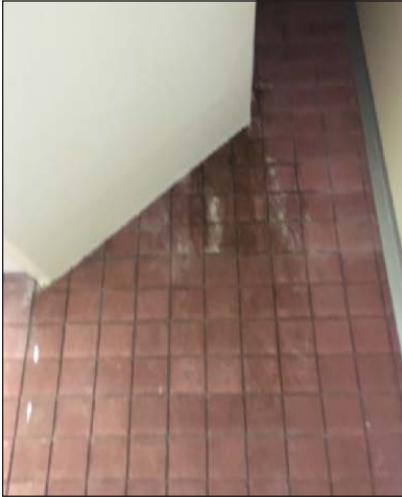
Repair water damage at all walls & soffits

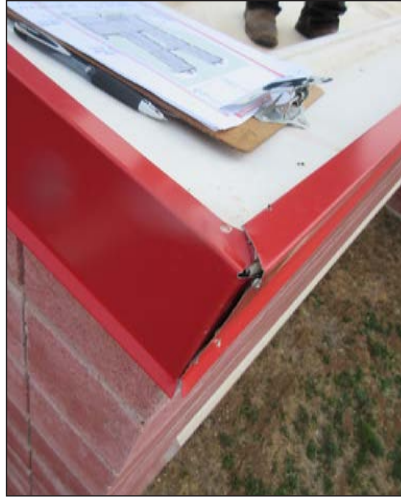
Install caulking at turn seams

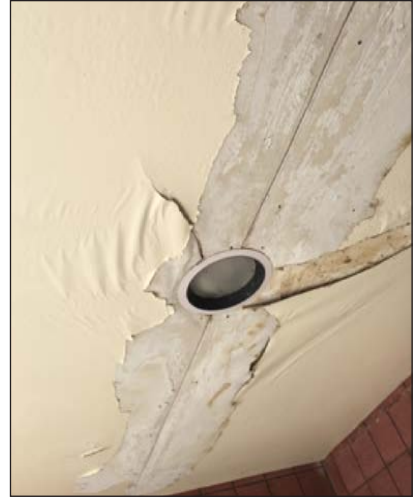
Patch & repair & paint damaged soffit at entrance

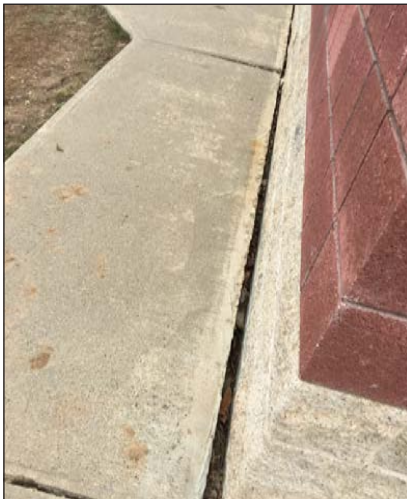
Reseal building perimeter at sidewalks

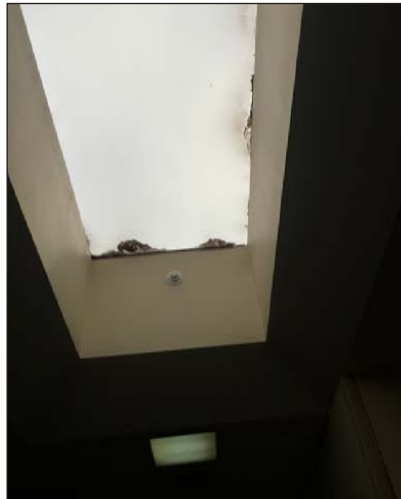
Replace all skylights

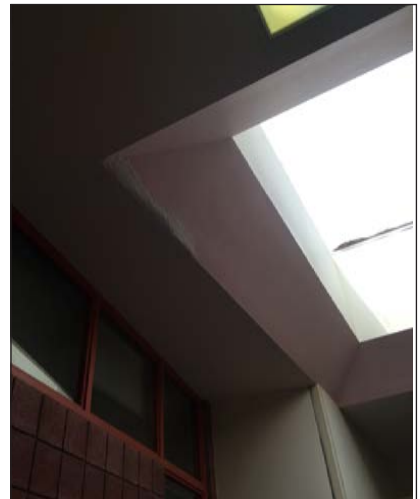
Repair water damage at all skylight wells

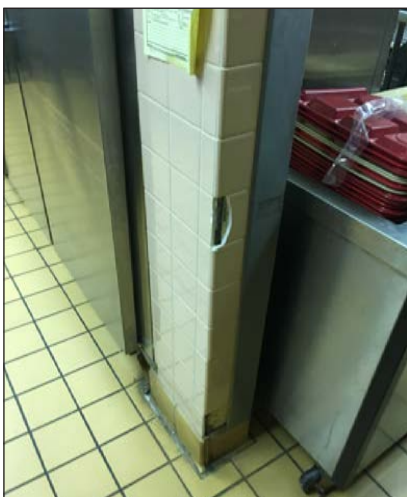
Replace all damaged wall tiles in kitchen

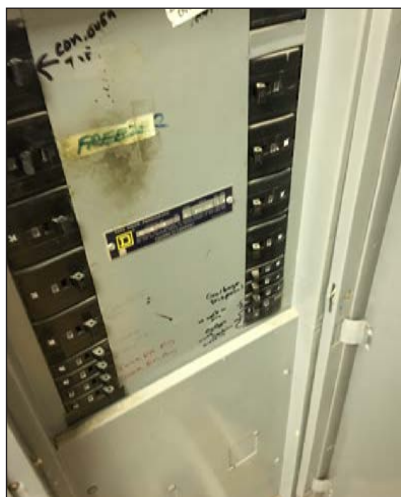
Fix locks/latches to kitchen panels

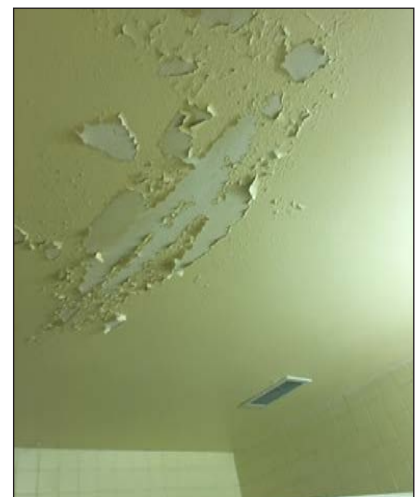
Repair ceilings in all restrooms
