Las Vegas City Schools

2017 - 2022 District-Wide Facility Master Plan

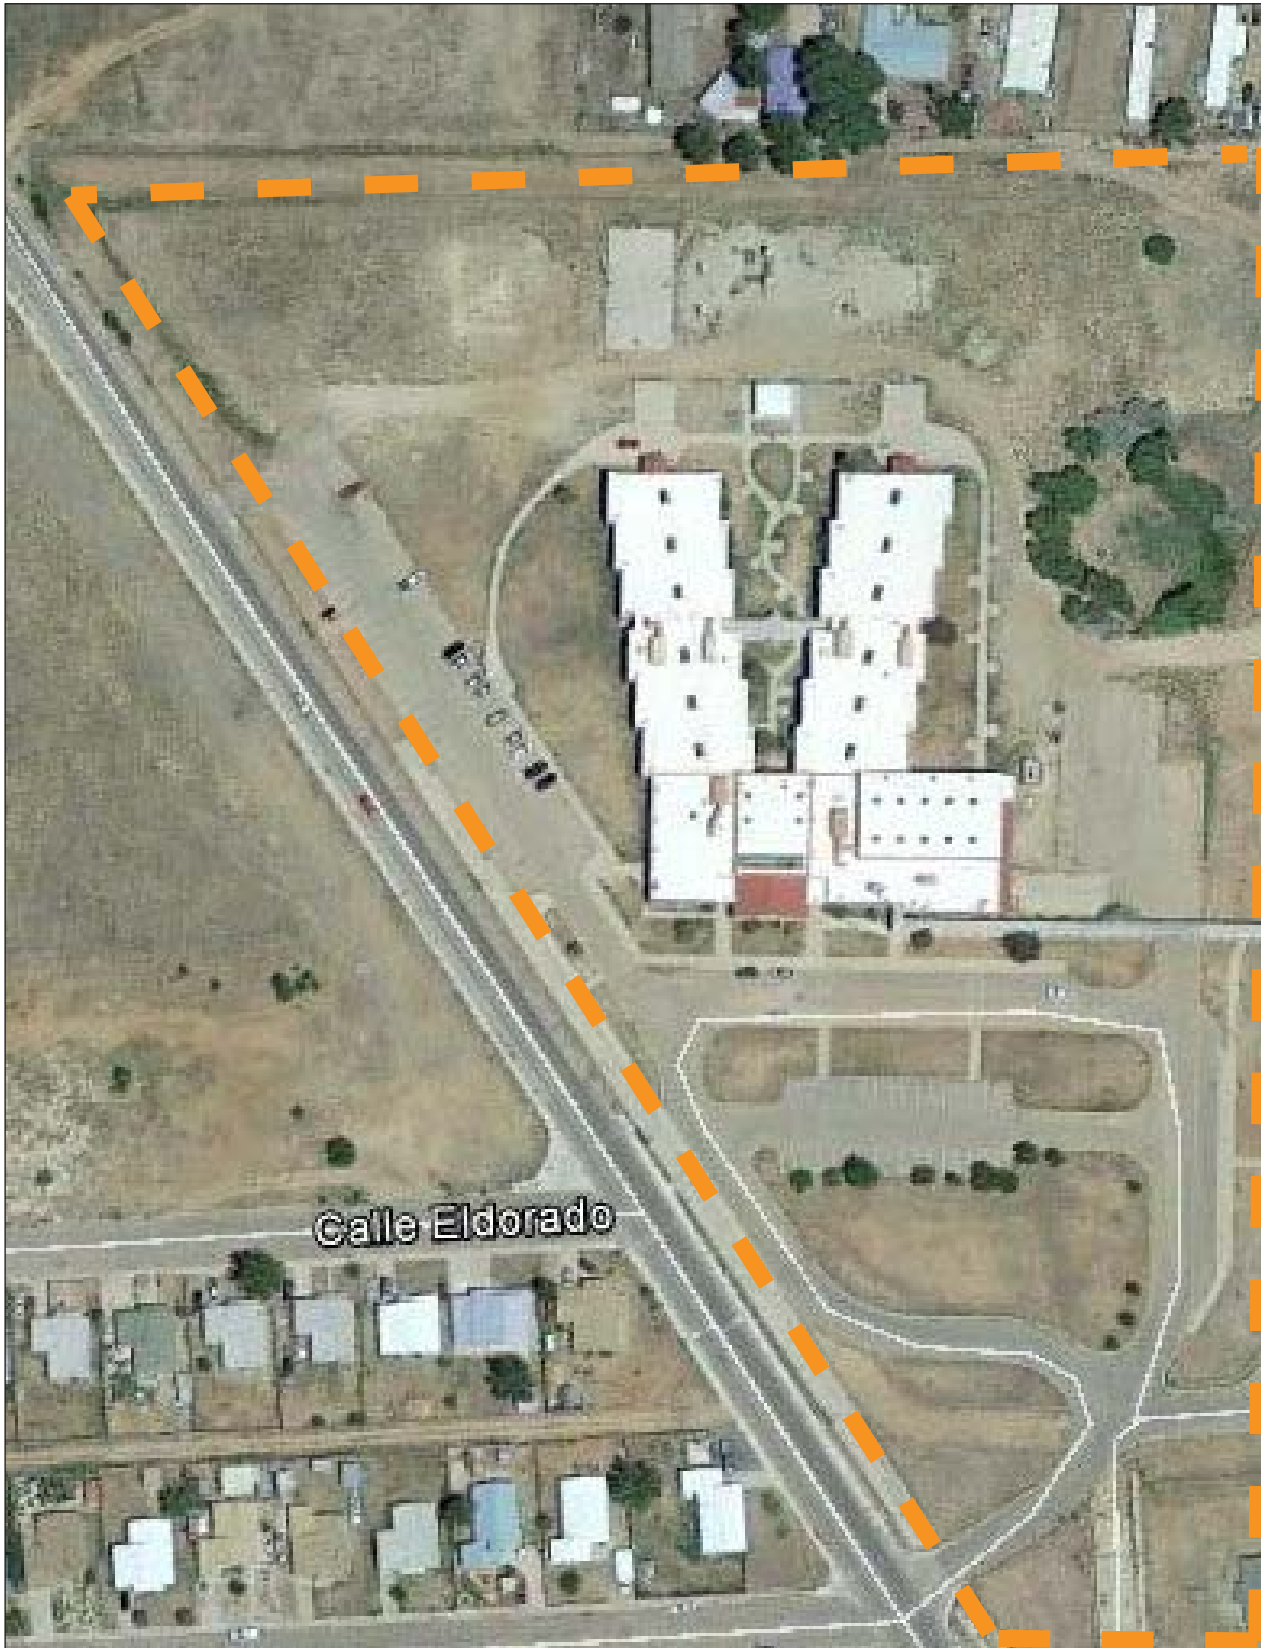
Site Plan - Sierra Vista Elementary
Las Vegas City Schools

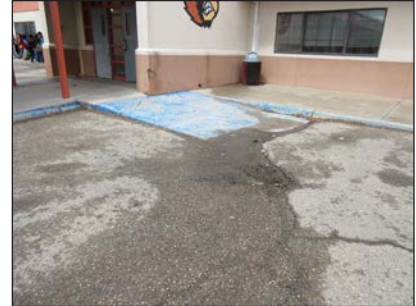
ADA access to the main entrance needs improvement

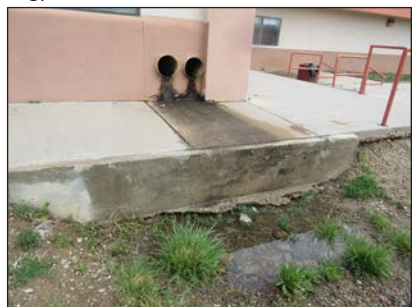
Regrade site & replace sidewalk. Provide under sidewalk roof draining

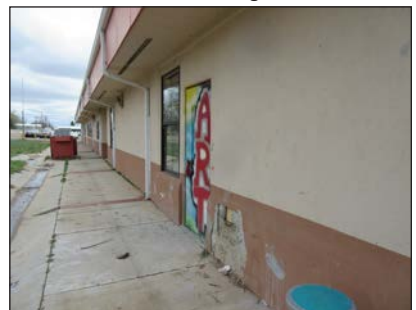
Repair stucco & recolor coat

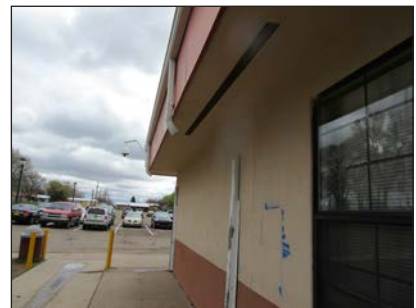
Repair /replace broken downspout

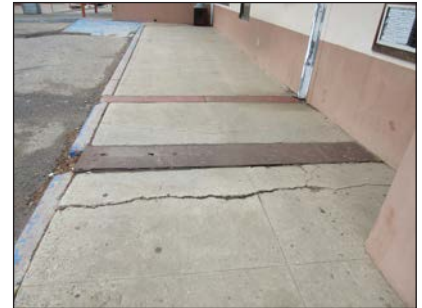
Replace broken/cracked sidewalks

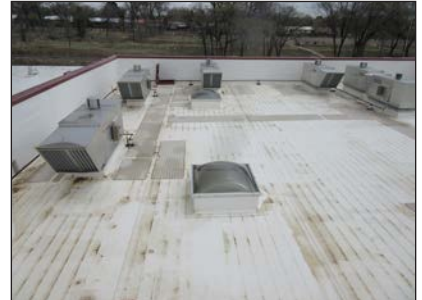
Roof maintenance needed

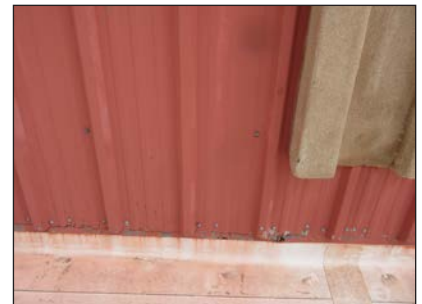
Rooftop metal panels need replacement

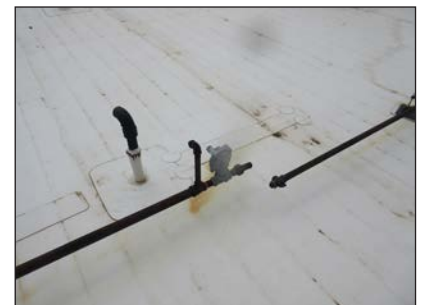
Reconnect gas lines & test for leaks-multiple locations

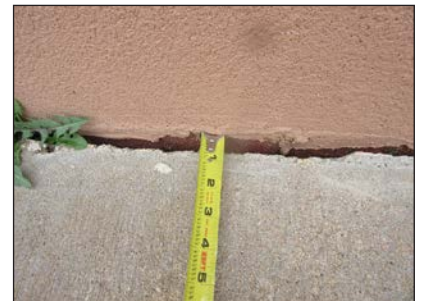
Settlement occurring-see structural report. Reseal wall base around perimeter

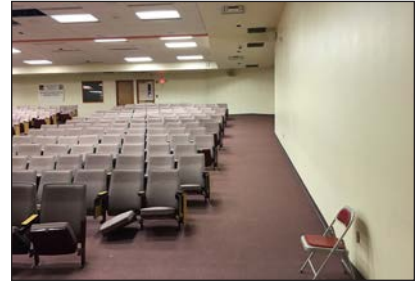
Handrails * landings need to be provided for ADA. Repair/replace seating

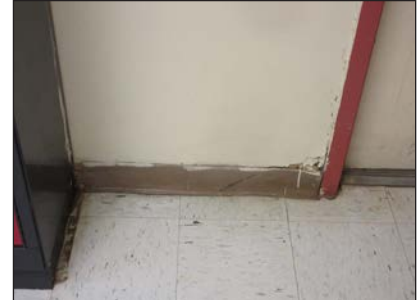
Replace flooring & wall base

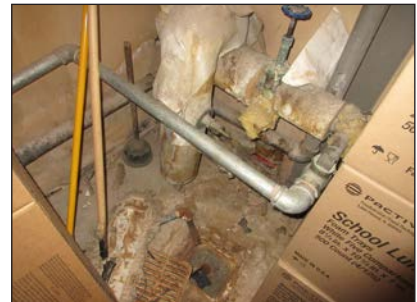
Replace piping insulation

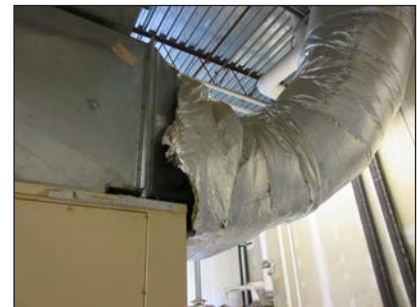
Ductwork insulation needs to be repaired/ replaced

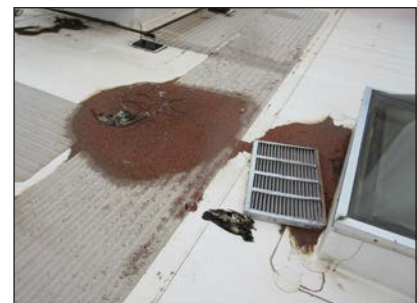
Remove debris & equipment on roof

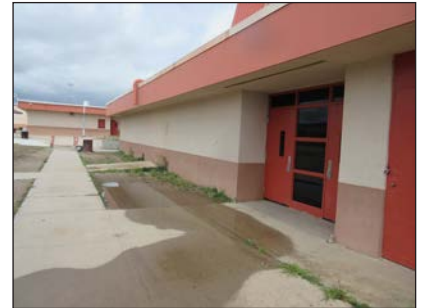
Drainage improvements on west side of gym needed

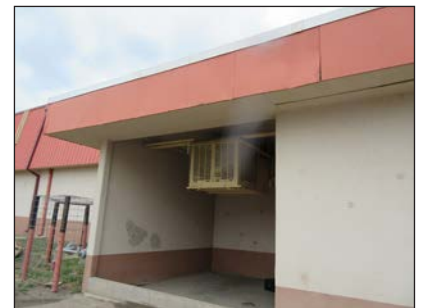
Replace evaporative cooler at kitchen

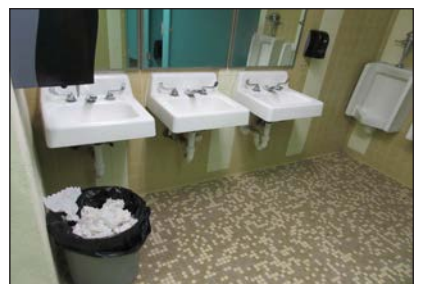
Renovate gym restrooms

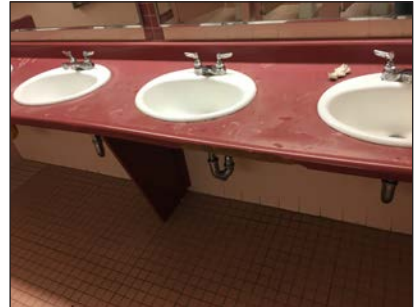
Replace sinks & counter tops

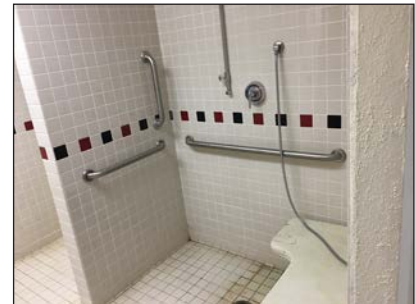
Repair ADA shower & provide curtain

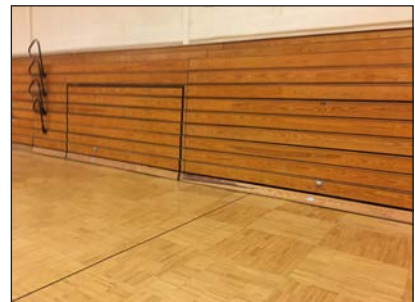
Replace bleachers & comply with ADA

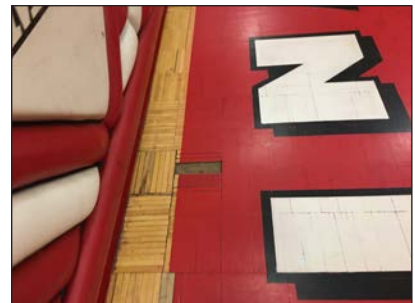
Replace gym flooring

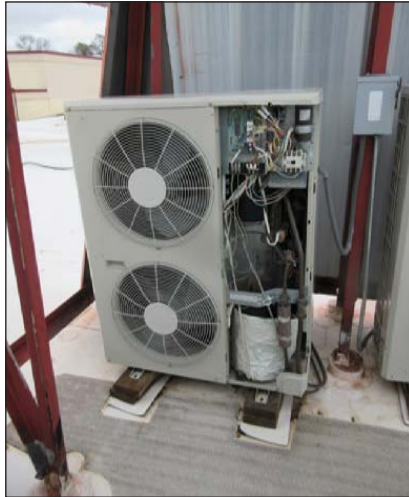
Rooftop equipment needs to be replaced/ repaired

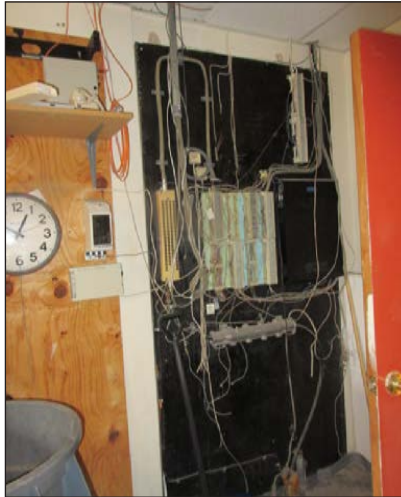
Telephone wiring/cabbling needs to be upgraded

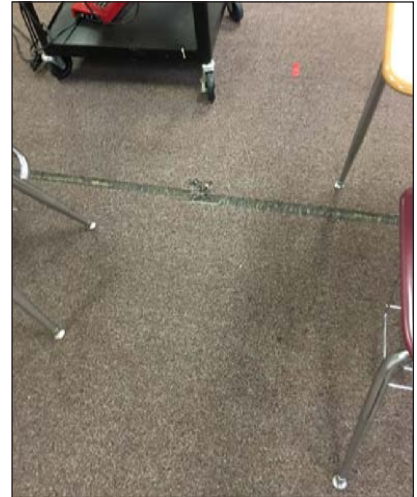
Replace carpet in all classrooms

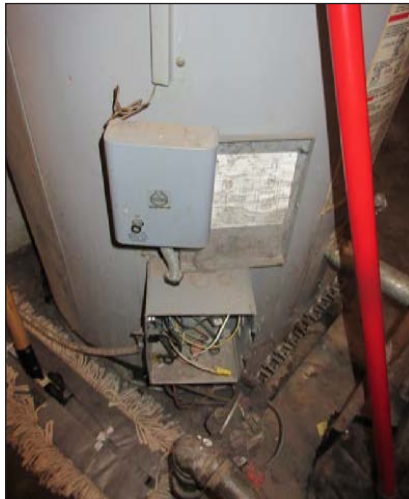
Water heater needs replacement

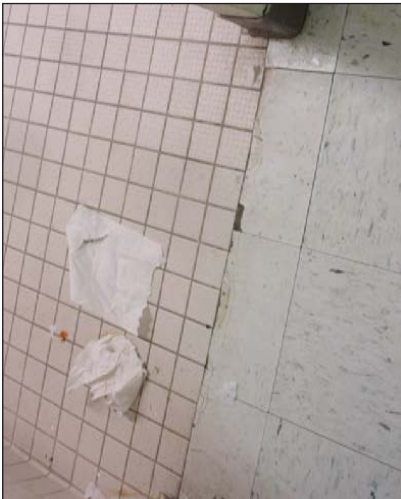
Replace VCT & provide transition strip

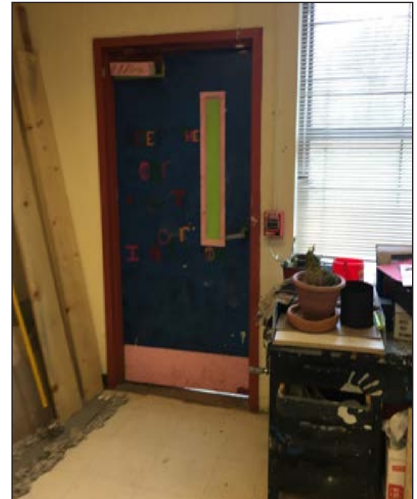
Replace door & hardware in the art room to meet egress requirements

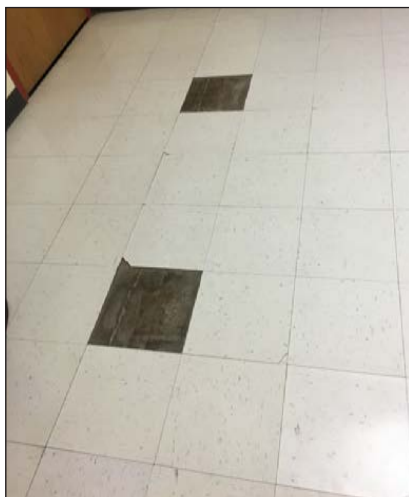
Replace VCT throughout

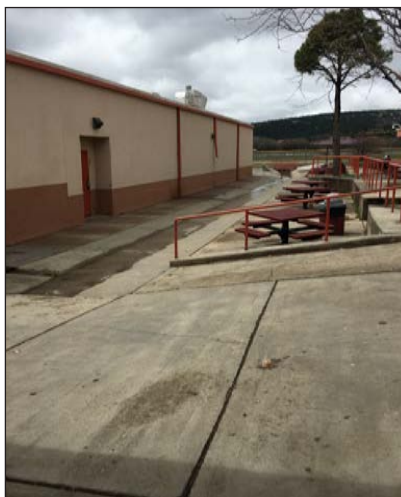
Drainage gutter/culvert needs to be replaced for positive flow

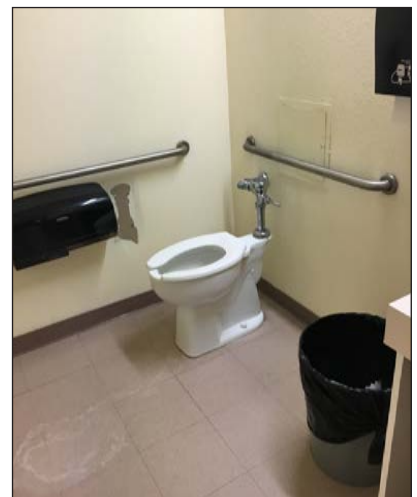
Renovate all restrooms & comply with ADA

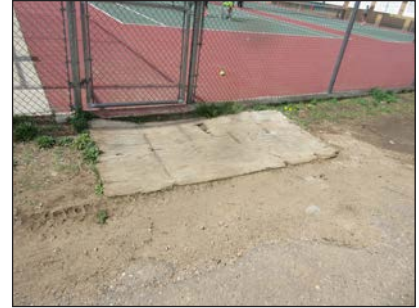
Replace concrete pad & provide sidewalk for ADA access

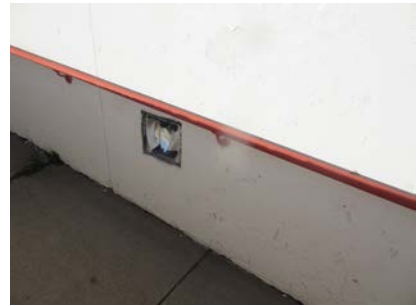
Replace broken ramp lighting

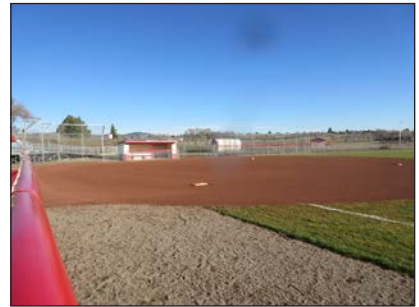
Field upgrades completed

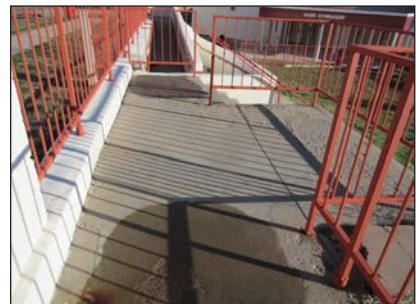
Replace spalled concrete & repaint metal rails

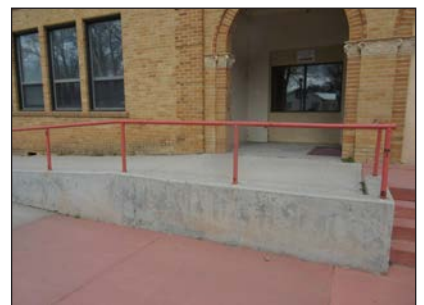
Replace handrails & comply with ADA & current code

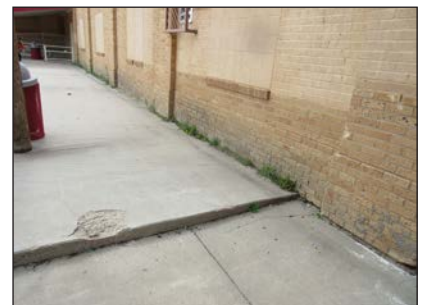
Replace damaged/uneven sidewalks

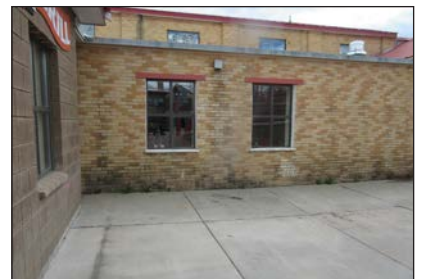
Replace exterior windows & tuck-point

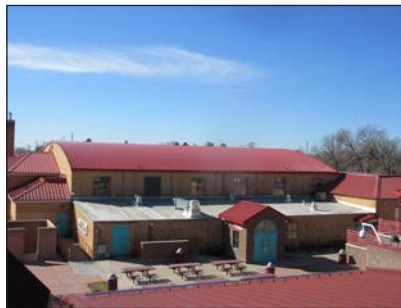
SECTION 4.0 - SUPPORT INFORMATION

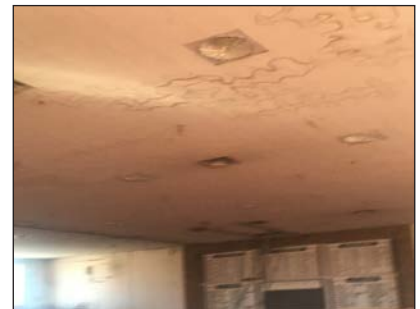
Replace damaged ceiling

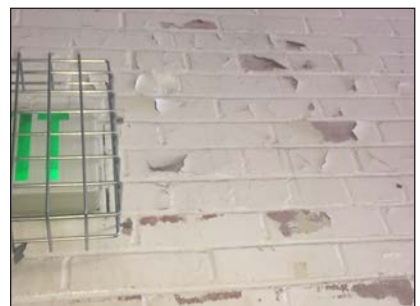
Scrape peeling paint & repaint interior walls

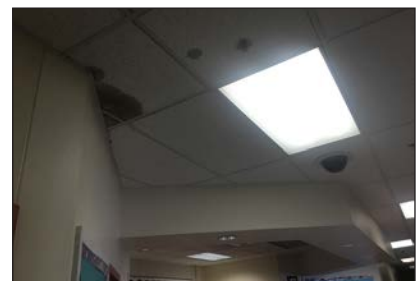
Replace stained/damaged ceiling tiles in admin area

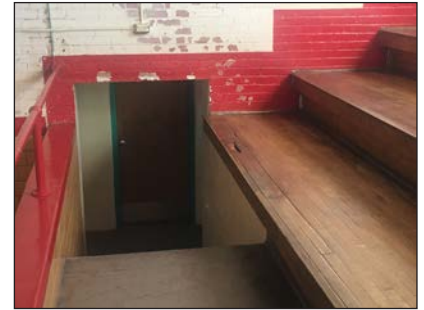
Replace missing handrail-safety hazard

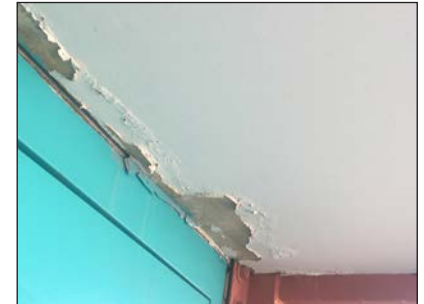
Repair water damage at exterior soffit

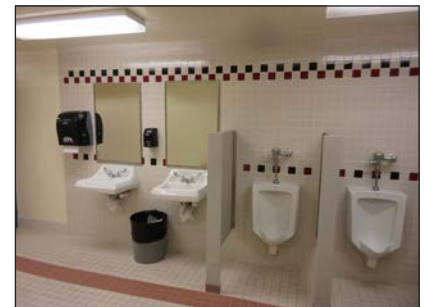
Lower level locker room in good condition

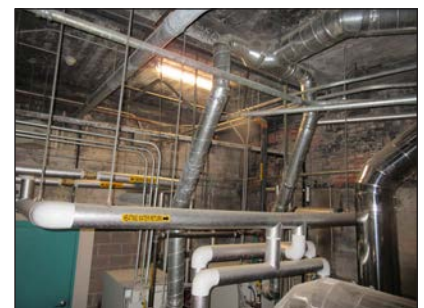
Existing Mechanical System

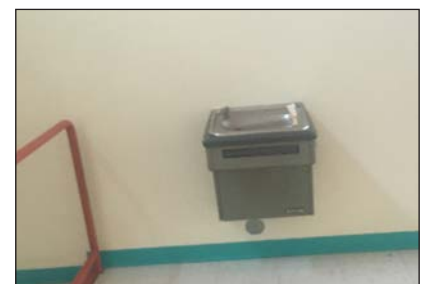
Replace water fountain

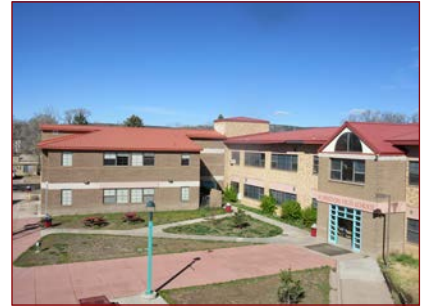
Main Academic Building & Student Commons

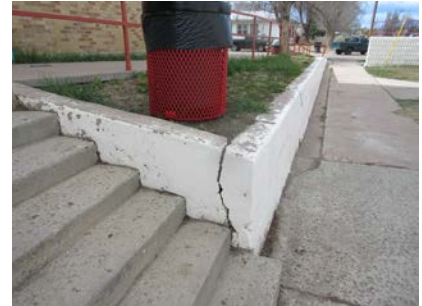
Repair retaining wall & provide handrails at steps

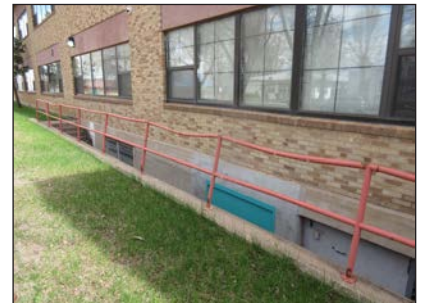
Basement access needs to be redesigned to improve drainage - North side

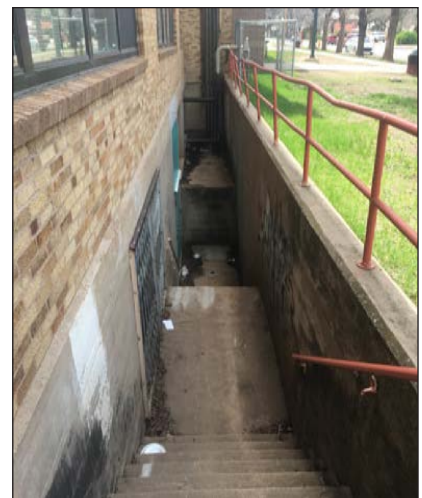
North side: replace basement access stairs

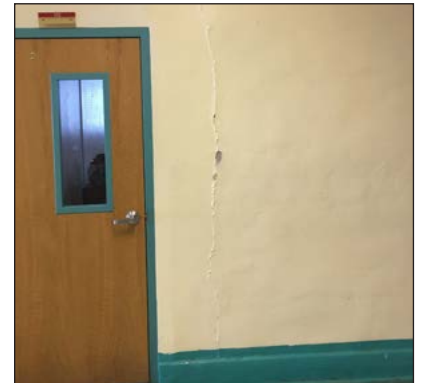
Repair wall damage & repaint

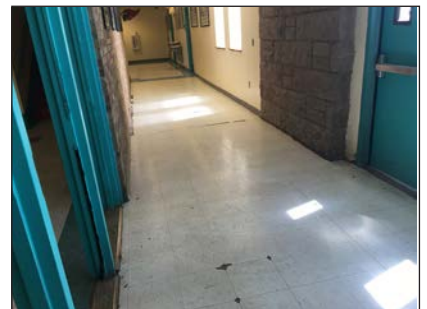
Replace flooring in corridors

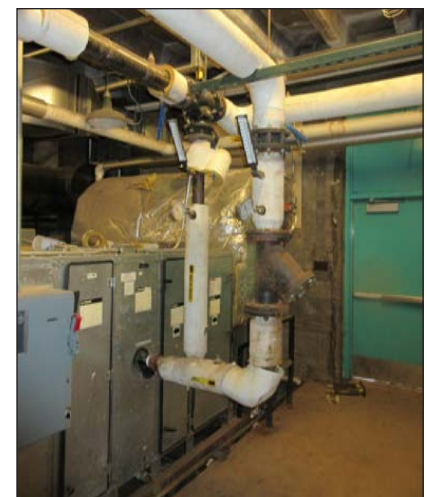
New Boiler System Cooling System Still Needed

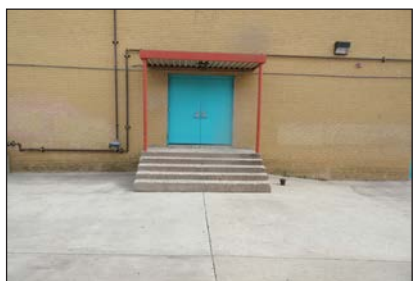
Replace spalled concrete steps & provide handrails

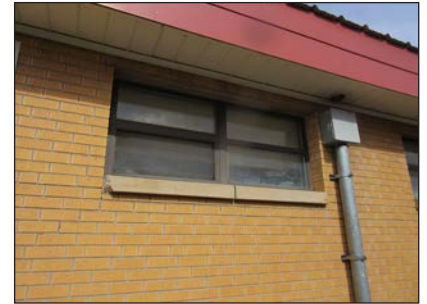
Replace exterior windows

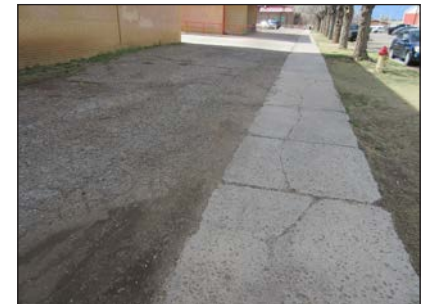
Replace damaged concrete sidewalks & reseal asphalt

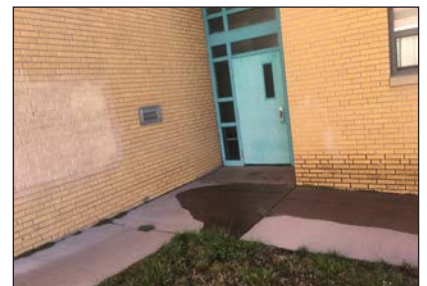
Replace exterior doors & improve drainage

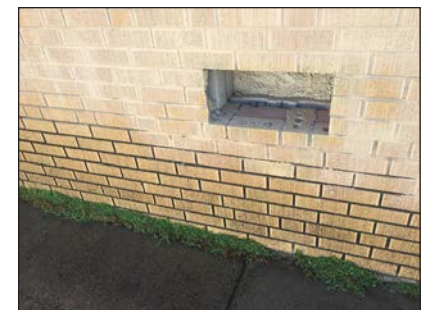
Replace missing exterior vent panel

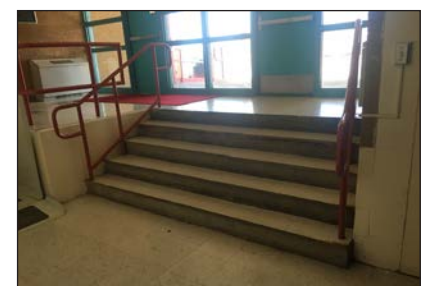
Replace stair nosing's

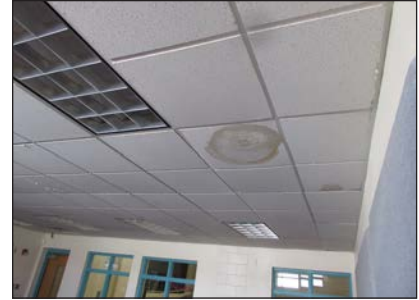
Replace stained ceiling tiles

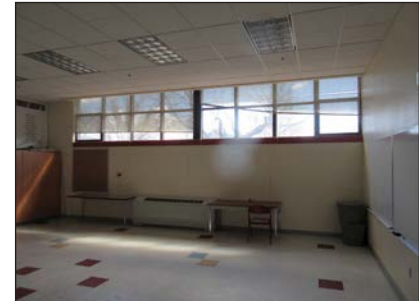
Replace damaged ceilings & upgrade lighting

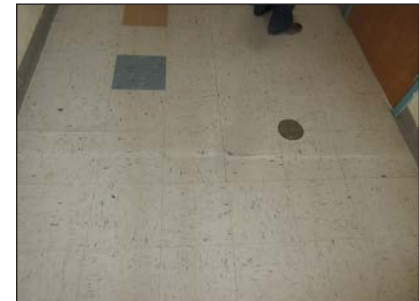
Replace VCT flooring

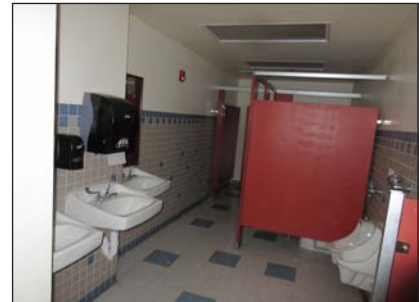
Restrooms need minor refurbishment

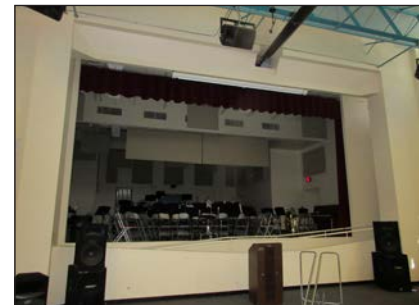
Stage area needs refurbishment

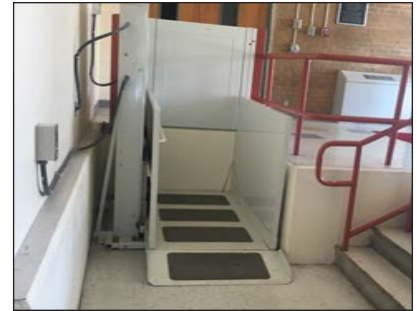
Wheelchair lift is operable but should be serviced

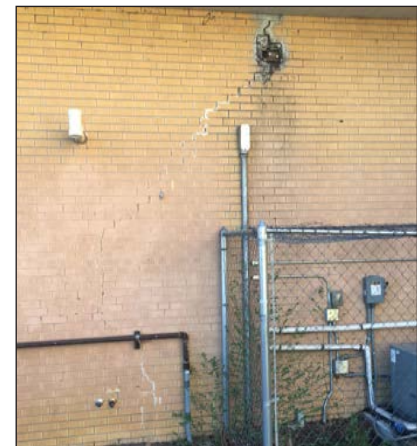
Stabilize structural settlement & repair masonry

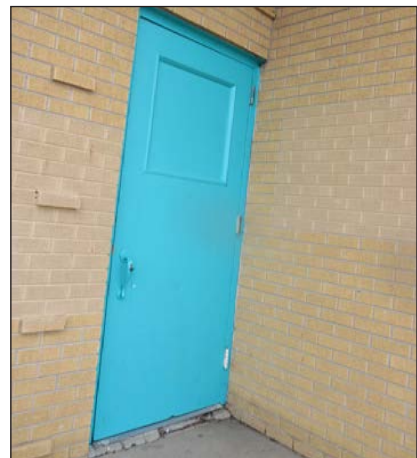
Replace exterior doors & hardware

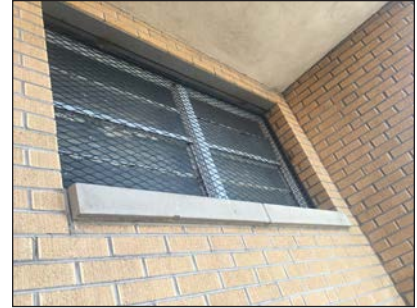
Replace all exterior windows-single pane

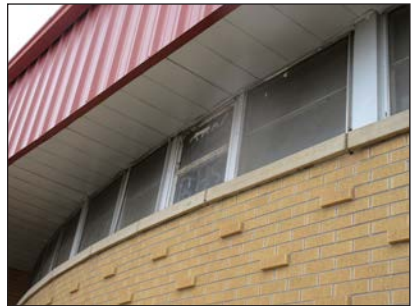
Replace exterior windows

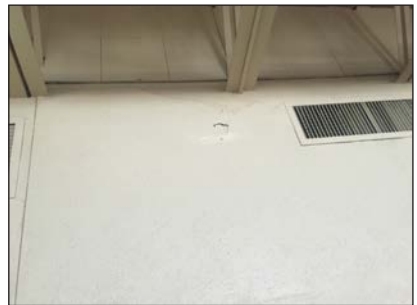
Repair interior walls & repaint

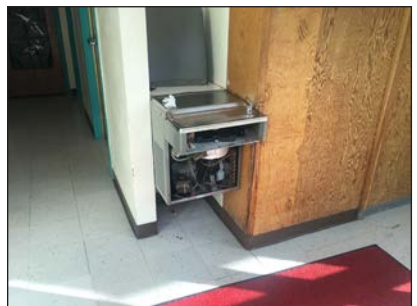
Replace inoperable water fountain

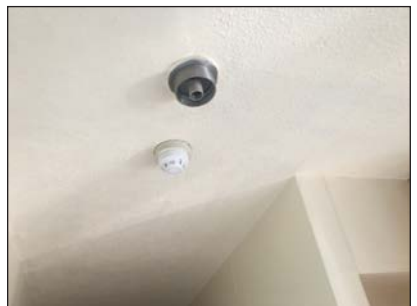
Replace light fixtures

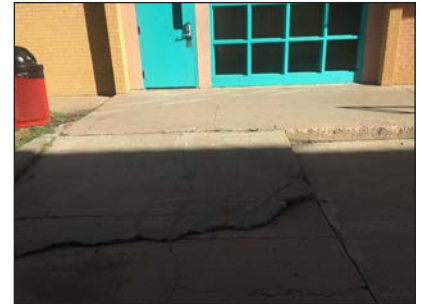
Replace broken/spalled concrete

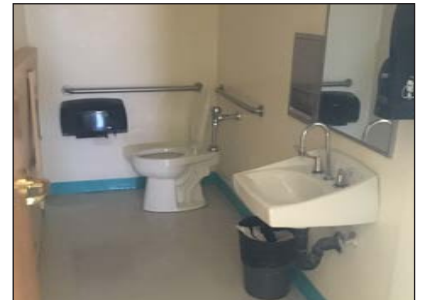
Renovate restrooms for ADA compliance

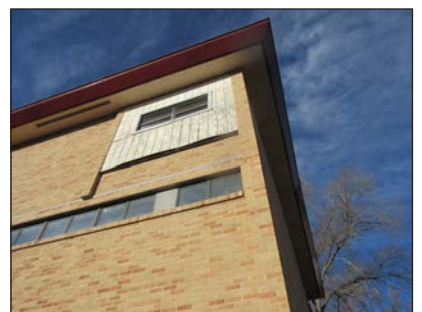
Replace exterior windows

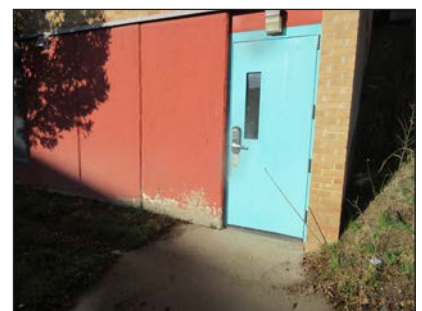
Replace exterior wood panels & lighting

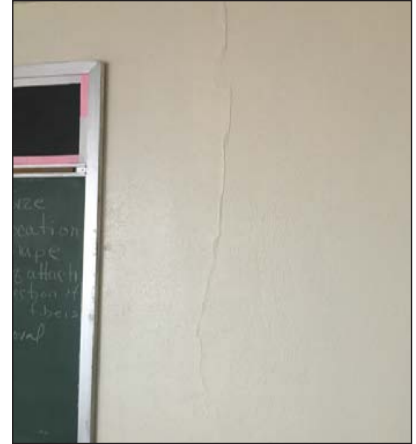
Repair interior wall cracks & repaint

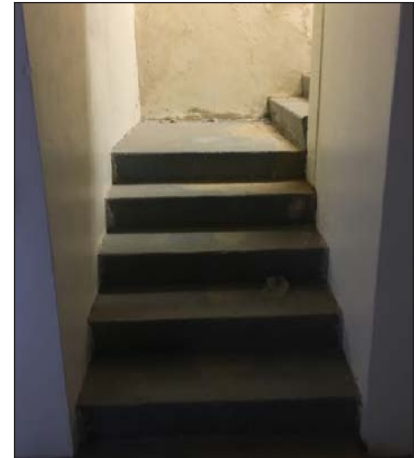
Handrails need to be installed at stairs

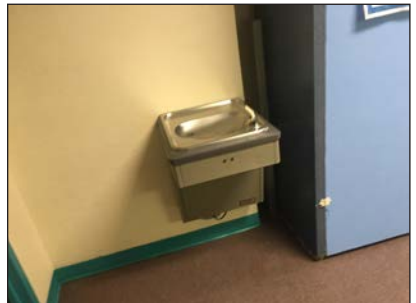
Replace water fountain

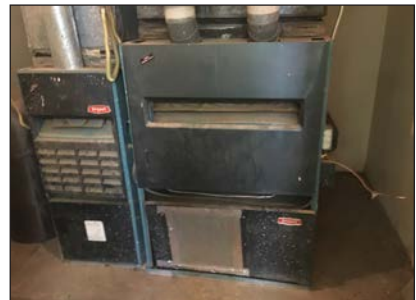
Furnace upgrades needed

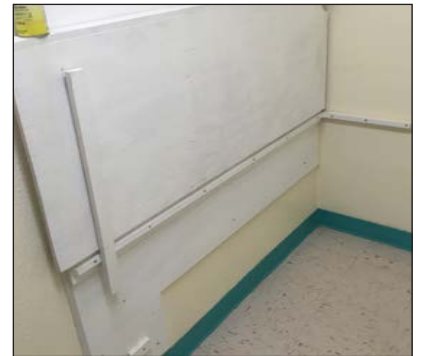
Install stainless changing table

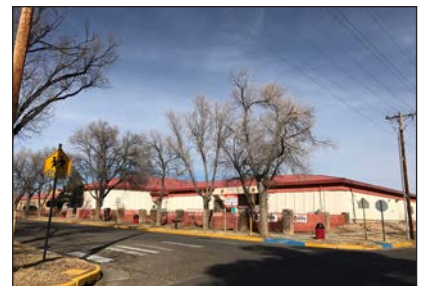
Career Education Building

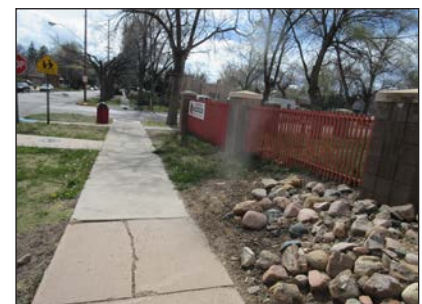
Replace broken/settling sidewalk

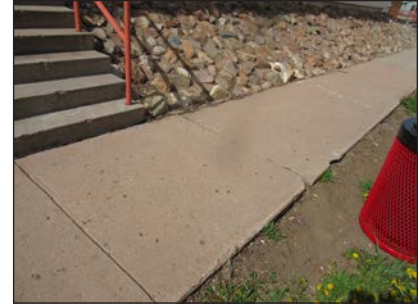
Extend handrails at steps to meet current code requirements

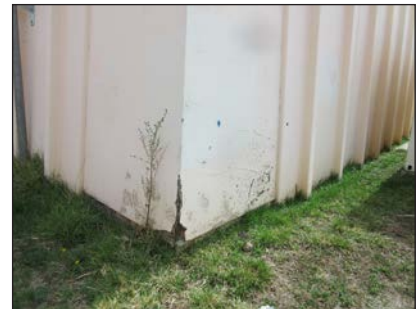
Repair concrete panels & repaint

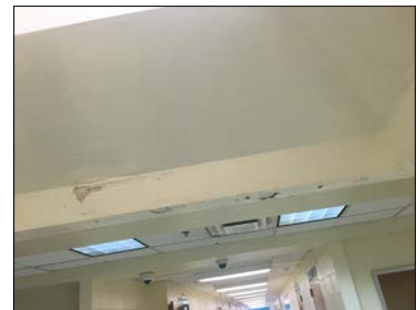
Repair water damaged ceilings & repaint

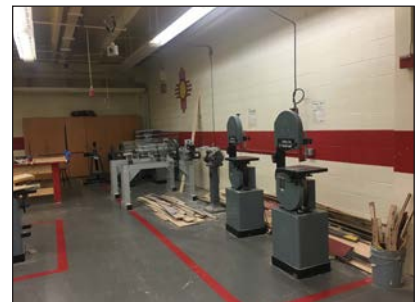
Install Dust Collection System on all Equipment

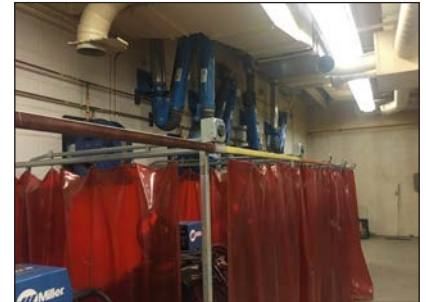
Replace all welding equipment hoods - Non Operable System

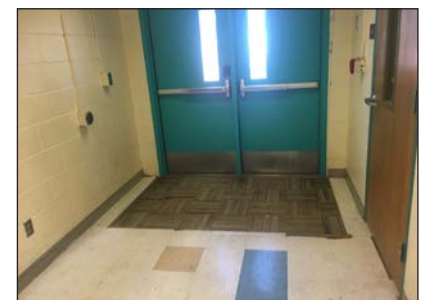
Replace exterior doors, frame & hardware

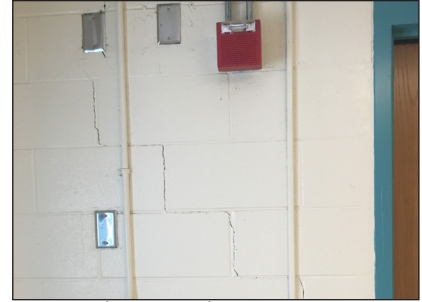
Repair settlement cracks

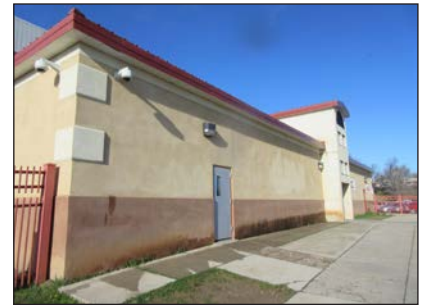
Repaint stucco & re-color coat

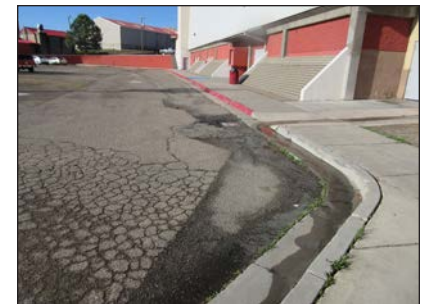
Repair [saving & resurface

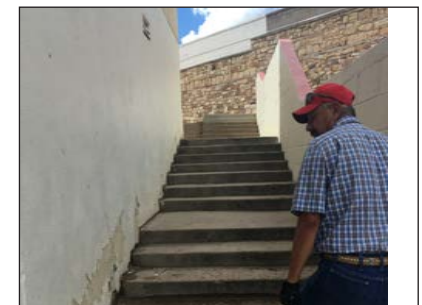
Repair/repaint walls & install handrails

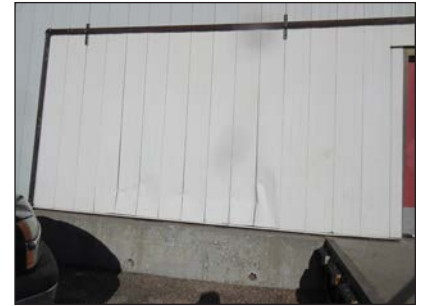
Replace damaged wall panels

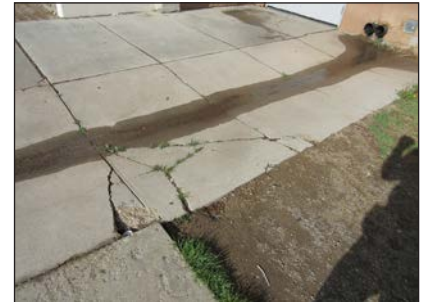
Replace broken sidewalks

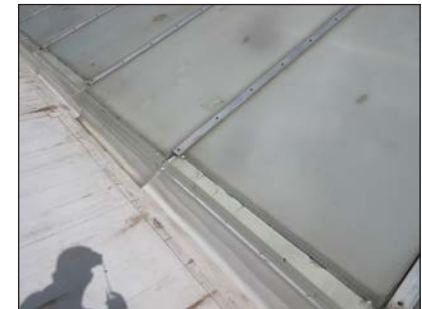
Replace all skylights. Multiple panels broken

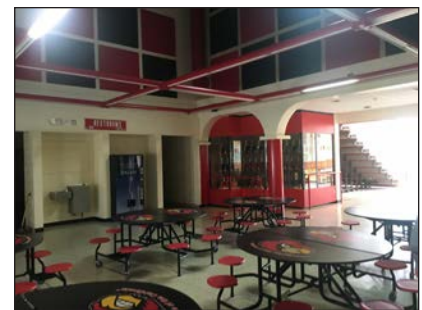
Renovate dining area

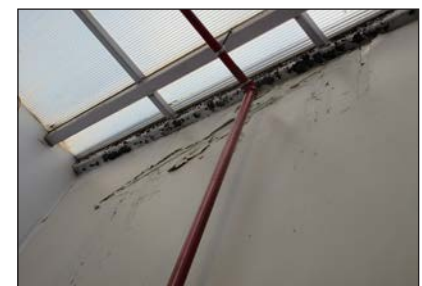
Replace skylights & repair wall damage

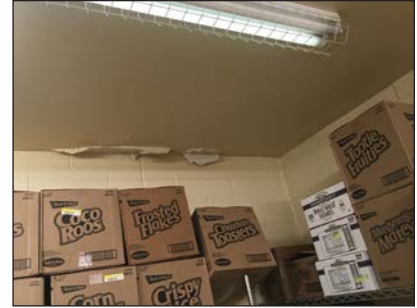
Repair roof leak damage in dry storage room

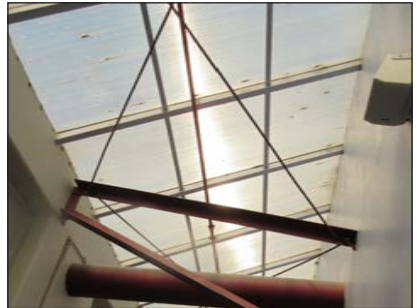
Complete kitchen renovation needed

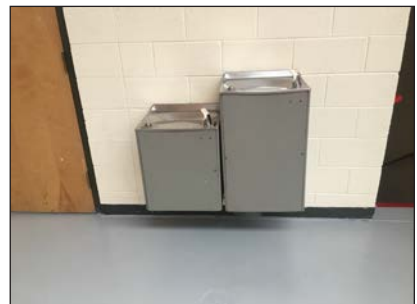
Replace water fountains

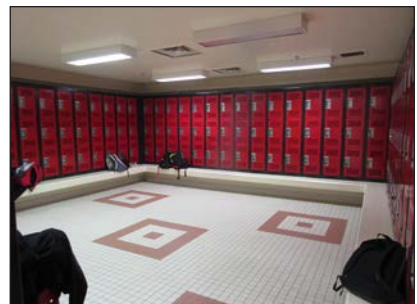
Locker rooms in good condition

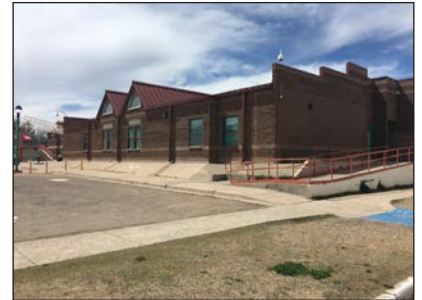
Media Center / Science Building

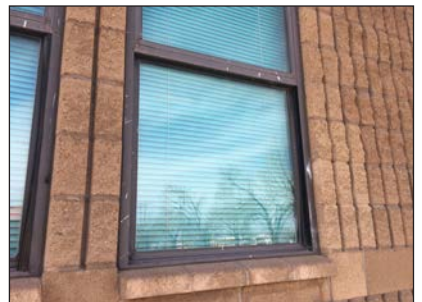
Replace exterior windows throughout

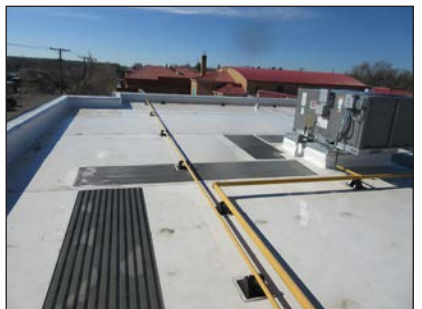
New Roof & Mechanical Systems

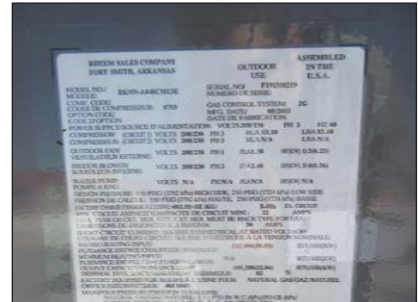
Replace glass block with kalwall system

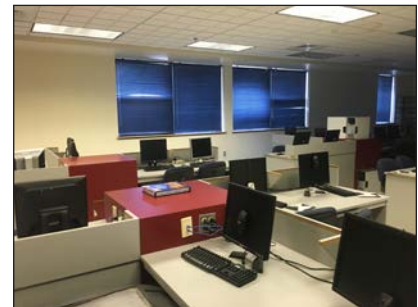
Reconfigure computer labs for multi-use instruction

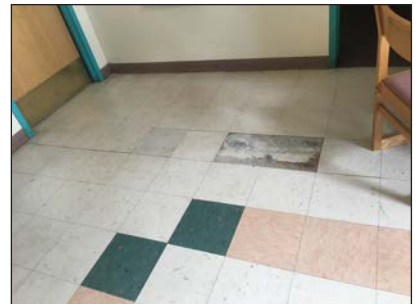
Replace VCT throughout

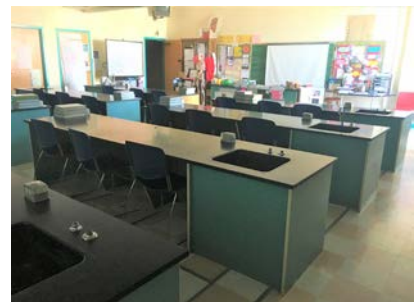
Renovate Science Lab

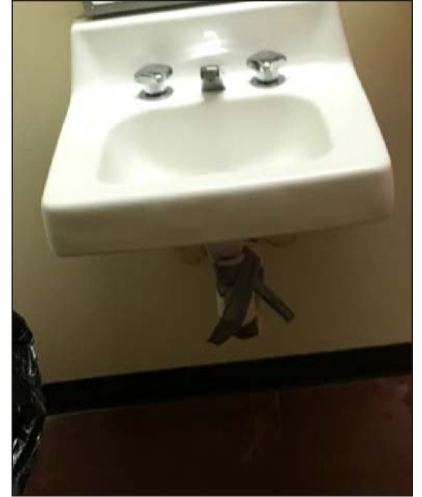
Renovate all restrooms & comply with ADA requirements

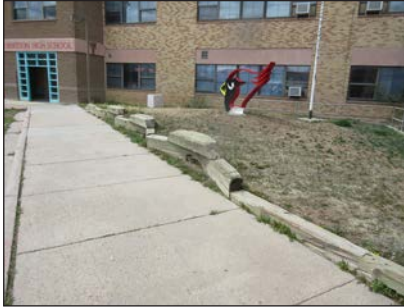
Replace damaged/spalled concrete sidewalks

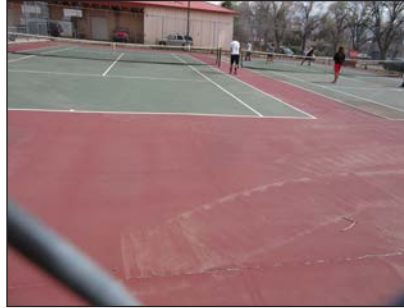
Repair cracks at tennis courts

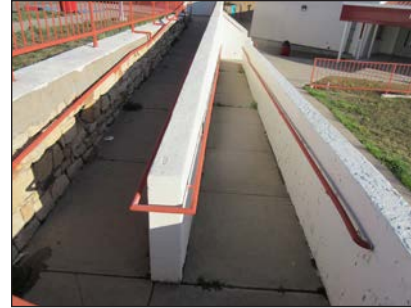
Stabilize retaining wall & repair ramp

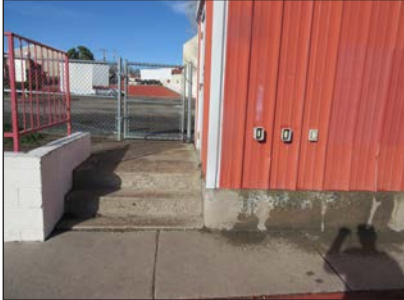
Provide handrails at steps

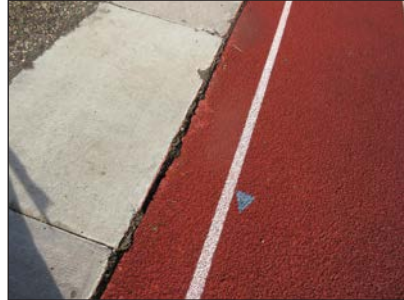
Repair edges around track

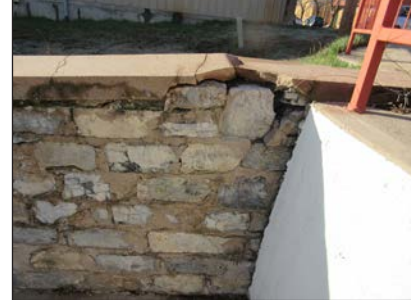
Repair rocks at retaining wall at south side of Gym

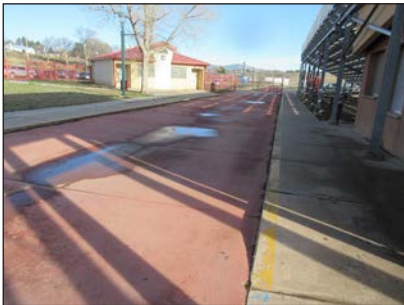
Drainage improvements needed

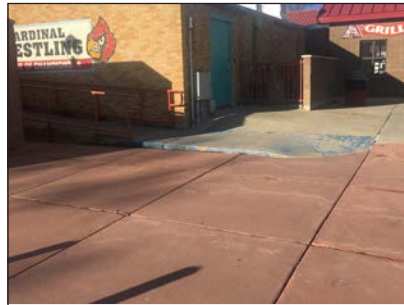
Replace broken/spalled concrete sidewalks

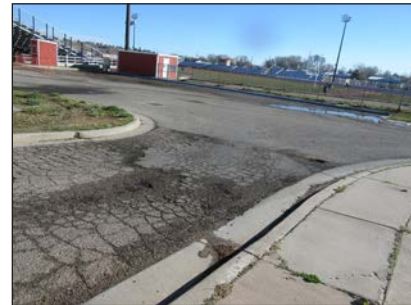
Repair & resurface asphalt

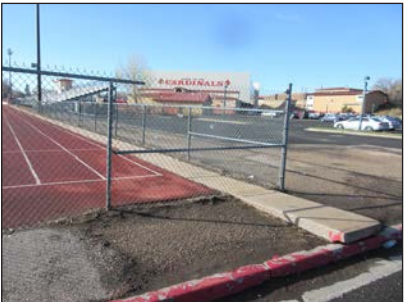
Replace broken/damaged sidewalks

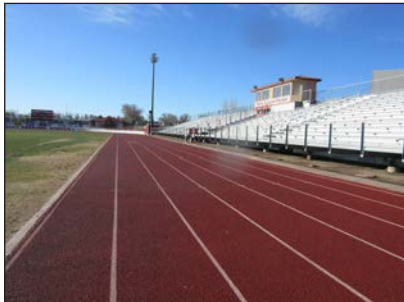
Track repairs needed at NW side

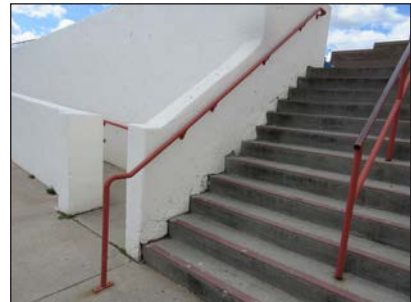
Replace handrails at steps to meet current code requirements

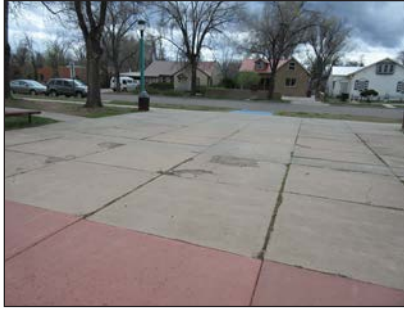
Replace broken/spalled concrete at main entry

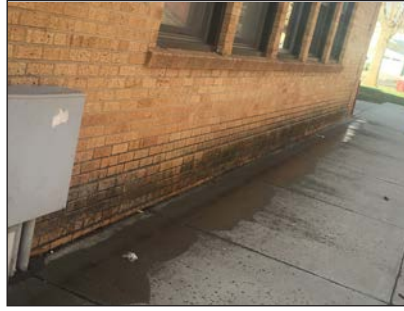
Roof drainage improvements needed on north side of building

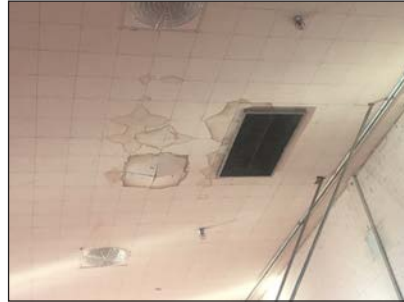
Replace damaged/stained ceiling tiles

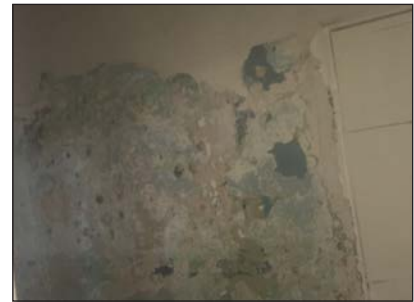
Repair wall damage at fire riser room

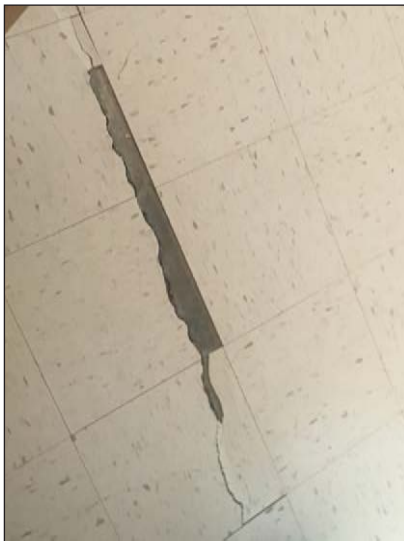
Replace VCT flooring

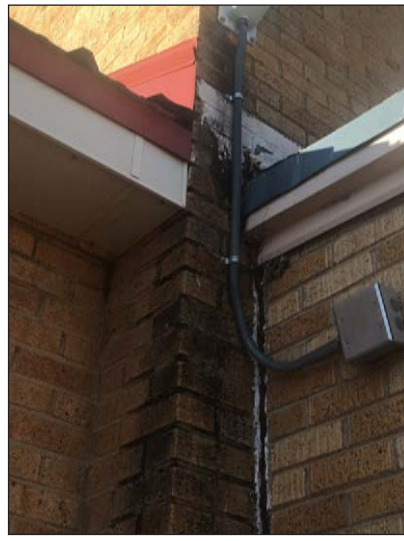
Roof drainage in this area needs to be corrected

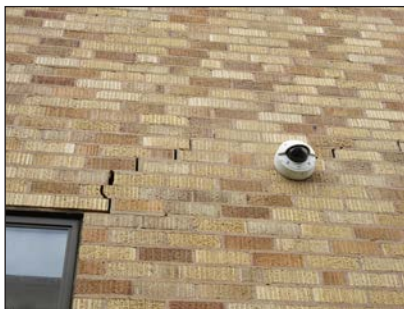
Repair exterior masonry, tuck-point & seal joints

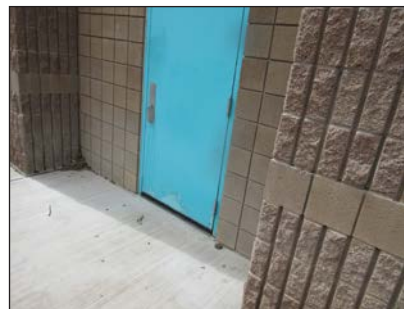
Replace exterior door frame & hardware

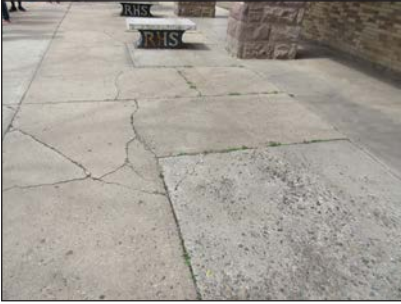
Replace broken spalled concrete

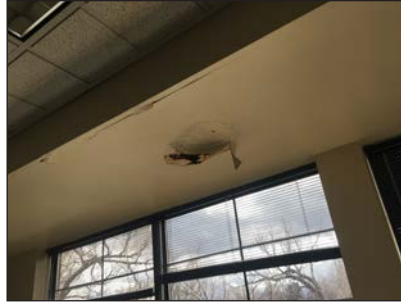
Repair soffits from water leak damage & repaint

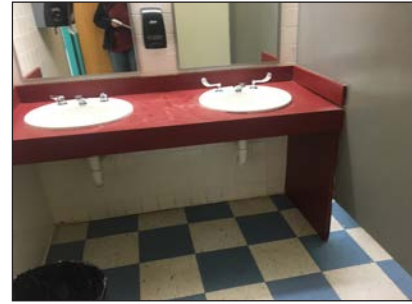
Renovate restrooms & comply with ADA

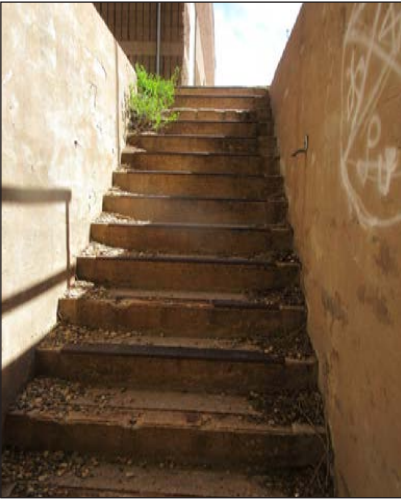
Replacement access stairs to basement & provide handrails

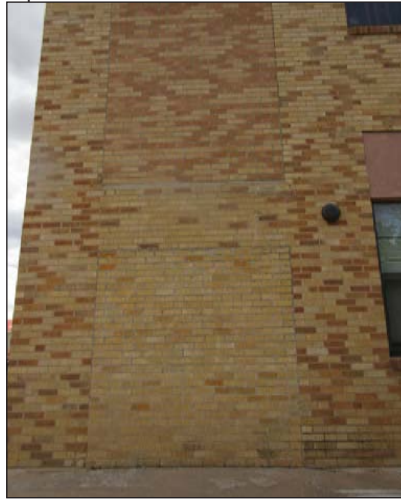
Repair masonry & tuck-point exterior

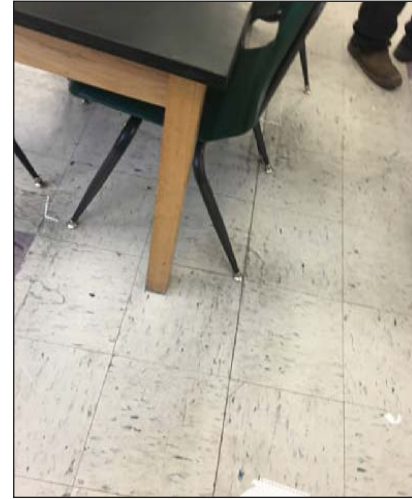
Replace VCT flooring

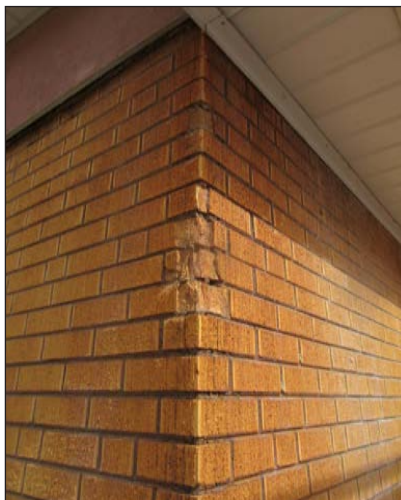
Repair /replace damaged brick

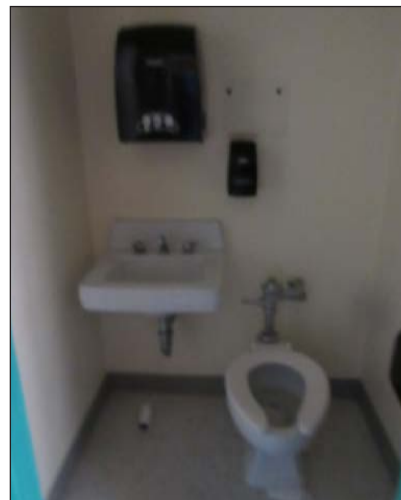
Renovate restroom in admin area- comply with ADA

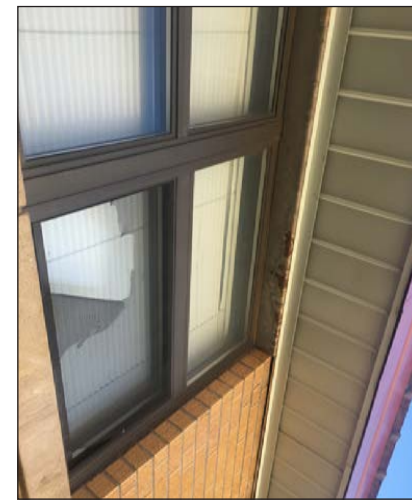
Replace/repair damaged window lintels

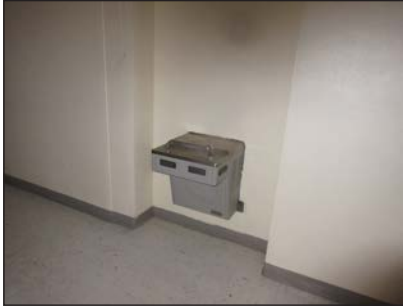
Replace water fountains
