Las Vegas City Schools

2017 - 2022 District-Wide Facility Master Plan

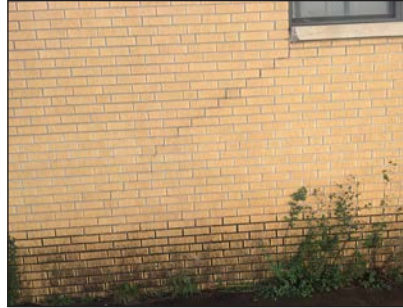
Clear weeds & reseal exterior wall perimeter.
Repair masonry & tuck-point

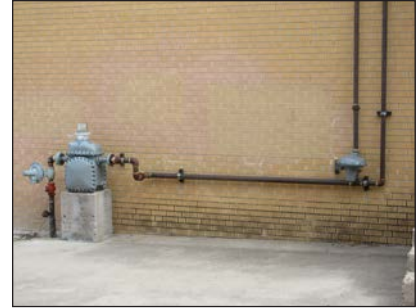
Clean masonry & tuck-point exterior walls

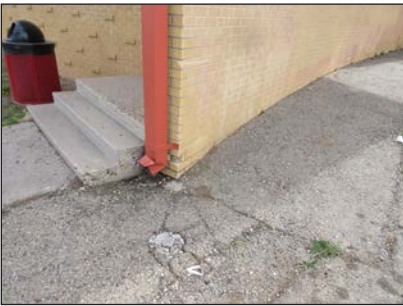
Replace broken/spalled concrete

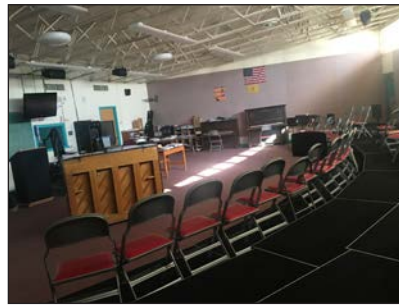
Choir Building - Upgrade interior

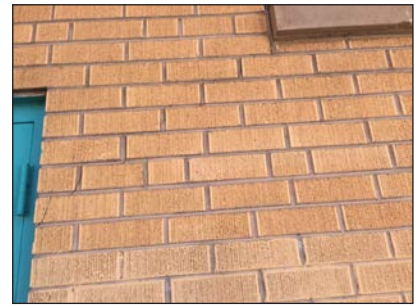
Repair & tuck-point exterior masonry

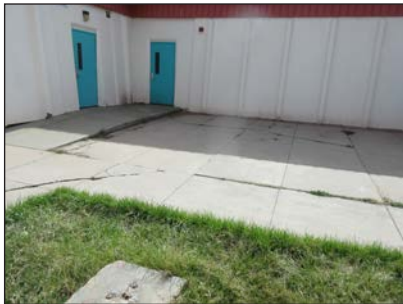
Replace broken/settling sidewalk

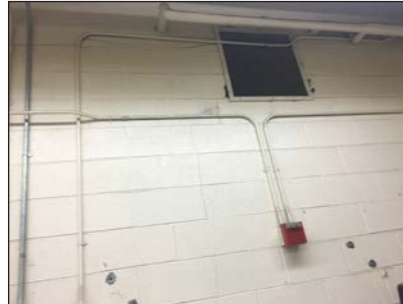
Replace ventilation system & repair walls

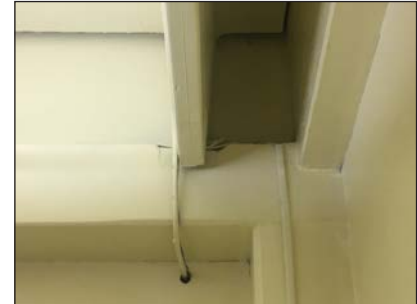
Repair per structural report

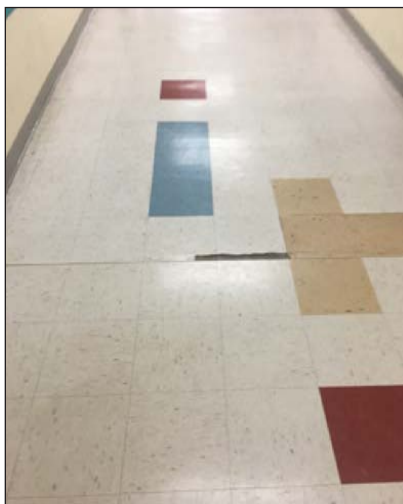
Replace VCT throughout except for SBHC

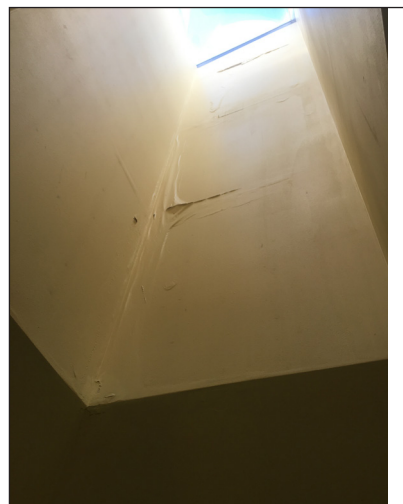
Repair water damage at skylight wells

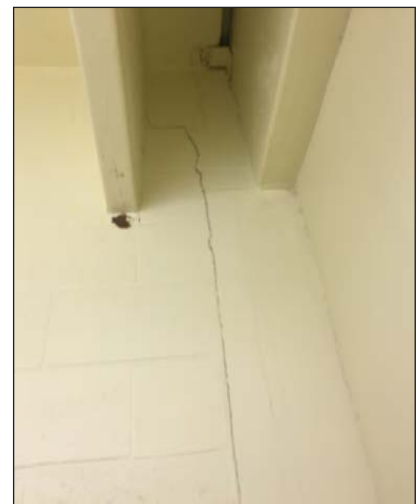
Repair masonry settlement & repaint

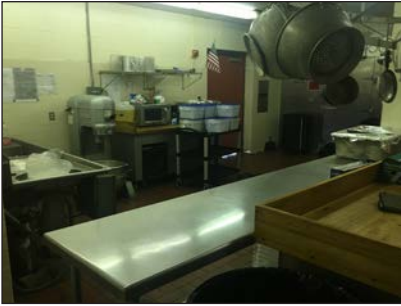
Complete kitchen renovation needed

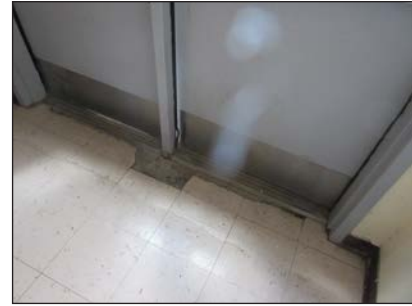
Replace VCT flooring

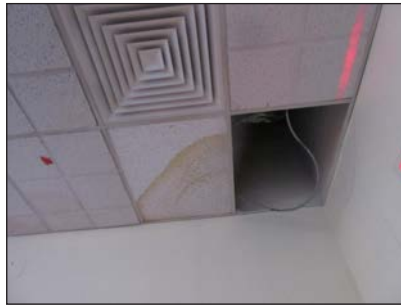
Replace damaged ceiling tiles

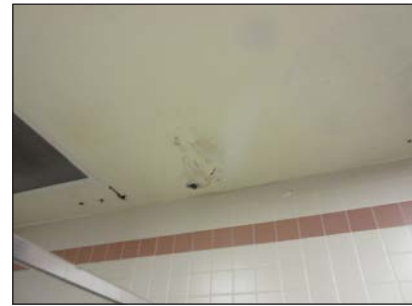
Repair water damaged ceilings in locker room

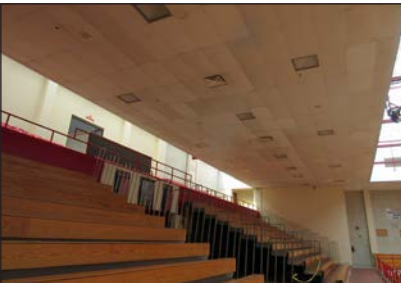
Replace wood bleachers

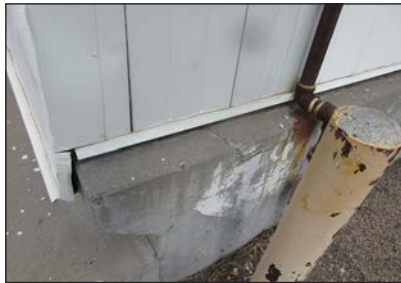
Reseal flashing at all metal wall panels

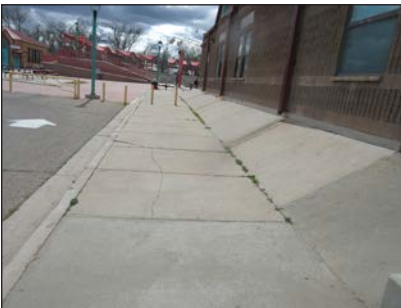
Replace broken/spalled concrete sidewalks

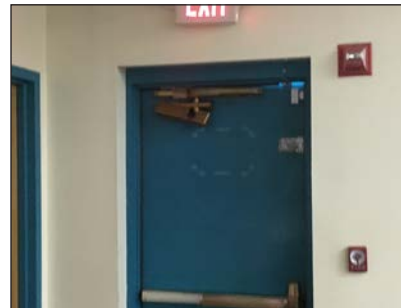
Replace exterior doors & hardware

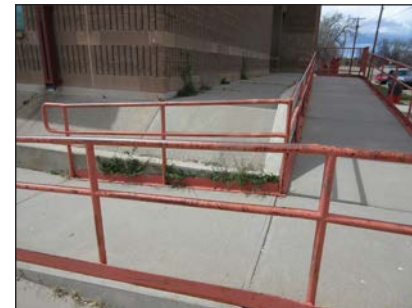
Repaint exterior railings

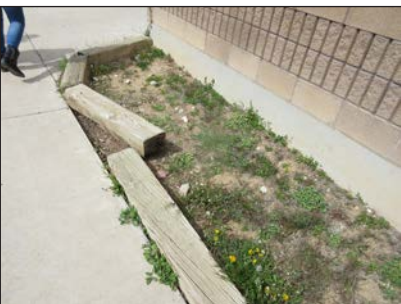
Reset/replace R.R. ties

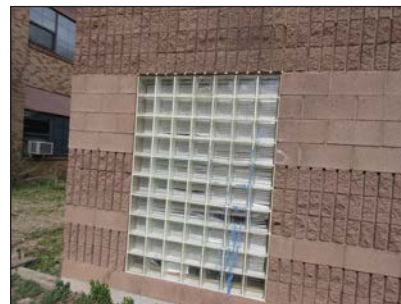
Replace glass block with kalwall system

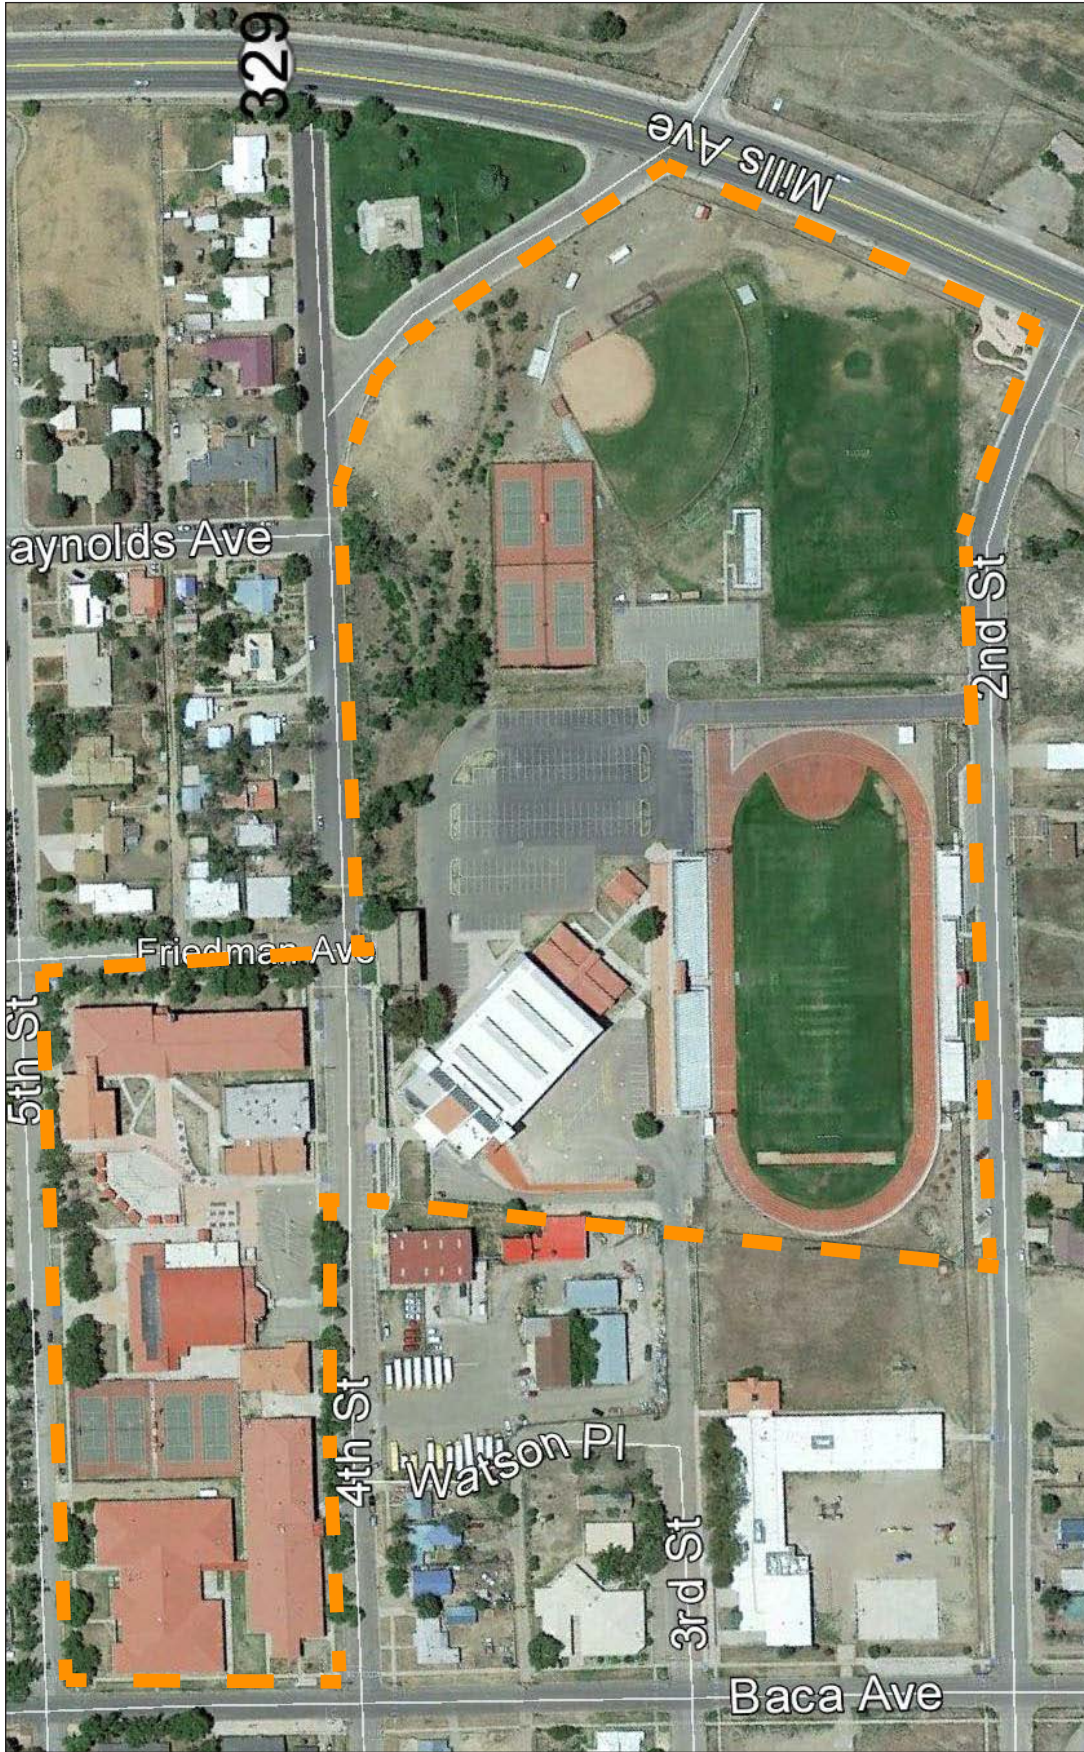
Site Plan - Robertson High School
Las Vegas City Schools

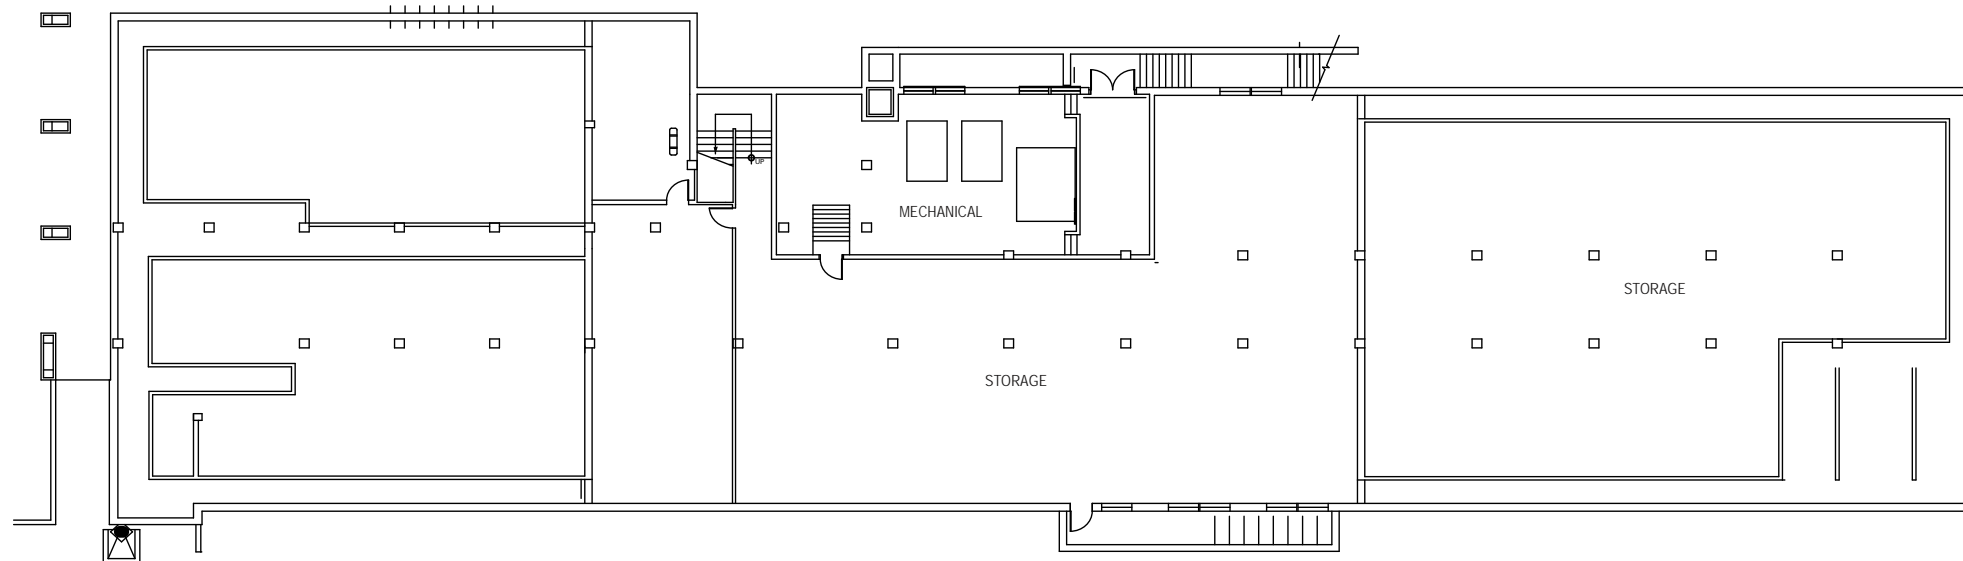
FLOOR PLAN - Basement & Foundation

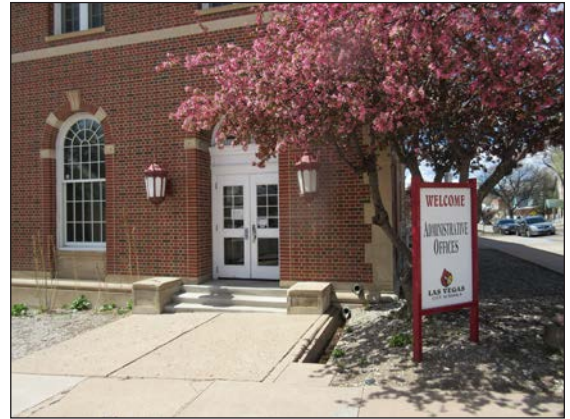
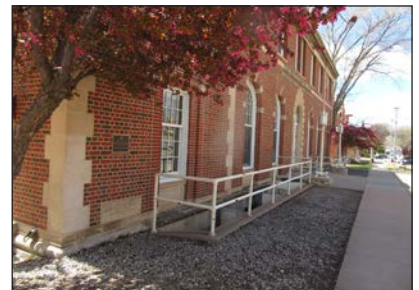
Main Entry to Building

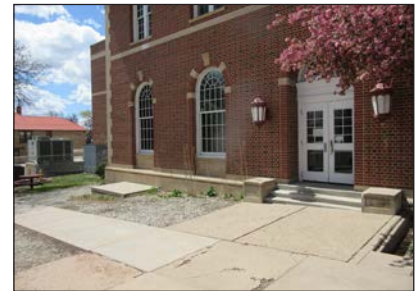
Side Entrance to Building - Broken Sidewalks

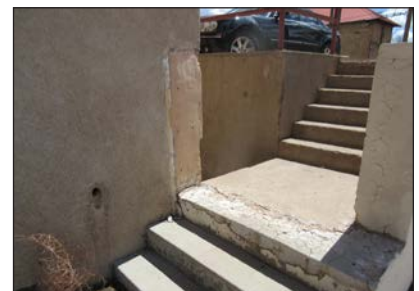
Rear Parking Lot Access Deteriorated Stairs/ No Handrails

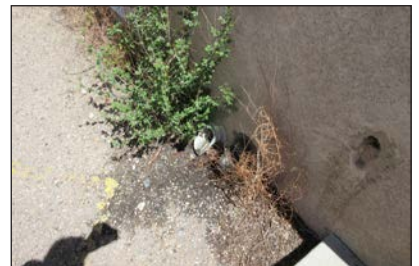
Roof Drain Discharge - water does not flow away from building

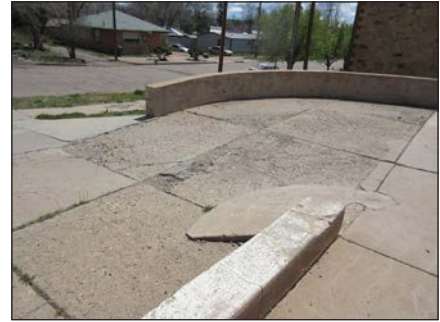
Deteriorated Parking Lot Paving - Rear

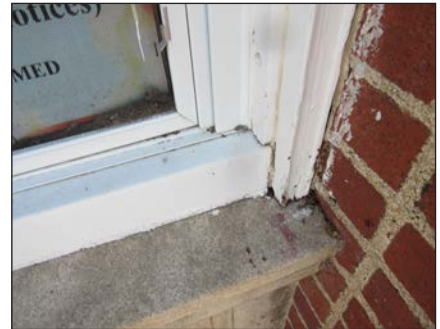
Wood Windows Need Refurbishment/ Caulking

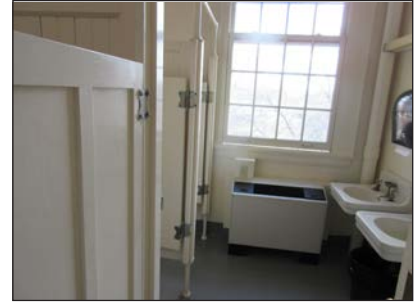
Original 1927 Restrooms - Restoration Needed

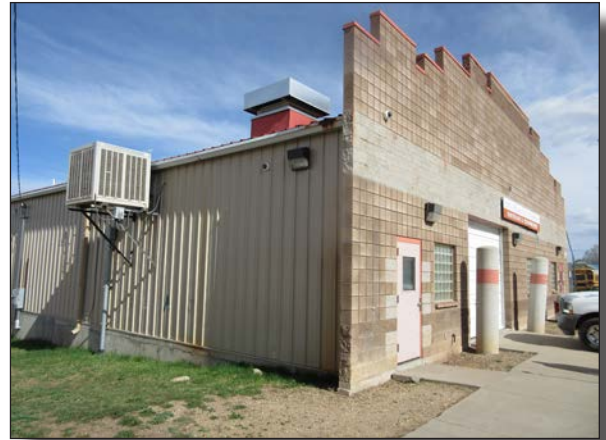
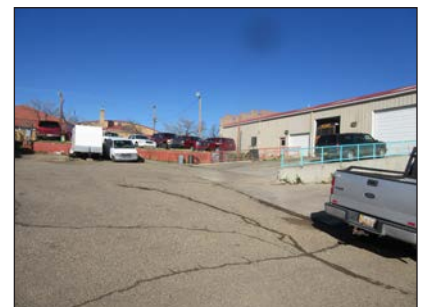
Resurface parking lot

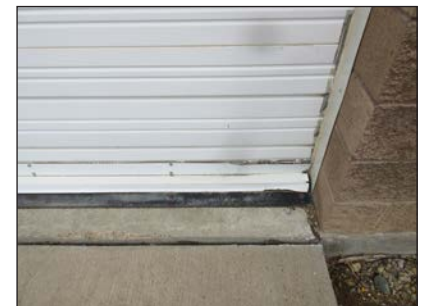
Repair/replace damaged overhead doors

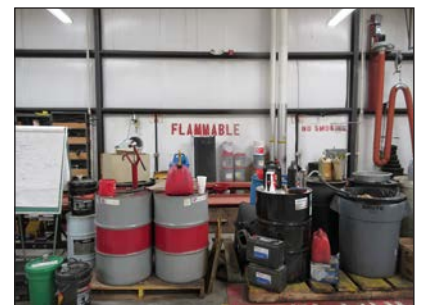
Due to amount of flammable material, a separate room enclosure may be required code analysis

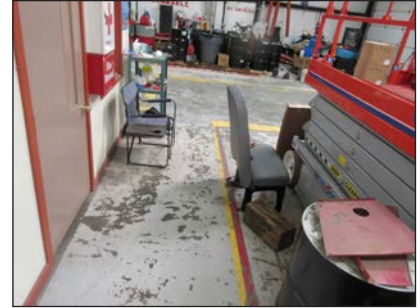
is via through-wall mounted evaporative cooling units that need to be replaced. There is no mechanical cooling in the open bay. The building does not have a fire sprinkler system in place and may be required in the event of a major renovation. There is both a fire alarm system with annunciators and strobes in place as well as an intrusion alarm system for security.

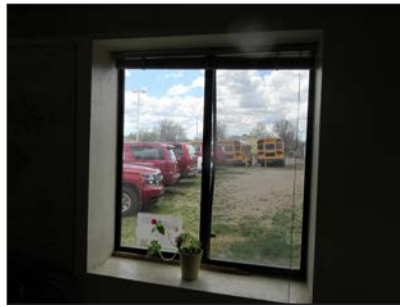
Replace exterior windows

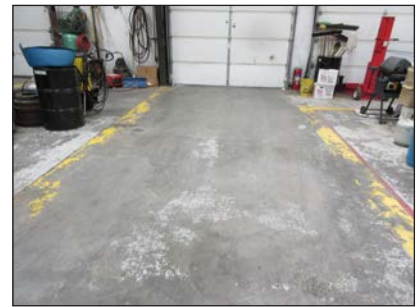
Re-stripe flooring to meet OSHA requirements

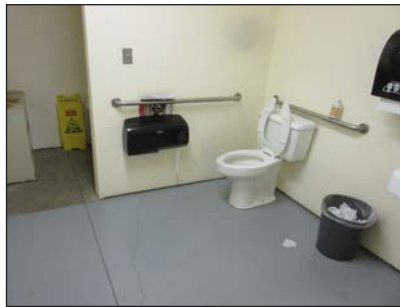
Restrooms in good condition but ADA upgrades needed

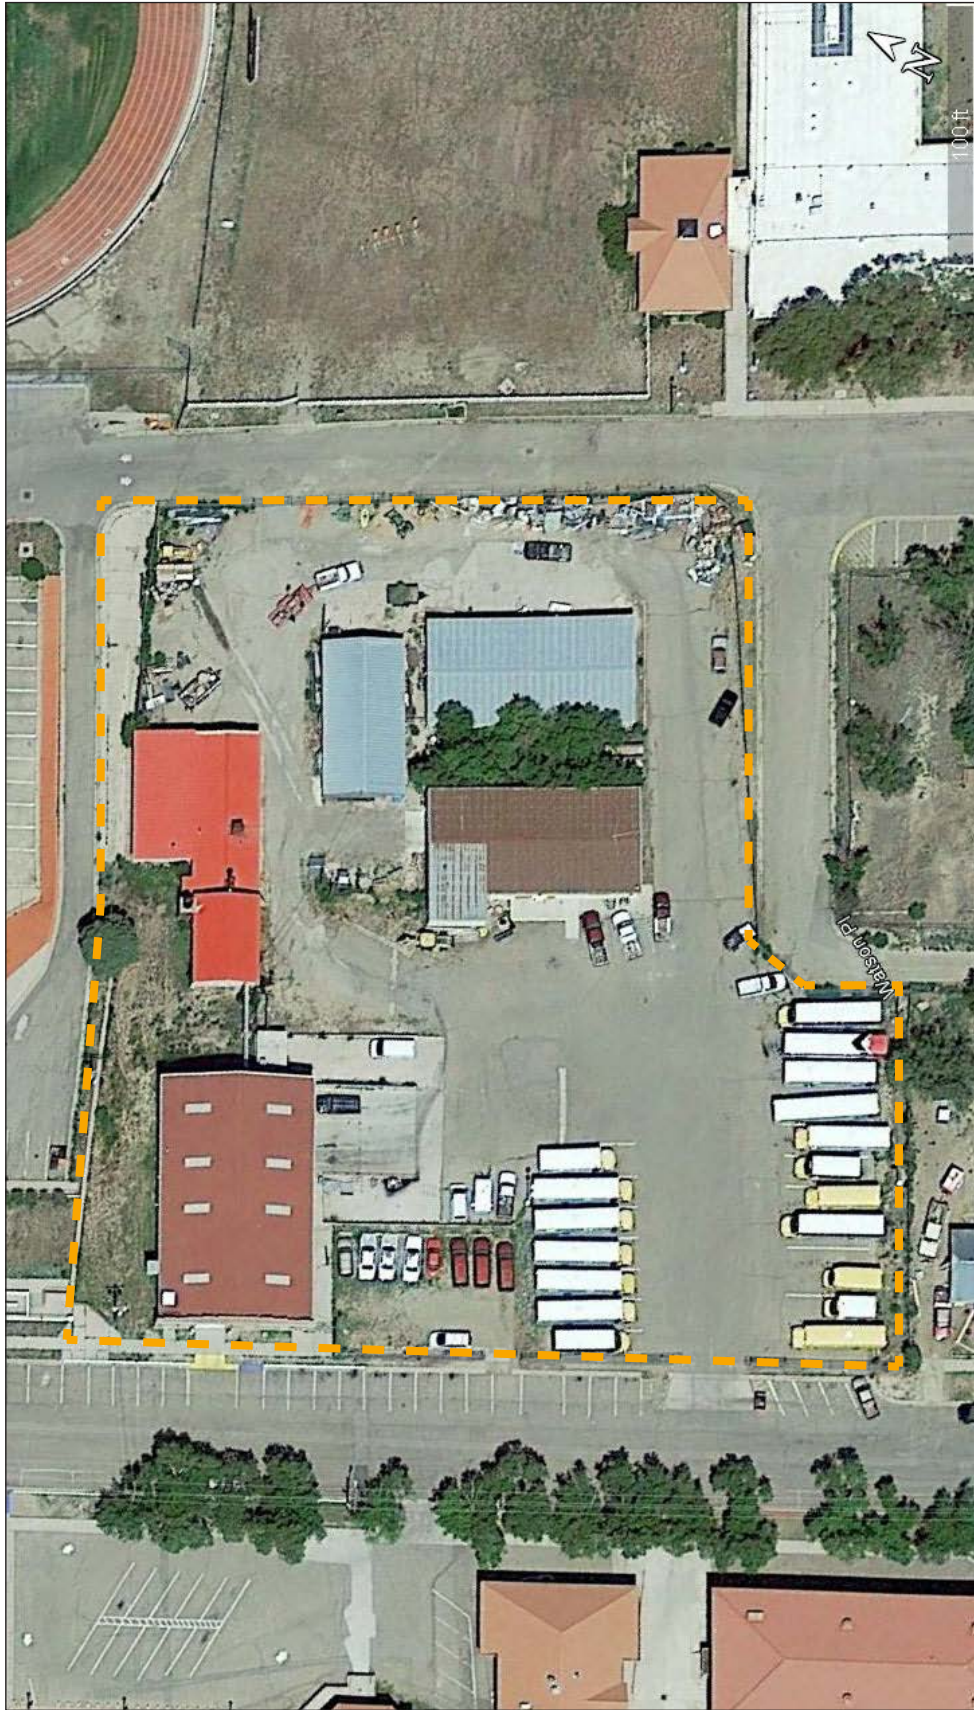
Site Plan - District Maintenance Complex
Las Vegas City Schools
