Turquoise Trail Charter School

*Facility Master Plan/ Ed Spec
2017 - 2022
October 26, 2017*

Visions In Planning, Inc.
Educational Facility Planning Consultants

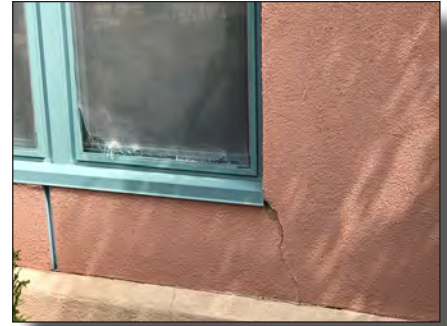
Structural/Exterior Closure: The original portion building constructed in 1990 appears to be constructed with concrete slab-on-grade with concrete footings and foundation walls. There are some areas of settlement occurring at the south sides of classroom wing B and classroom wing D that should be monitored. The exterior wall structure

consists of CMU and/or metal stud framing with 5/8” exterior gypsum board that has been covered in a cementitious stucco system that is in need of significant repairs and areas of complete replacement.

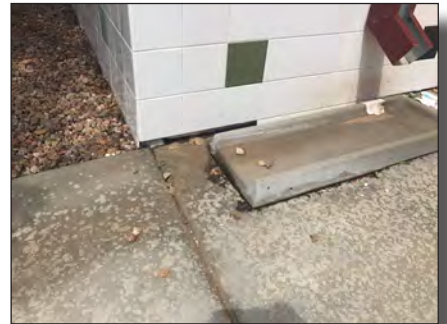
The new classroom addition and new gym constructed in 2011 consist of concrete slab-on-grade with concrete footings and foundation walls. The exterior wall structure consists of CMU and/or metal stud framing with an Exterior Insulation and Finish System (EFIS) that is in good condition.

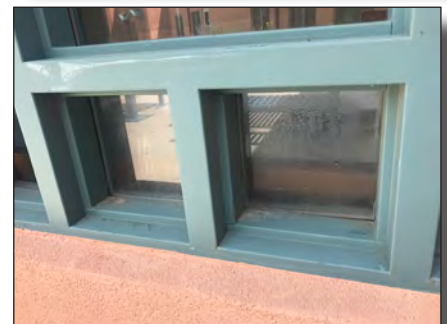
The exterior doors are hollow metal and are comprised of either solid panel or have glazed vision panels; and the door frames throughout the facility are hollow metal. The exterior doors, frames and hardware classroom wing B are in need of replacement. The exterior windows are a combination of hollow metal or aluminum units that are fixed double pane or operable units that are double pane, many of which have broken seals and condensation visible. Only the window units that are part of the original 1990 construction need to be replaced and should be completed in conjunction with the stucco repairs.

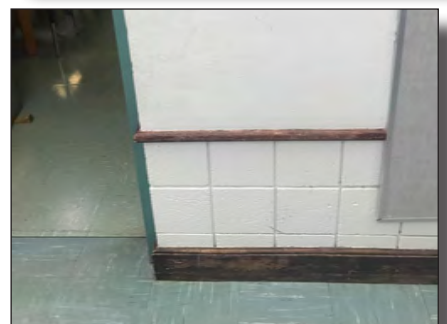
Interiors: Partition wall types include painted gypsum board walls and painted concrete block in some locations. The interior wall finishes are in good condition overall, however there are several areas that are in need of repainting such as the cafeteria and some corridors. There is wood trim installed throughout the corridors of the 1990 portion of the building that needs to be refinished/ stained or painted. The ceilings consist of 2’x4’ suspended acoustical panels in the classrooms, and painted gypsum board in the restrooms and storage rooms.

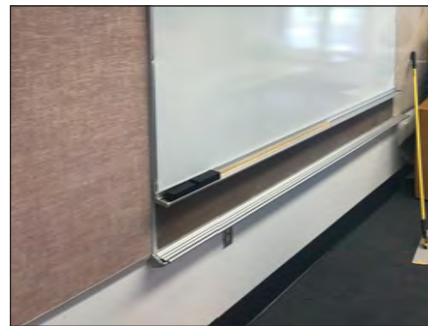
Flooring throughout the facility is in good to fair condition and consists of: VCT in the corridors and portions of classrooms in classroom wings B, C, and D, cafeteria; polished concrete in the corridors and portions of

classrooms in classroom wing A and main entry lobby area, and carpet tile in a portion of all classrooms, offices, and library. All restrooms have ceramic tile floors and wainscots. The interior door systems are hollow metal frames with solid wood doors with some having vision panels, all are in good condition, however do need to be refinished and the door hardware in classroom wings B, C, and D needs to be upgraded to be ADA compliant.

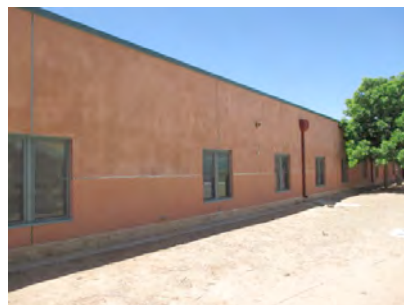
The Turquoise Trail school building was original designed and constructed circa 1990. As-built drawings indicate that exterior wall construction consists of CMU and/or metal stud framing with 5/8" exterior gypsum board with 7/8" cementitious stucco system comprised of stucco, metal lath and one layer 15# felt. (DETAIL #2) No weep screed is installed and stucco extends below grade or hard scape.

A protruding, decorative color band at grade to approx. 16 inches above grade is formed with rigid insulation with a 45° angle and covered with the stucco assembly. The assembly continues below grade. It does not appear that the water resistive barrier or metal lath maintained any continuity from the wall above over this detail, allowing the stucco to crack at the 45° joint. The base of the rigid insulation is exposed to the earth and not wrapped by the stucco finish coat. The cracking and the exposed rigid insulation allow water to enter the system. (PHOTOS #5 & #7)
