ESTANCIA MUNICIPAL SCHOOL DISTRICT  
**5 Year Facilities Master Plan**  
 FINAL • 2018-2022 • # 5339

# Executive Summary

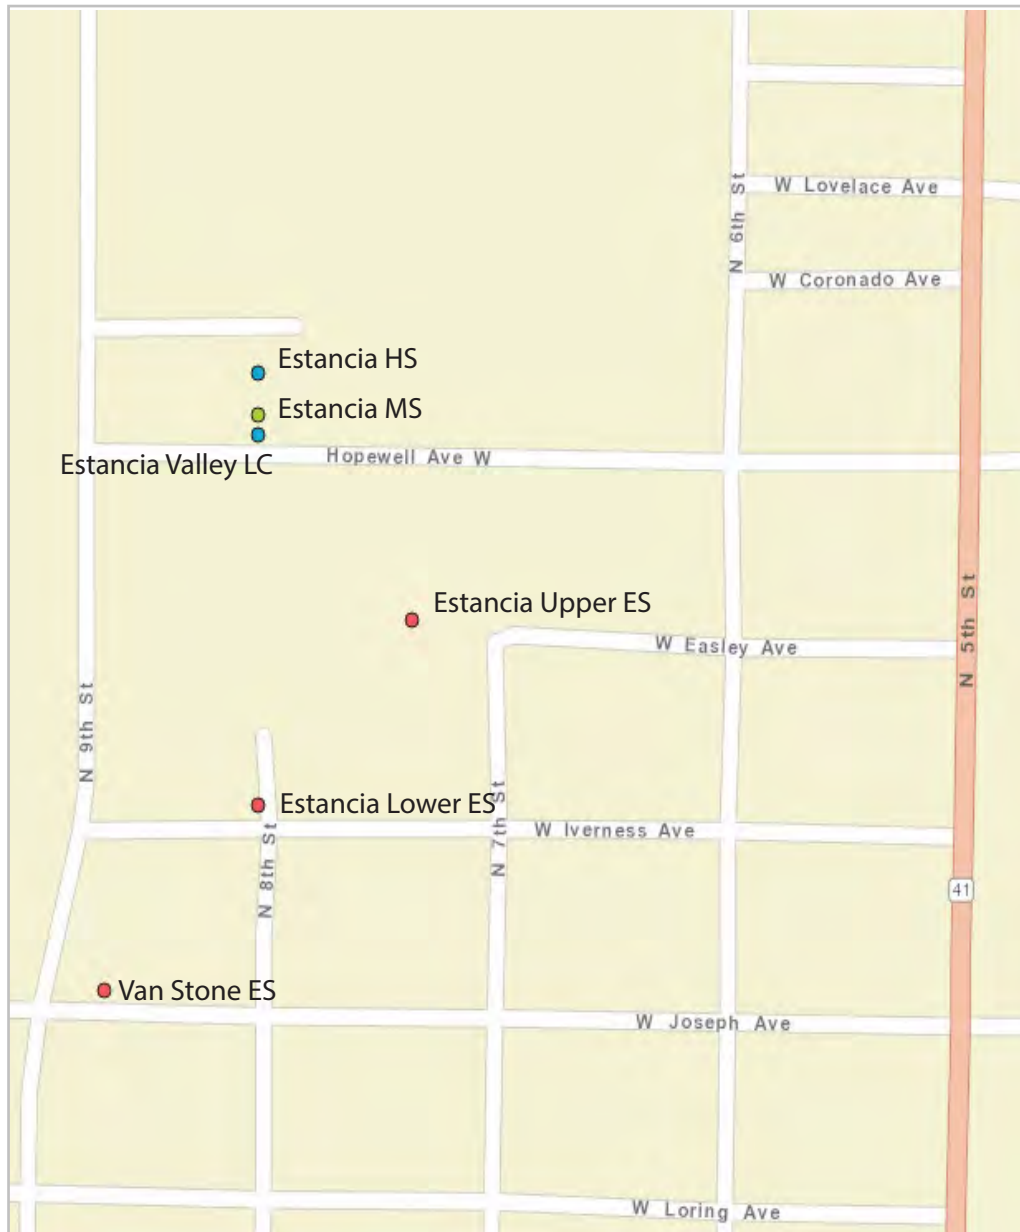
In the following map each EMSD School location is depicted. All five of the existing schools are located on one site that is approximately 60 acres. Estancia Valley Learning Center is no longer a separate of the high school and is being used for the Special Education Program. Administration and district storage are also located on the premises.

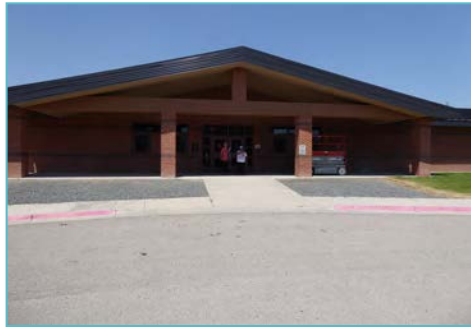
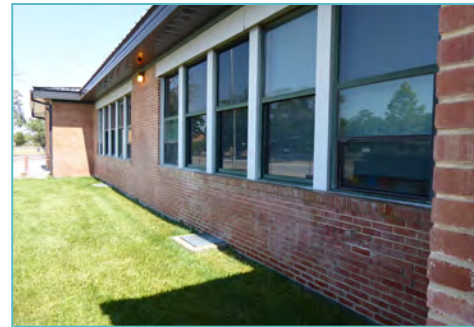
*Water heaters are maintained and in working condition. Water fountains have some hard water spots. Recommend cleaning water fountains.*

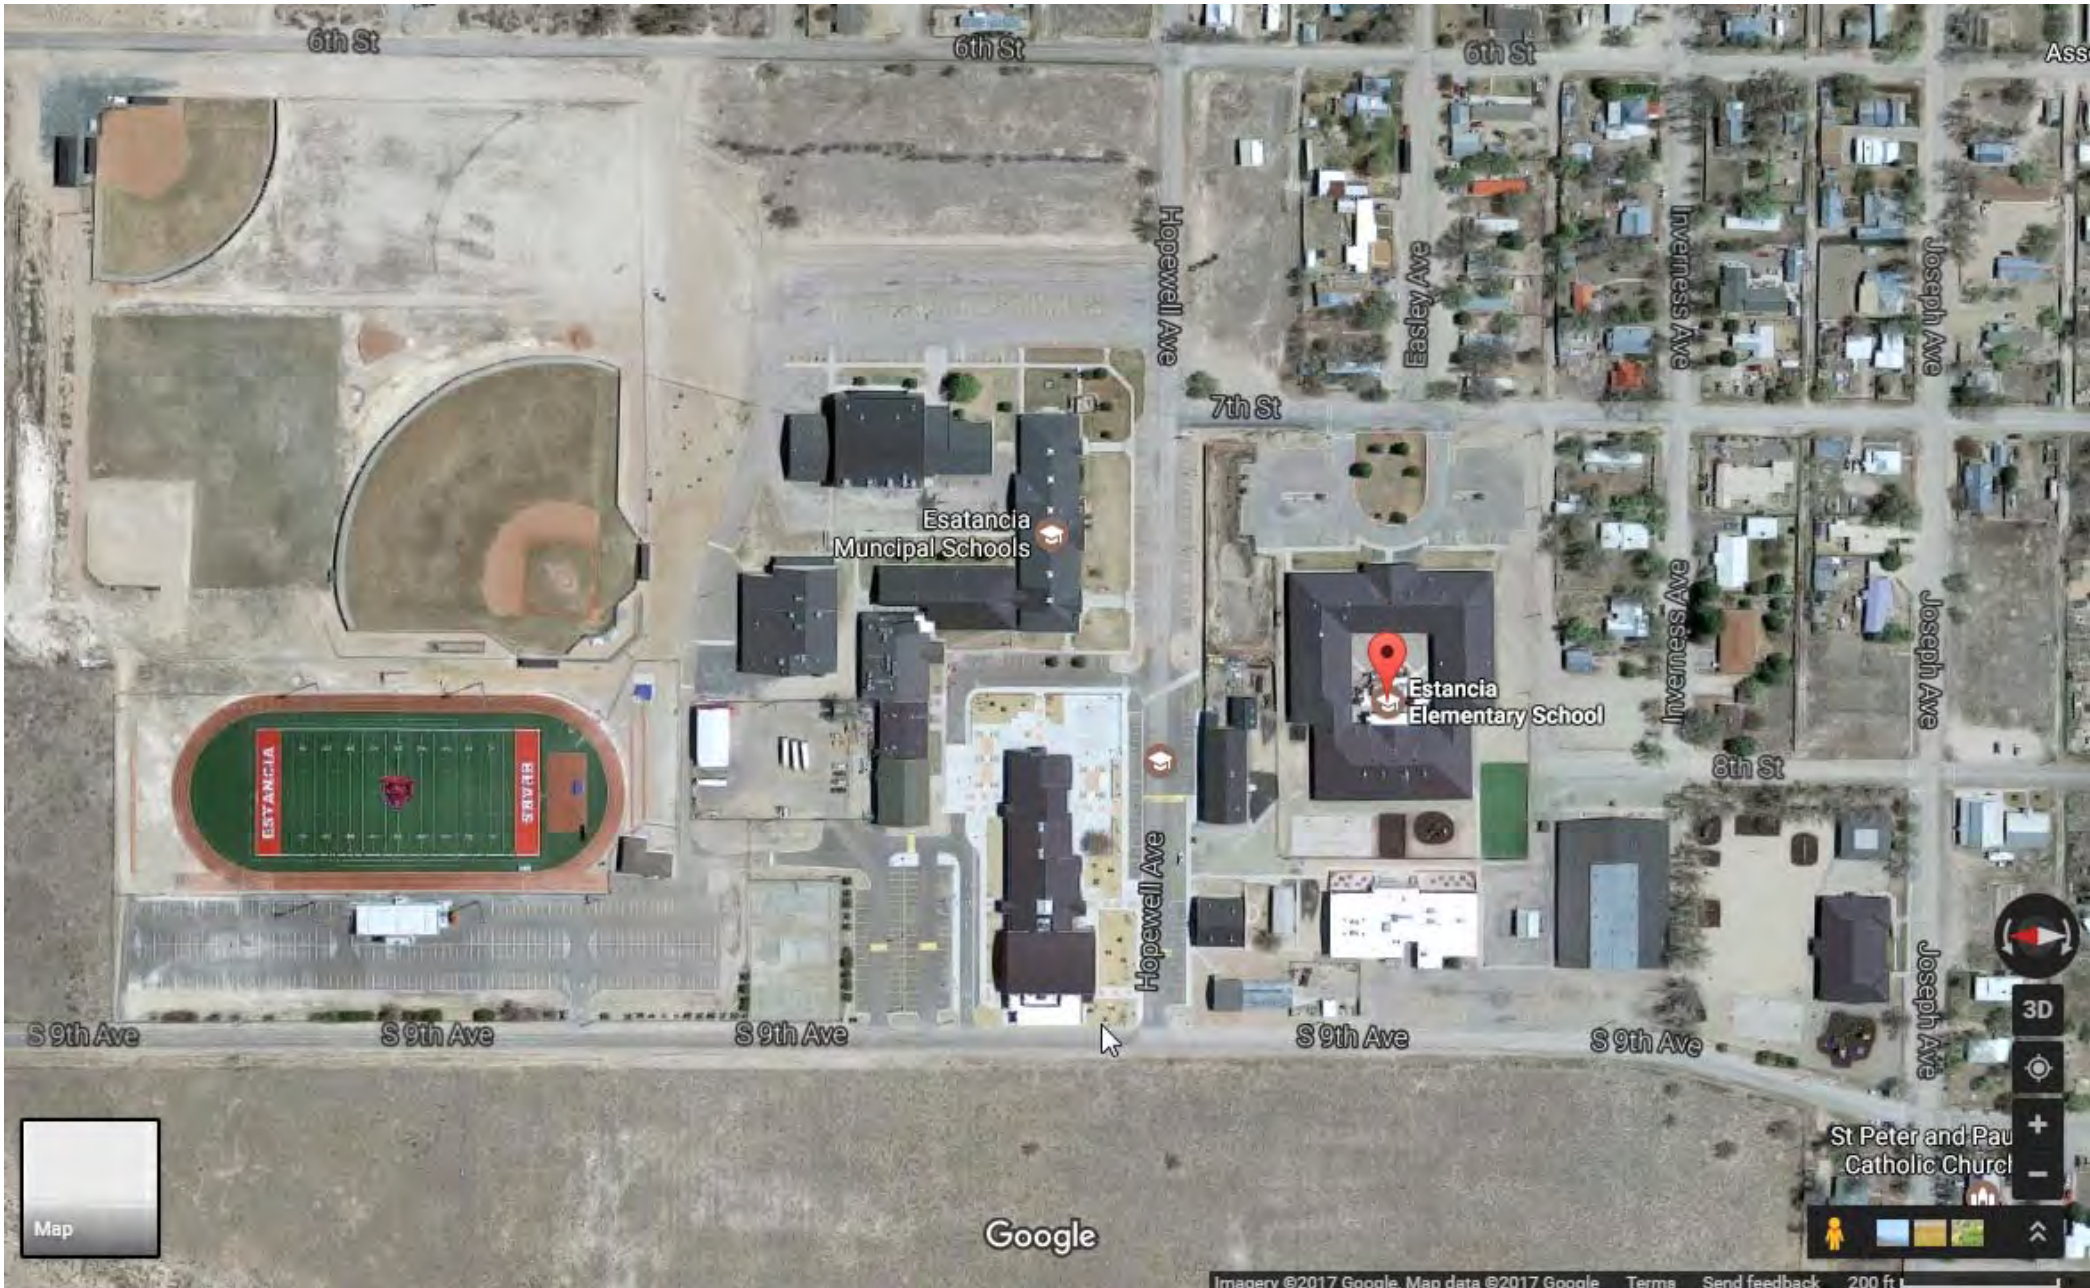
**AERIAL PLAN**

Floor plans unavailable, please contact PSFA for assistance

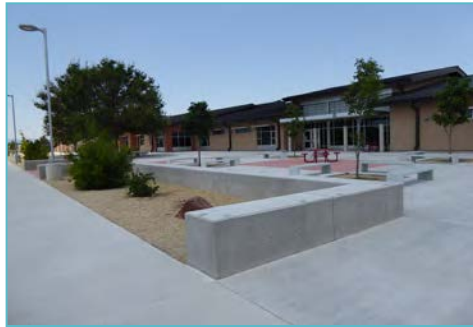
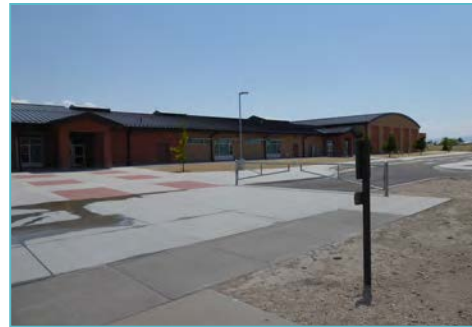
*Plumbing ,water heaters are new ,in good working condition. Drinking fountains clean maintained and functional.*

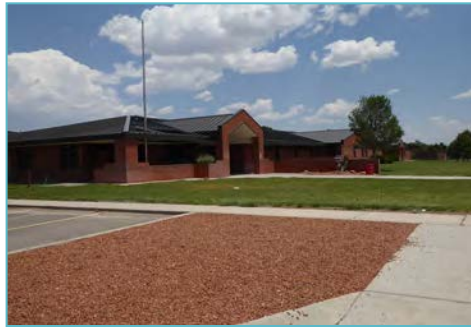
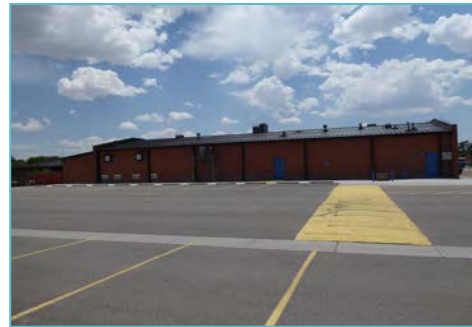
*Water heaters / plumbing is well maintained and in working condition. Drinking fountains need improved cleaning. Eye wash stations are in working condition. Drains are free of debris.*

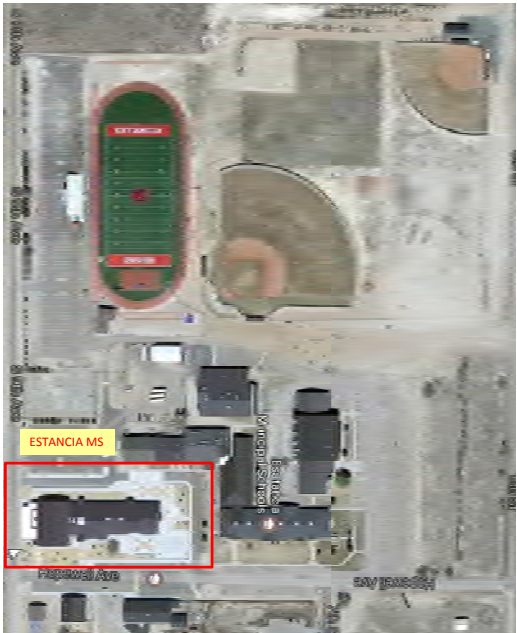
AERIALS	Estancia MS

<p>The aerial photograph shows a school campus. At the top, there is a green oval-shaped field, likely a track or sports field. To its right is a baseball field. Below these are several buildings. A red rectangular box highlights a specific building in the lower-left quadrant of the image, which is labeled 'ESTANCIA MS' in a yellow text box. Other buildings are labeled 'ESTANCIA MS' and 'ESTANCIA MS' in white text. The surrounding area includes parking lots and roads.</p>
