MORIARTY EDGEWOOD SCHOOL DISTRICT
5 Year Facilities Master Plan
 FINAL • 2018-2022 • # 5333

Executive Summary

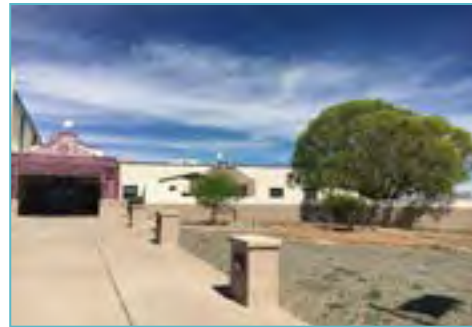
Drinking fountains are clean and operational. Mop sinks and drains are free of obstruction and drain properly. Water heaters are accessible and in good working condition. Recommend sweeping water heater closets.

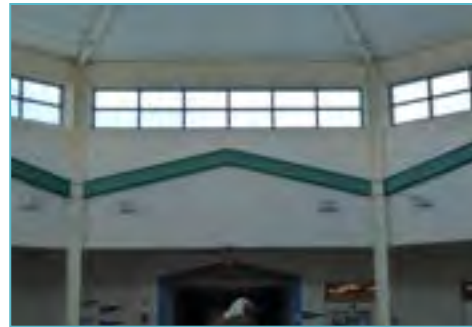
Water fountains contain water deposits on drinking fountains due to hard water. Water heater has inappropriate storage around it. Recommend removing stored items. Recommend assessment of water treatment for facility to determine if working per manufacturers specs. Satisfactory performance level.

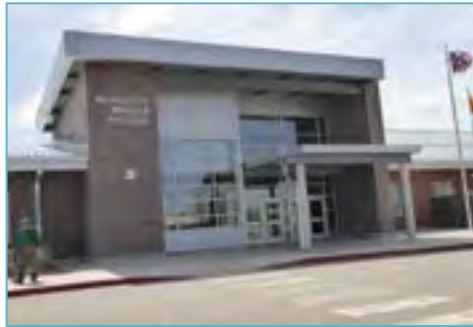
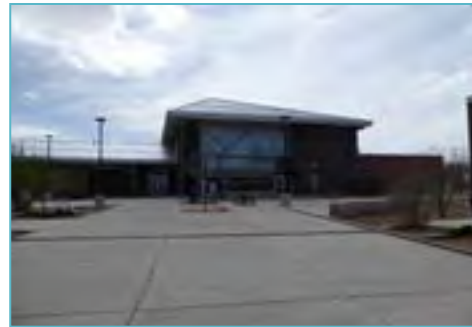
Observed 1 water heater with corrosion on piping due to leak. Recommend repairing leak and replace rusting pipe. Water fountains are clean, new and in good working condition. Hot /Cold water available Satisfactory performance level with a minor deficiency for damaged piping on water heater.

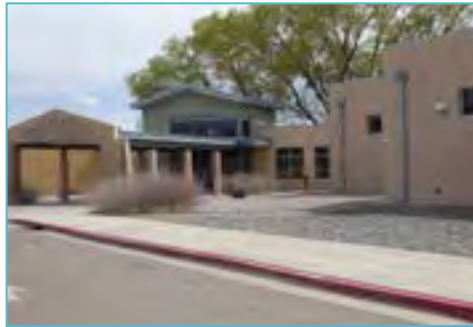
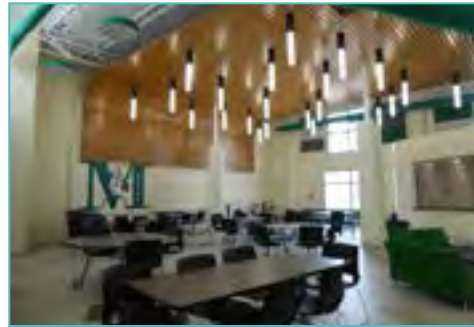
Water heaters not maintaining 3'-0" clearance, but are in working condition. Recommend removing excess storage to maintain 3'-0" clearance at all times. Water fountains are in working condition but have hard water staining on stainless steel.
