# San Jon Municipal Schools Facility Master Plan 2016 - 2021

December 12, 2016

Visions In Planning, Inc.  
Educational Facility Planning Consultants

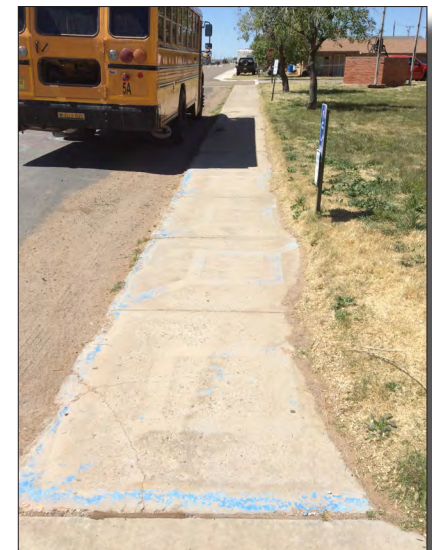
Parking is available on the south-side of the elementary classrooms, and along 7th Street and is also used for bus drop-off/ pick-up. The parking lot is a combination of deteriorated asphalt and gravel, all of which is in need of replacement. The parent drop area is located in front of the main building along 7th Street and is adequate for the loading and unloading of students, however, it is in need of road maintenance from the Village of San Jon.

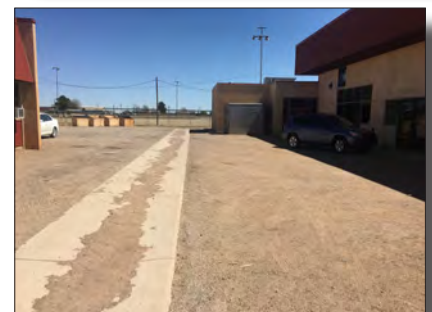
While the site is relatively flat with adequate overall site drainage, there are few areas around the campus where ponding is a problem (east side of the main building). The concrete sidewalks around the main building has several areas of spalled surfaces and settlement that need to be replaced to prevent tripping, and meet ADA requirements. There are also several large trees that are adjacent to the facility that either need to be removed or trimmed to reduce debris on the roof. Landscaped areas include grass areas around the facility are not supplied by an irrigation system and are manually watered.

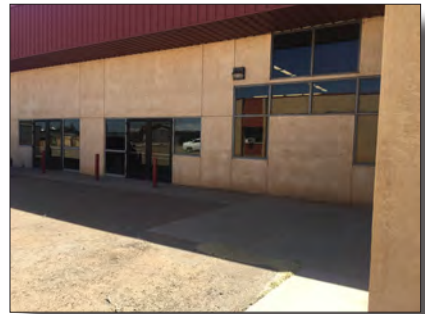
The exterior doors are hollow metal and are comprised of either solid panel or have glazed vision panels; and the door frames throughout the facility are hollow metal, many of which are in need of replacement and/ or door hardware upgrades. The exterior windows at the middle and elementary classrooms are operable single and double pane steel/aluminum units with most having thru-window residential grade A/C units. The windows in the corridor in front of the Old Gym are the original single pane steel window units from 1960 and need replacement, as well as the window units (including clerestory) in the Natatorium need to be replaced as the window seals are deteriorated and in some areas broken allowing condensation in between the panes. The window units adjacent to the New Gym are in good condition.
