Turquoise Trail Charter School

*Facility Master Plan/ Ed Spec
2017 - 2022
October 26, 2017*

Visions In Planning, Inc.
Educational Facility Planning Consultants

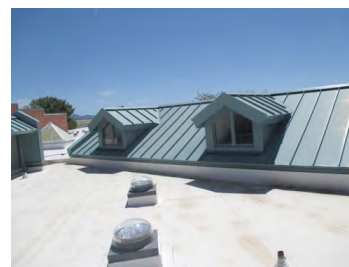
Leakage was reported in the Entry Hallway at dormer windows on northwest side. Existing construction is metal skin / roof system over wood frame. No underlayment is evident. Wood is exposed and visible

in some areas. (PHOTOS #14 THRU #19)

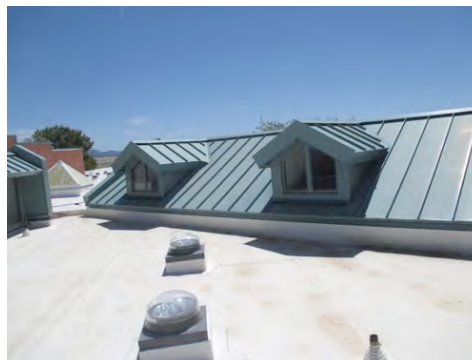
Leakage was reported in Entry Hallway at dormer windows on northwest side. Existing construction is metal skin / roof system over wood frame. No underlayment is evident. Wood is exposed and visible in some areas. Surface joints between metal pieces were unsealed. (PHOTOS #14 THRU #19)

Correct installation would include a high-temperature, waterproof membrane installed over the wood framing and under the metal system. To do this would require complete removal of the existing metal, installation of the underlayment and reinstallation of the metal system. Tolerance for leaks, available funds and intended lifespan of the building should be considered. Recommend maintaining a log of leaks with regular monitoring of existing condition. Should TTCS and SFPS elect to make comprehensive repairs, detailing and additional material information could be developed at that point.

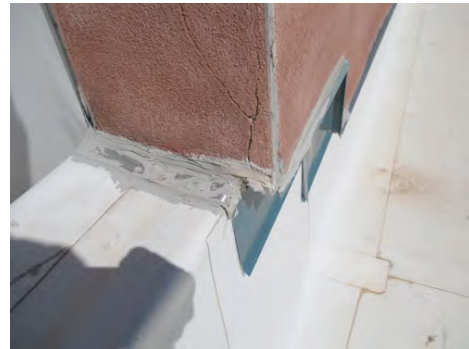
Roof to wall terminations, where parapets or low walls meet adjacent perpendicular walls, are poorly detailed with surface or butt terminations, no flashing / counterflashing, and no saddle flashing at the substrate.

At parapet to sidewall intersections, create ‘saddle flashing’ with single-ply membrane, vertical extension 8 inches up wall and 16 inches onto parapet. Terminate all edges of single-ply with termination bar and counterflashing to cover termination bar. Ensure sealant between term bar and stucco. If concurrent with stucco repairs, new metal saddle flashing at substrate could be properly integrated with stucco. *Avocet can provide a sketch for this detail if requested.*
